**TAILINGS AND PRODUCTION ROCK SITE
2011 ANNUAL REPORT**

Hecla Green Creek Mining Company

April 15, 2012

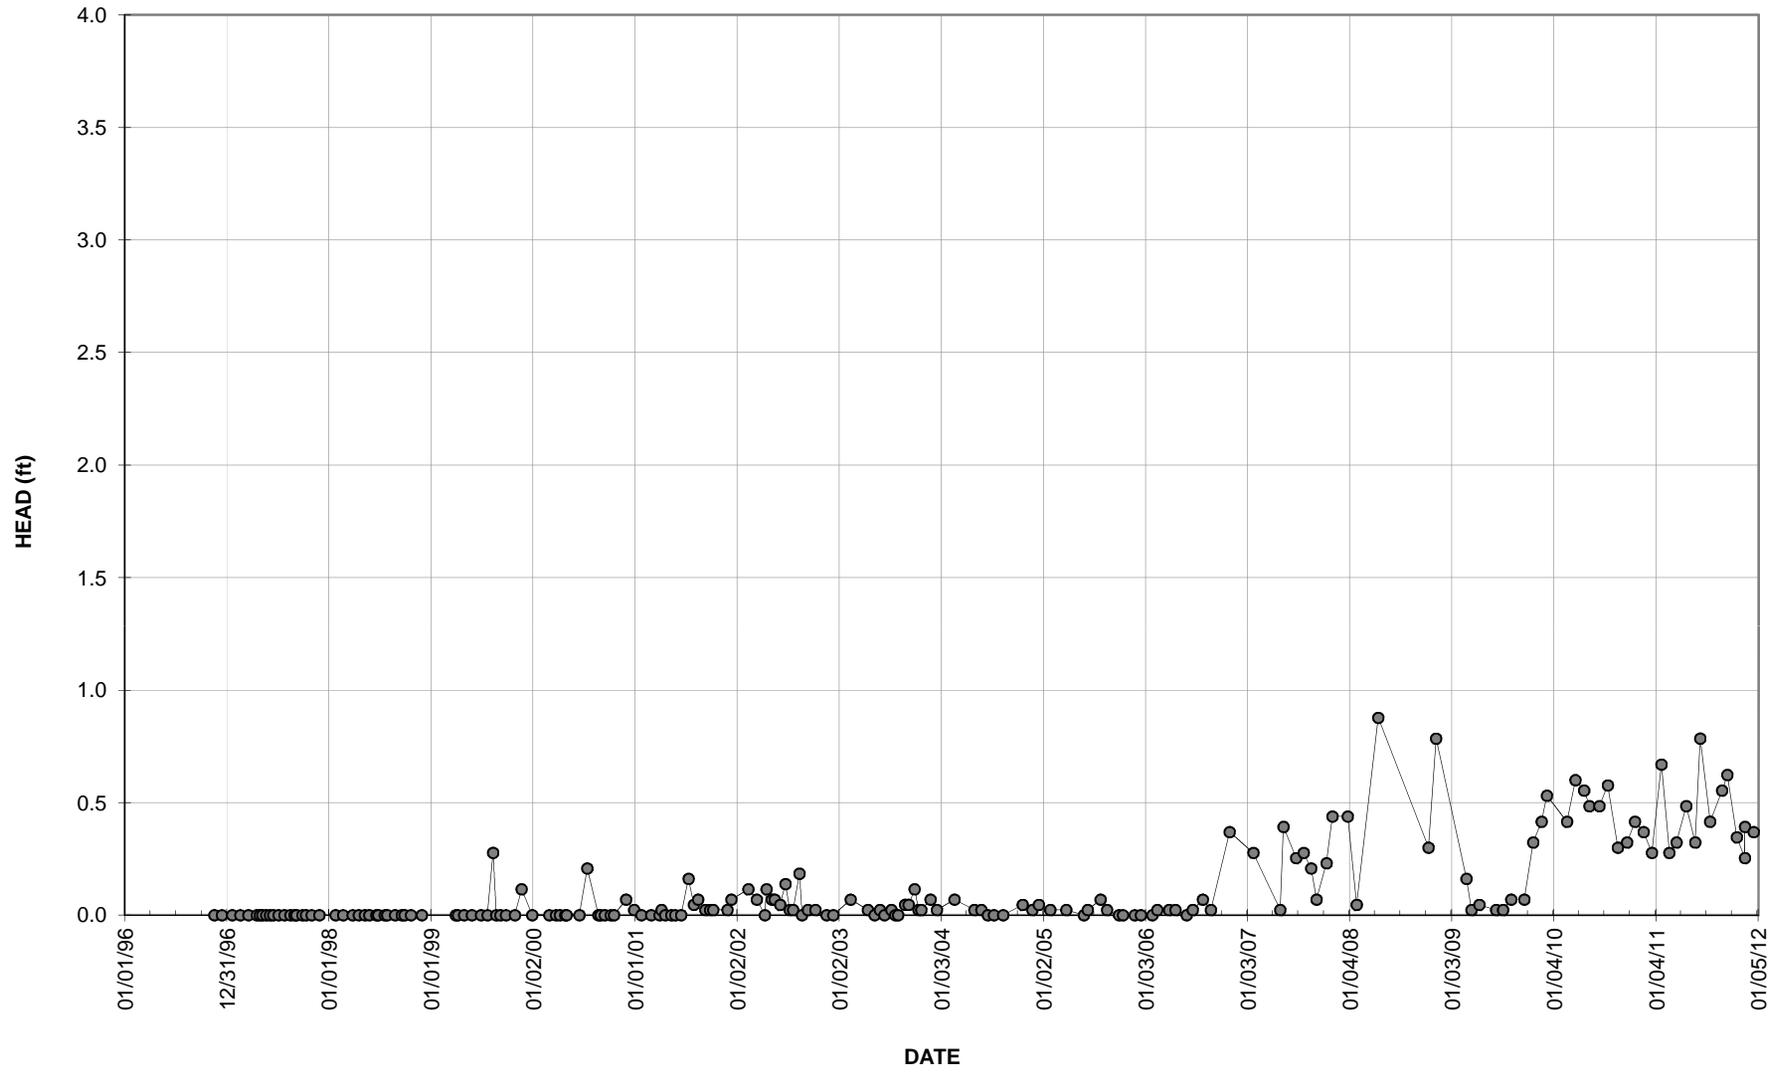
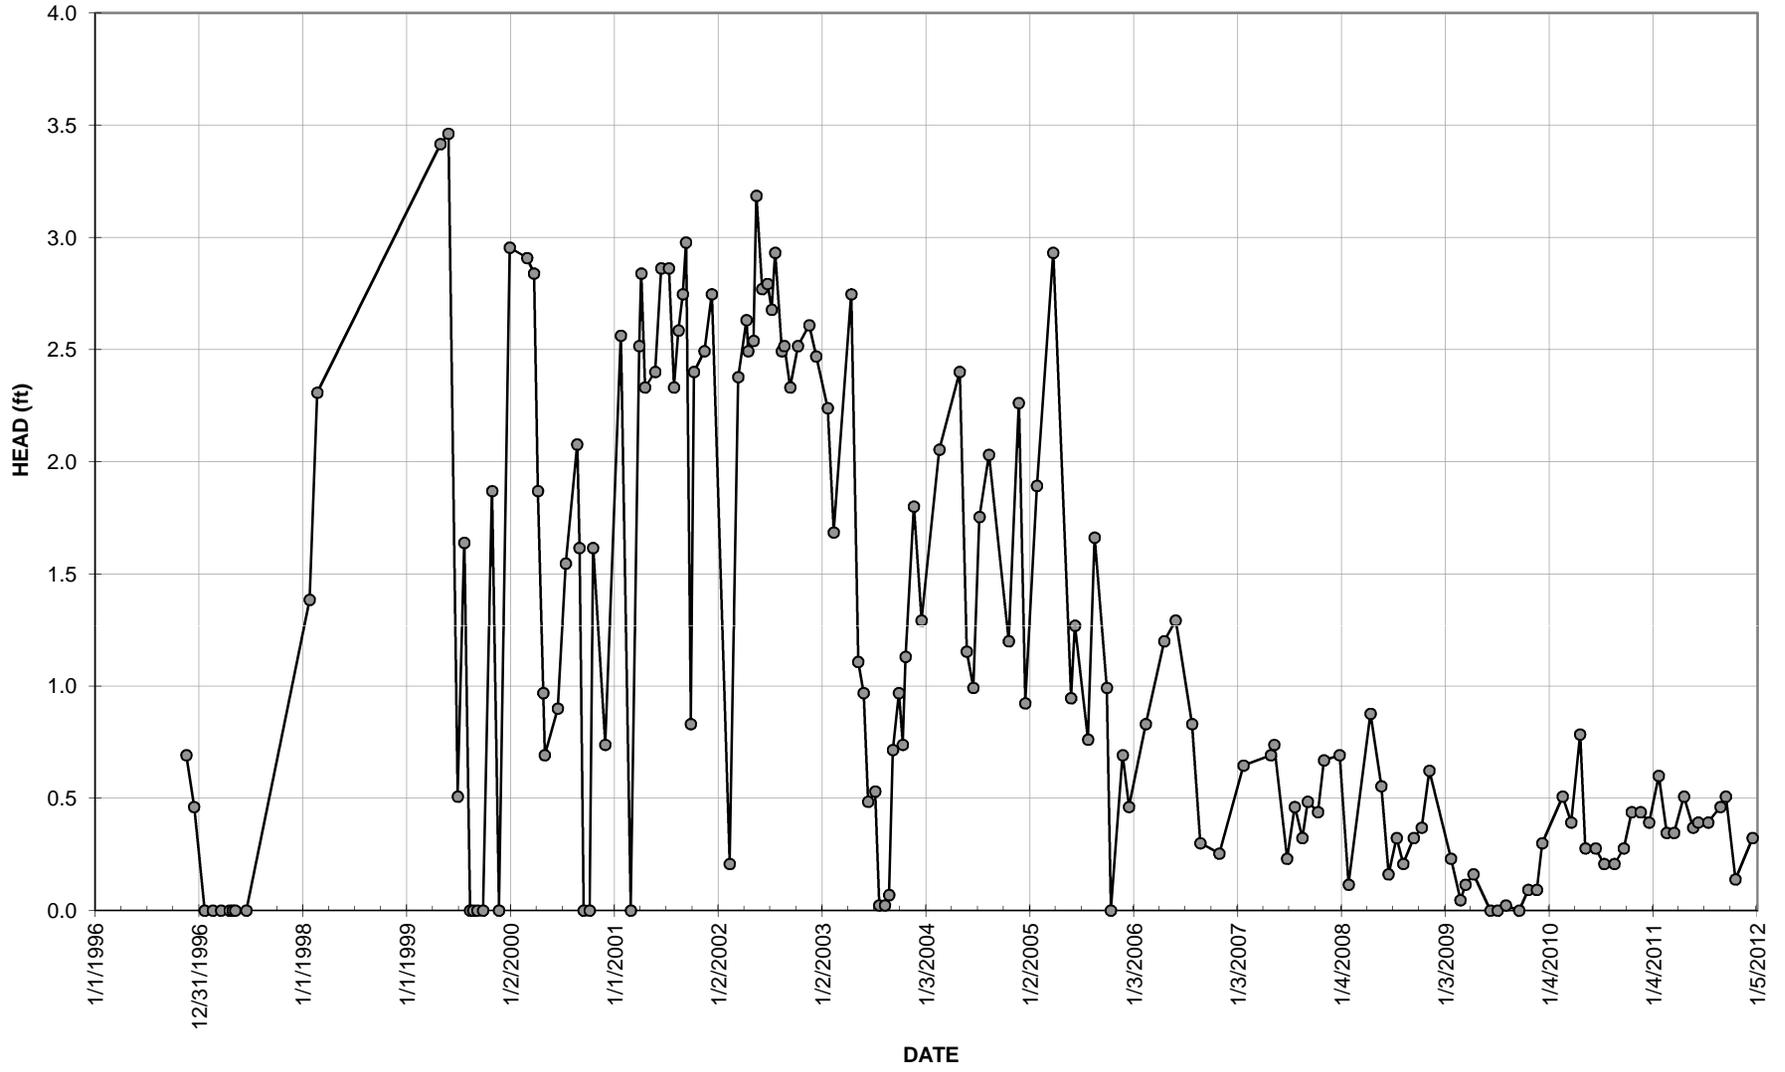
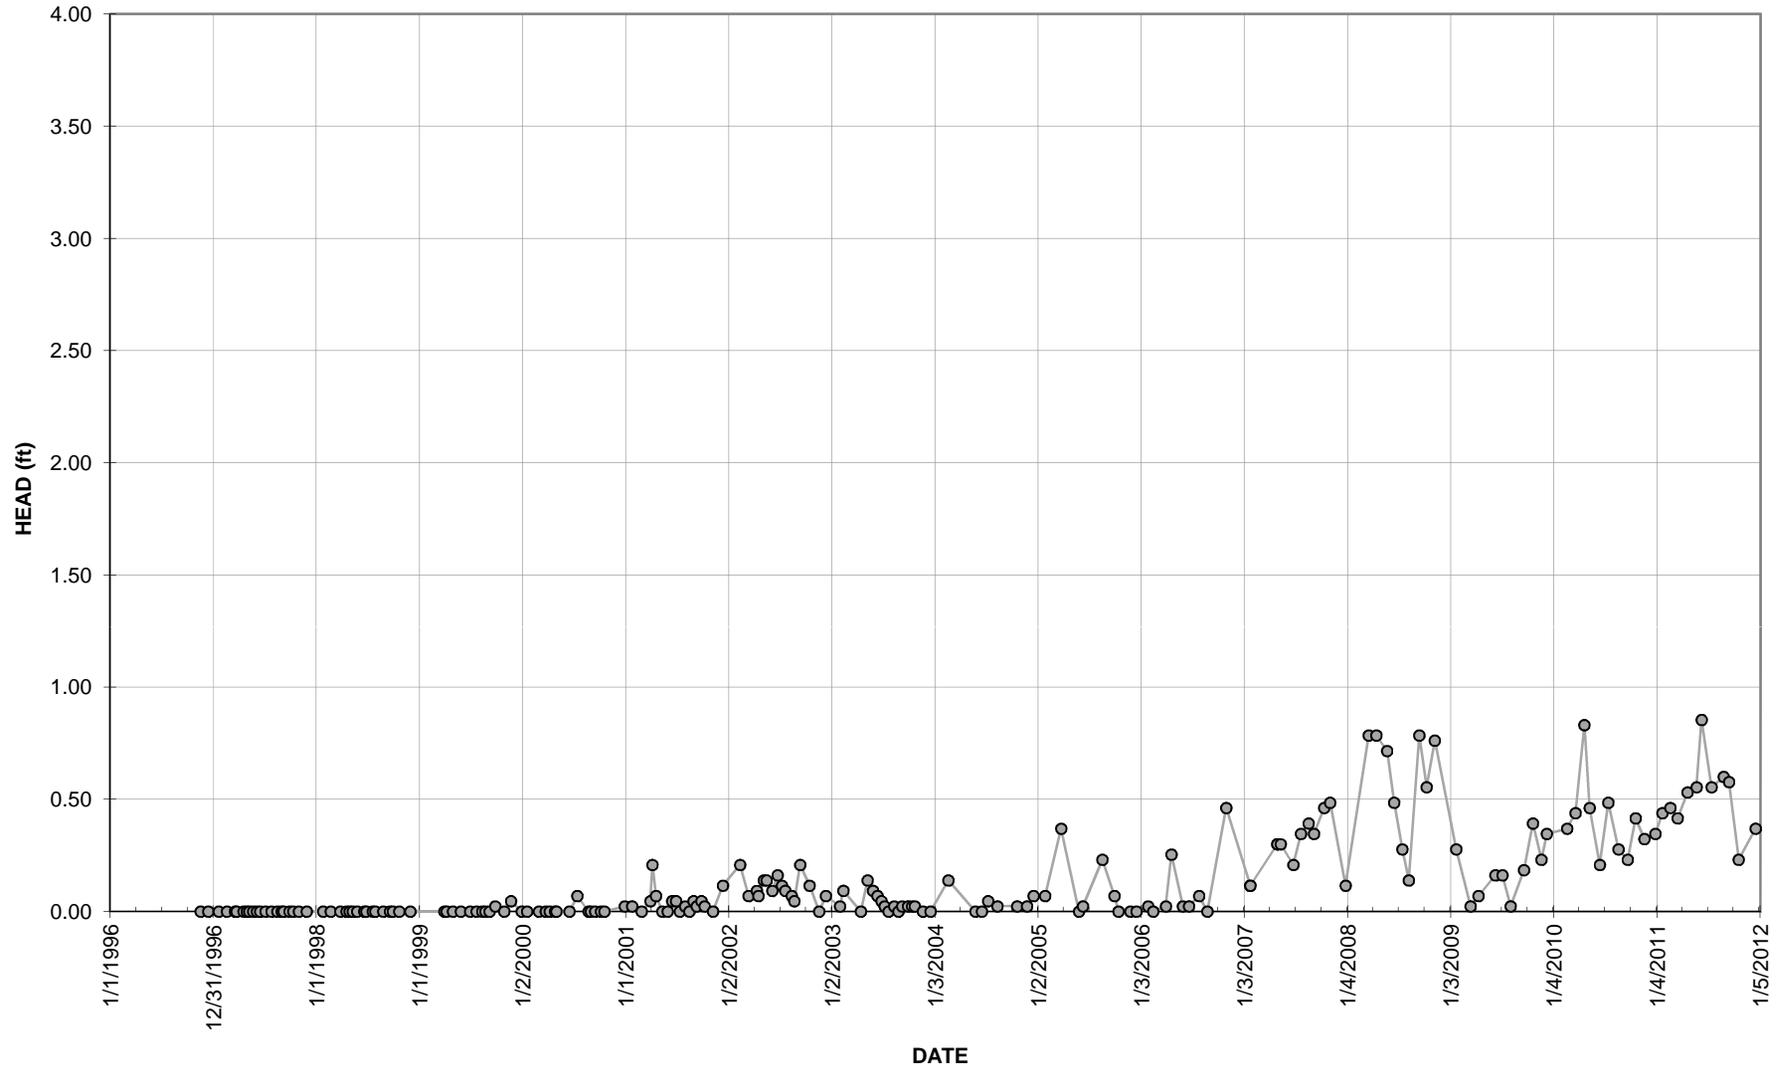
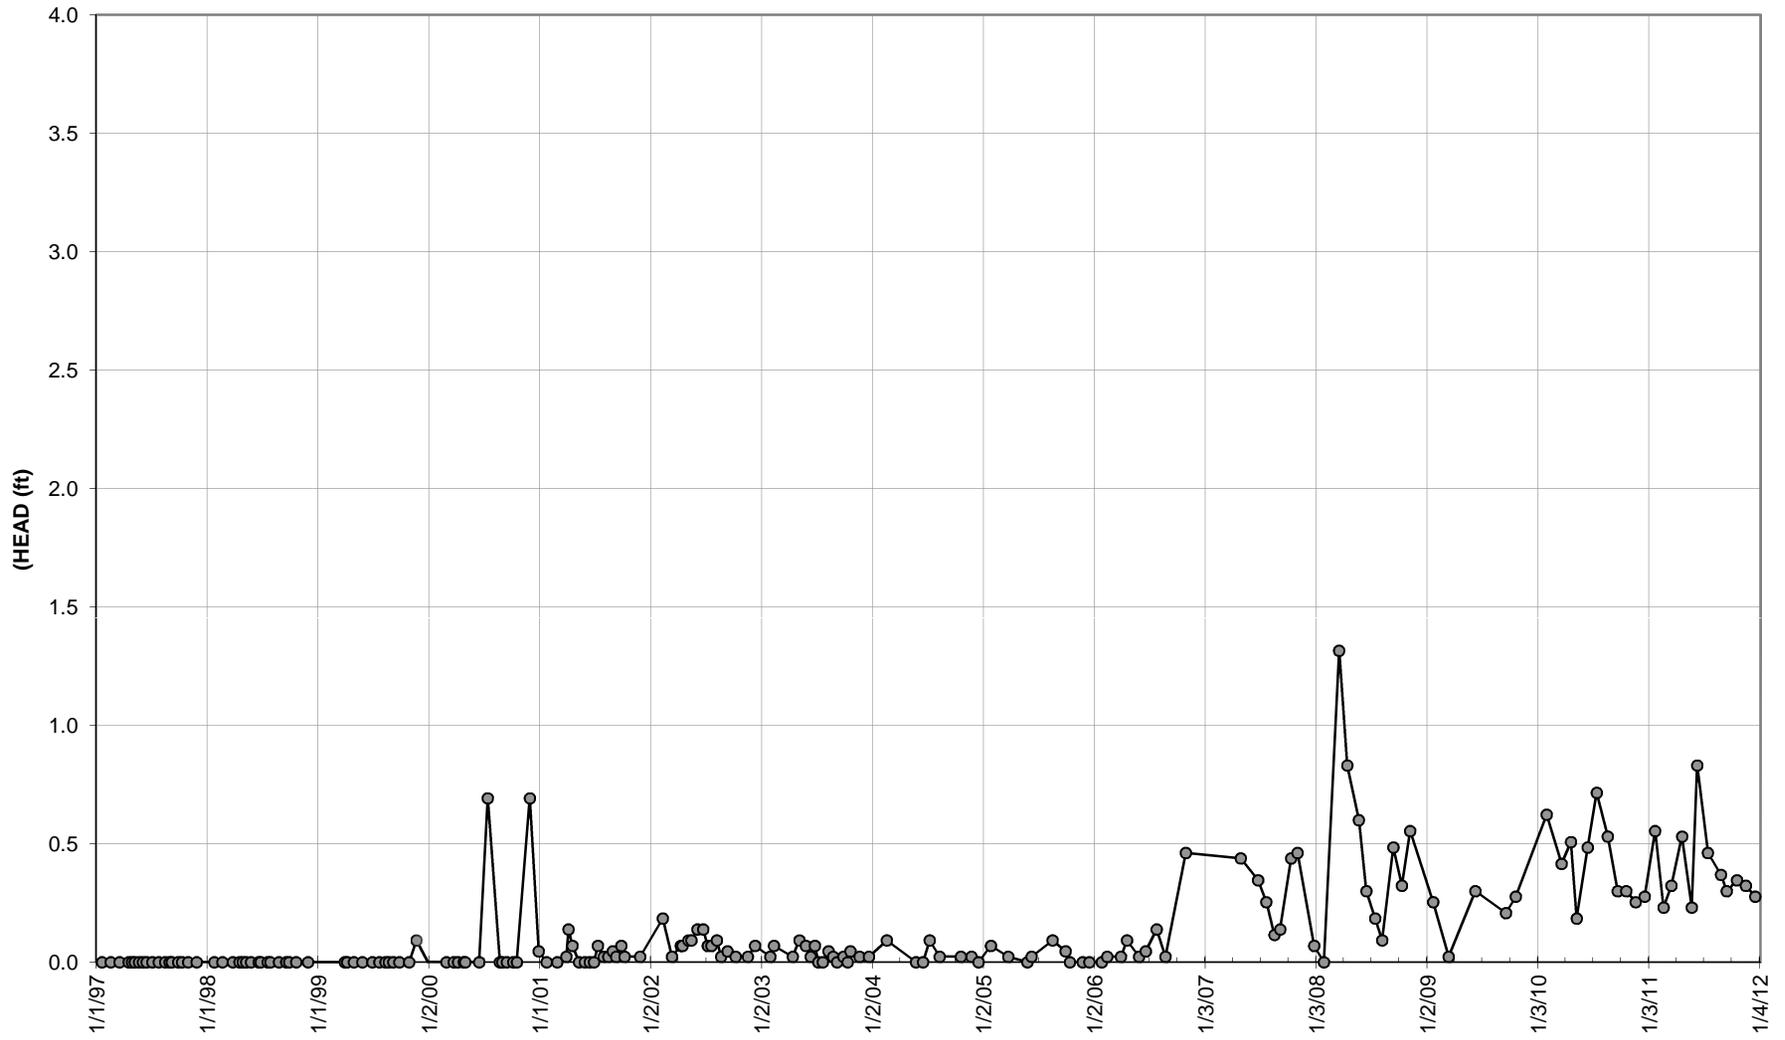
Well and piezometer water level data are provided in Figures 3.1 to 3.12. The lack of significant pressure in piezometers installed close to the base of Site 23 (piezometers 52-55, Figures 3.1 to 3.4) demonstrates that the pile remains free draining. This is consistent with the construction of a network of finger drains under the pile and a blanket drain at the pile toe. Comparison of historic versus modeled flow from the finger drains and the curtain drain indicated they are performing as designed and as necessary (EDE 2004). See Appendix 2 for piezometer and finger drain locations. The lack of pore pressure at the toe indicates that pile stability has been maximized. Water levels from several monitoring locations are shown in Appendix 2. The inferred water table is 30 to 60 feet below the base of the production rock pile material up-slope of the Site 23 active placement area and 5 to 20 feet below the base of material placed in Site D and the toe of Site 23, respectively (see also Figures 3.5 to 3.12). MW-23-00-03 data showed an atypical drop in water elevation in August 2007. However, data collected after that date are within the historical data range. Observations from wells completed in the colluvium below the sites indicate that perched water tables and braided flow paths exist beneath the site (e.g. compare Figure 3.6 and 3.7). This unit also shows large (up to 10 feet) fluctuations in head levels, which are consistent with perched, confined conditions and channel-like flow. There is a distinct seasonal pattern to the water level fluctuations beneath Site 23/D, particularly in the alluvial sands (Figures 3.9 and 3.11).

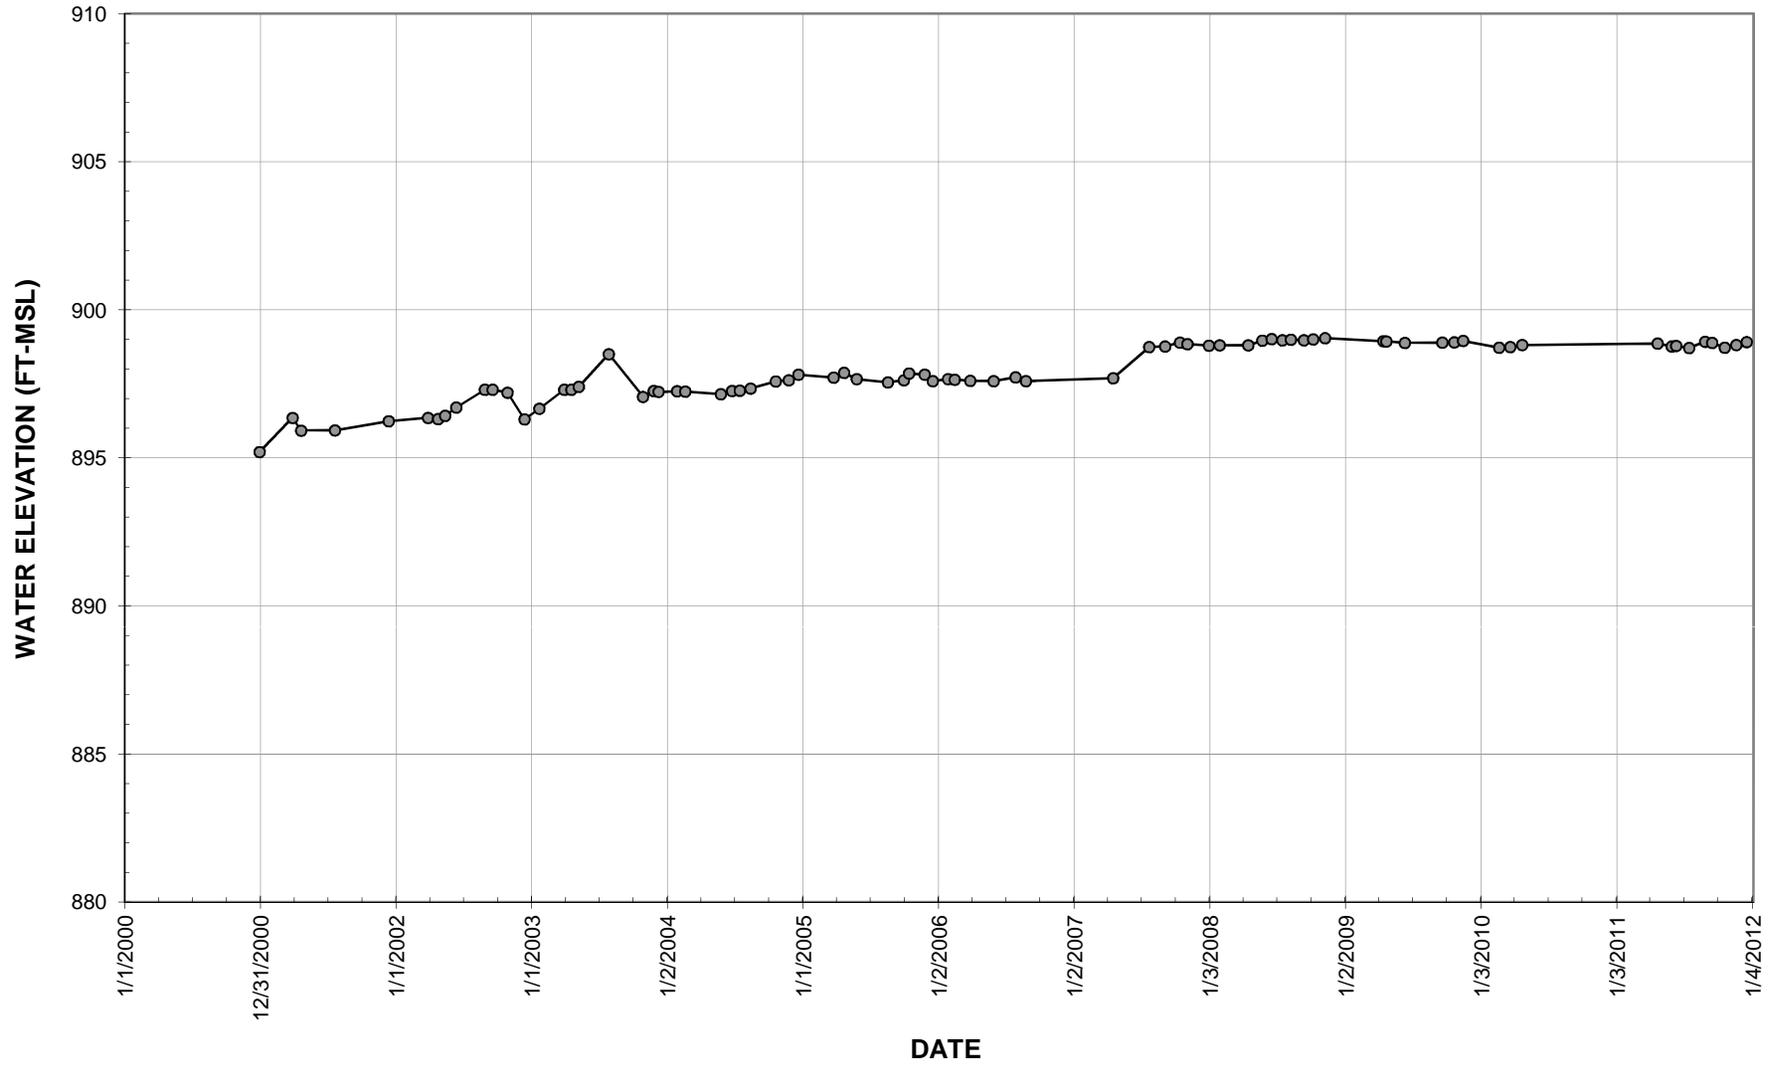
Figure 3.8 Water Level Data for Well MW-23-98-01

The silty/clay till that underlies the colluvial unit impedes downward flow and has an upward hydrologic gradient caused by its confining the more permeable bedrock below it. MW-23-98-01 (Figure 3.8) is completed in the till unit and indicates a water table near the top of the till, which is approximately 100 feet below the existing topographic surface. Alluvial sands occur between the colluvial unit and the silt/clay till near the toe of Site 23 and under Site D. Data from MW-23-A4 and MW-D-94-D3 (Figures 3.9 and 3.11) indicate that the sands are saturated. A curtain drain installed in between Site D and Site 23 in 1994 collects water that flows at the base of the colluvial unit and the top of the alluvial sands (see as-built and sections). This drain helps reduce pore pressures in the foundation of Site D, as well as capturing infiltration waters from Site 23.

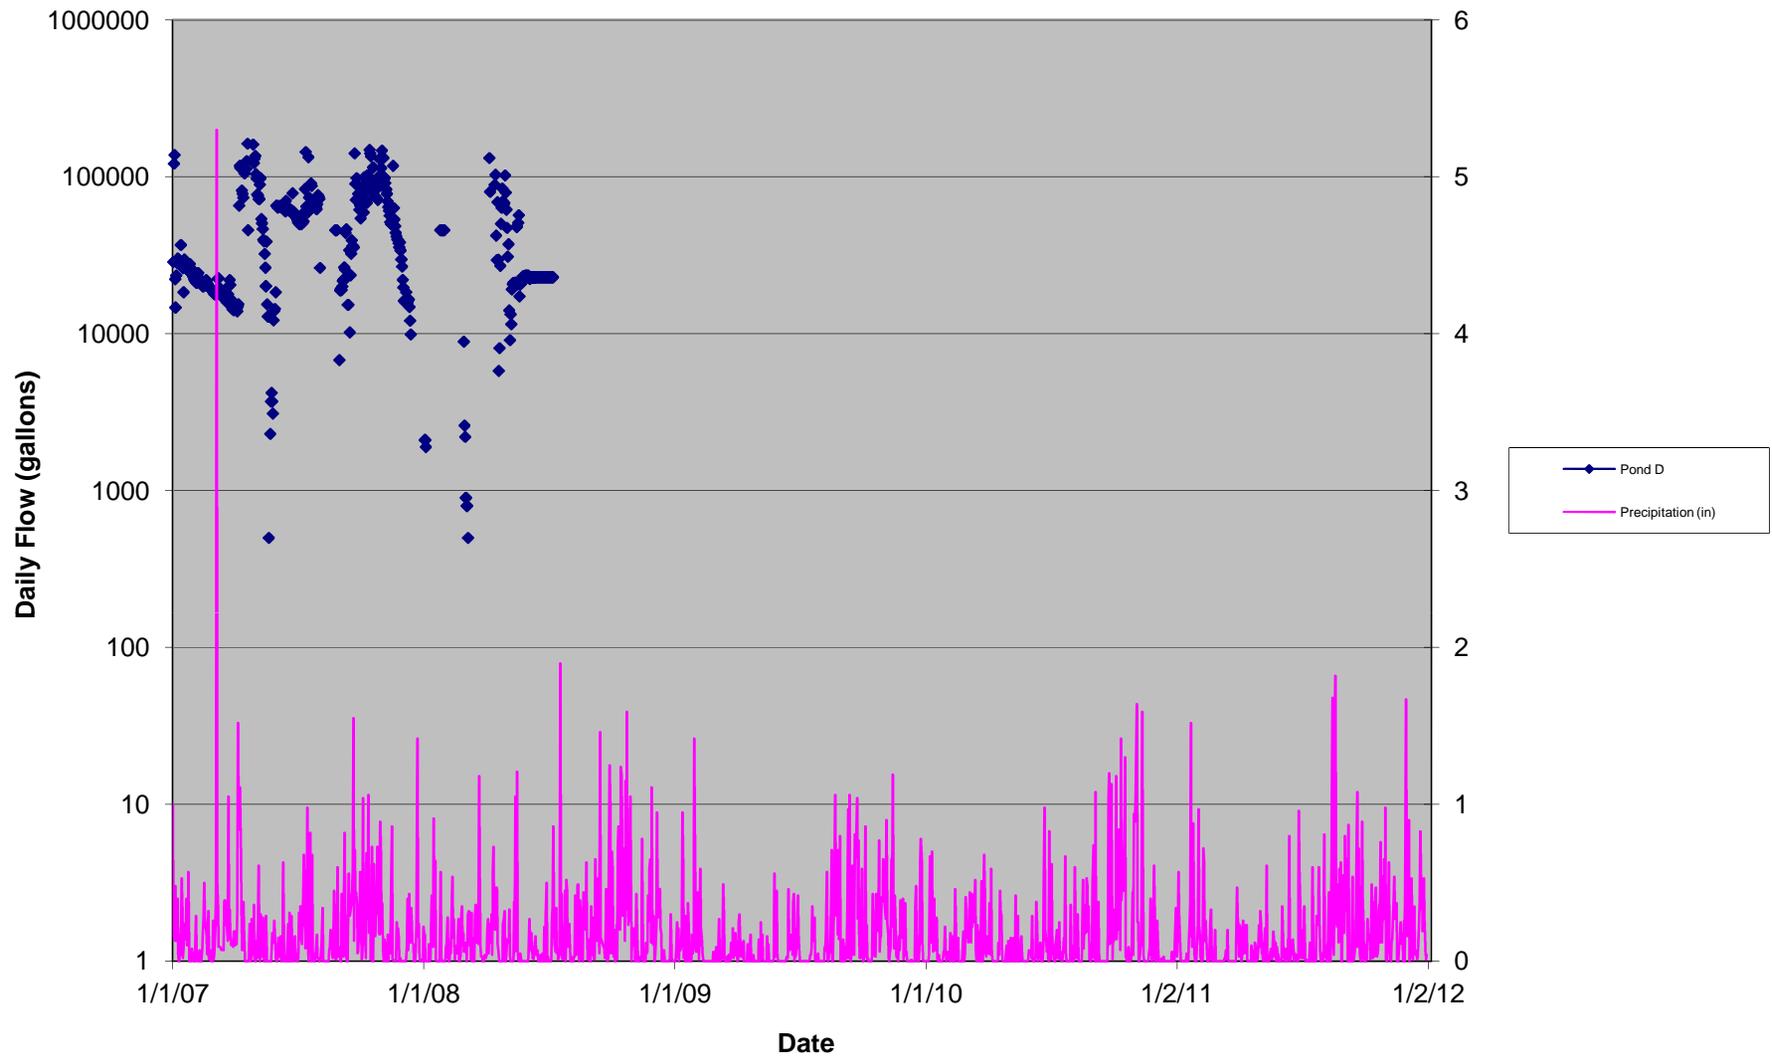
FIGURE 3.13 POND D FLOW DATA

Flow data for Pond D are shown with precipitation in Figure 3.13. The Pond D flow meter was not operating from July 2008 through 2011 due to changes in pumping/piping as noted above. Once all equipment is in place and operating, flow measurements will resume.

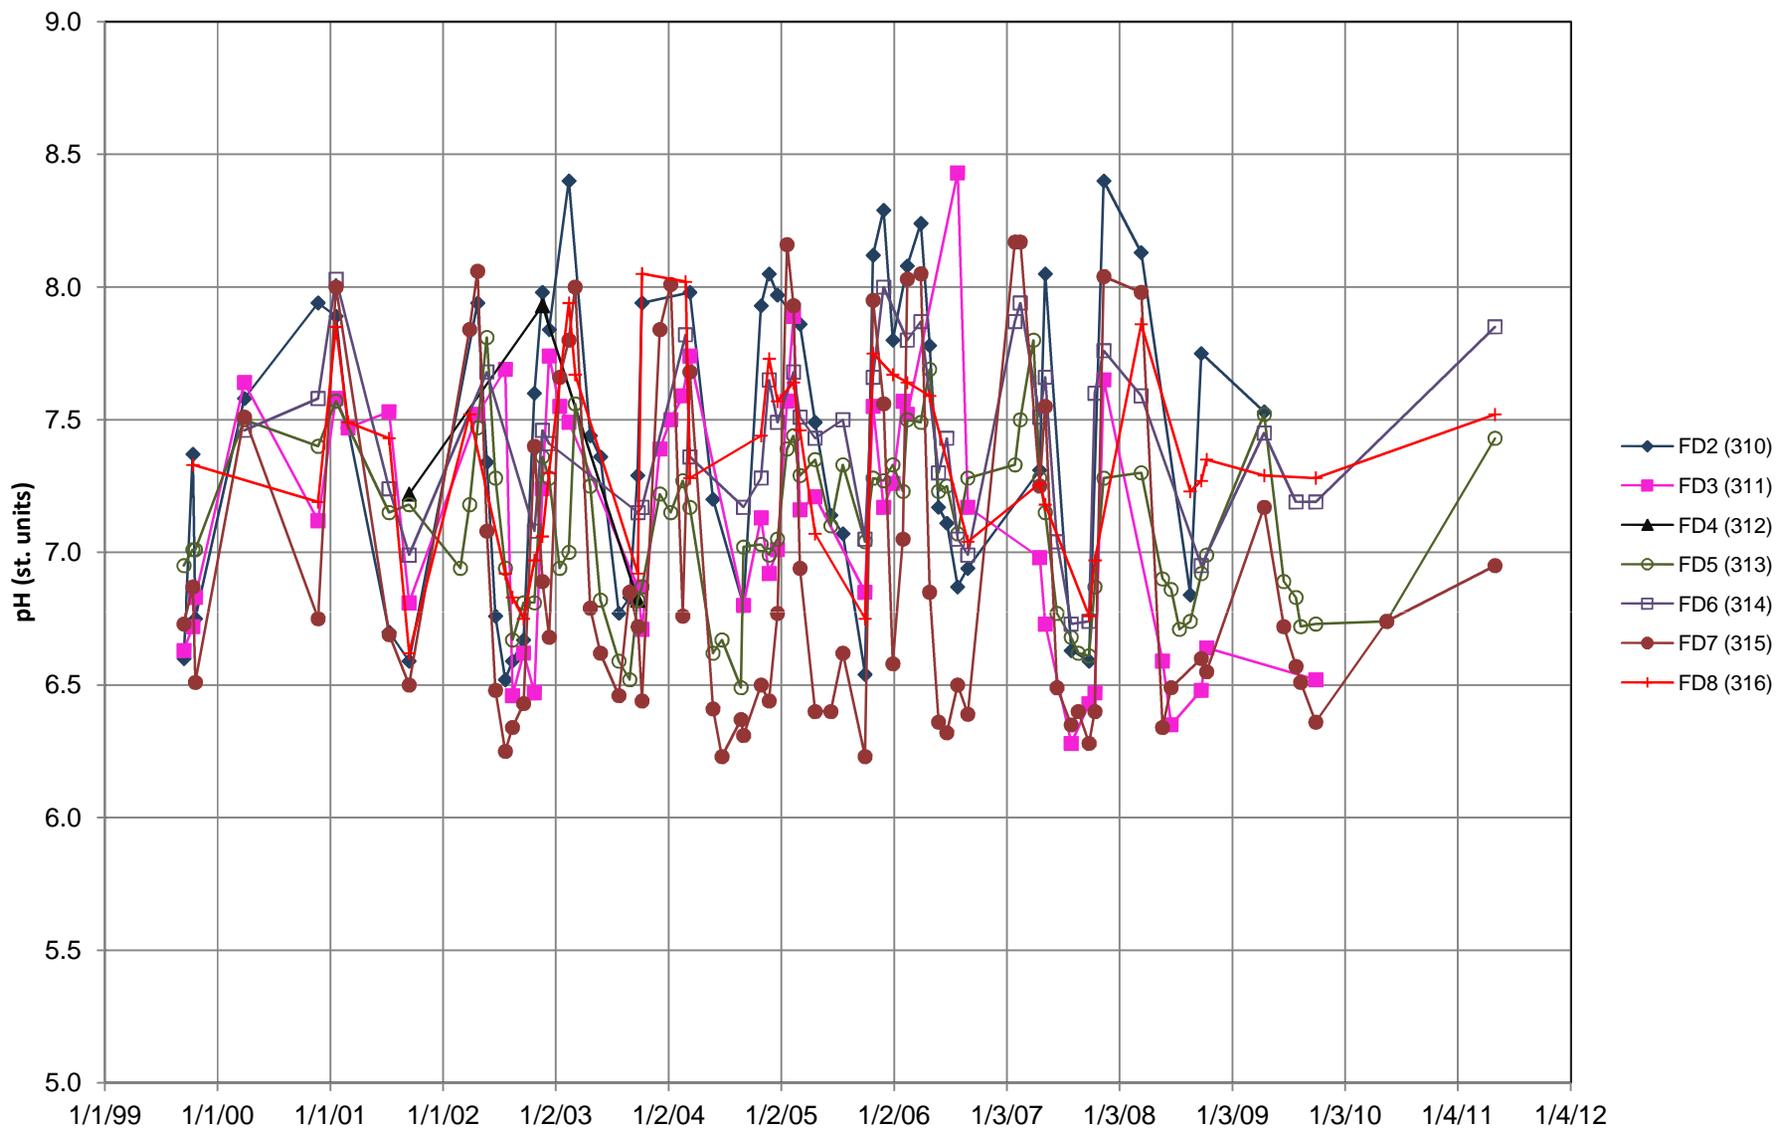
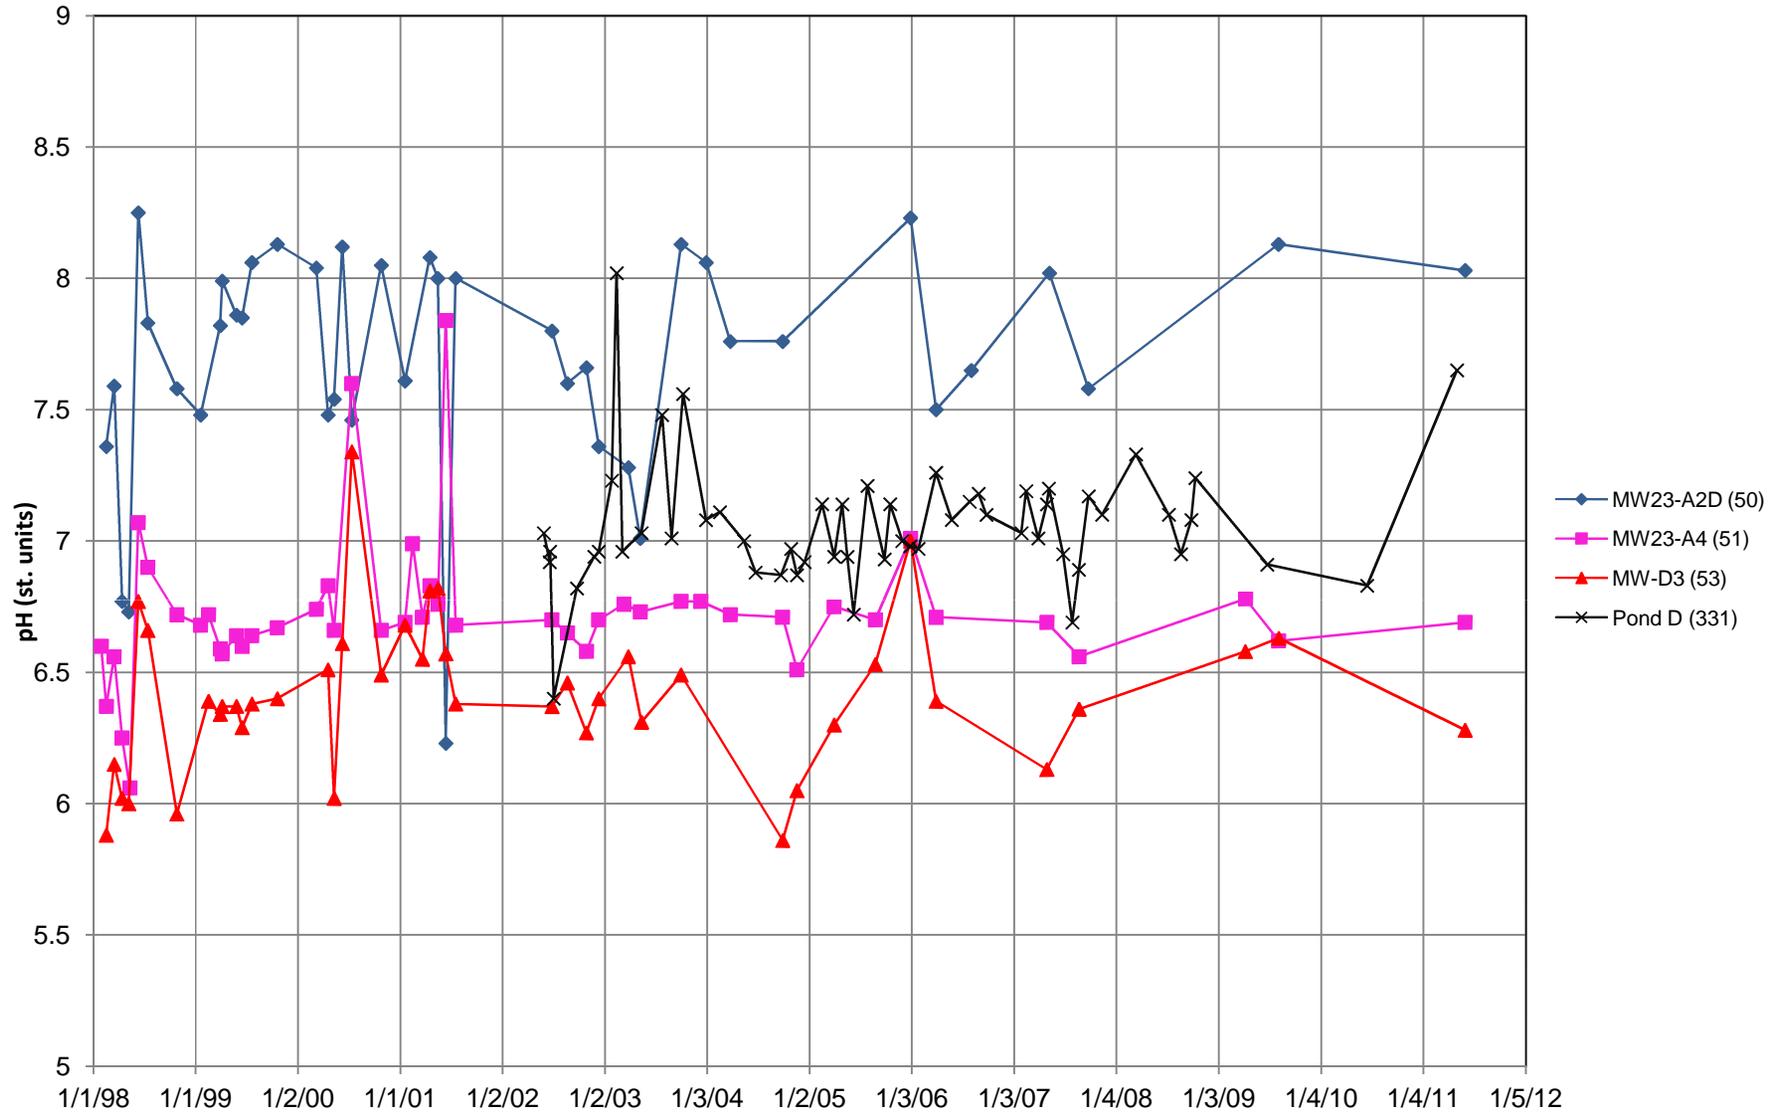
Figure 3.14a shows the pH of waters collected from Site 23 Finger Drains 2 through 8, and Figure 3.14b shows the pH of monitoring wells MW-23-A2D, MW-23-A4, MW-D3 and Pond D (see as-built in Appendix 2 for locations). Values of pH were between 6.3 and 8.0 for all internal monitoring site samples in 2011. The lower pH values (generally pH 6.0 to 7.0) were recorded in MW-23-A4 and MW-D3, both of which are completed in alluvial sands beneath Site 23 and Site D, respectively. MW-23-A2D, which screens colluvium upgradient of Site 23, typically has the highest pH (generally pH 7.0 to 8.5). The Site 23 finger drains fluctuate at values between those of the monitoring wells. Figures 3.14a and b suggest that waters from different foundation units have different pH values and that Site 23 and Site D contact waters and the materials with which they are in contact exhibit sufficient buffering capacity to prevent acidification of site drainage in the near term. Seasonal fluctuations are apparent in the finger drains with highest pH values occurring in winter months and lower pH in mid to late summer.

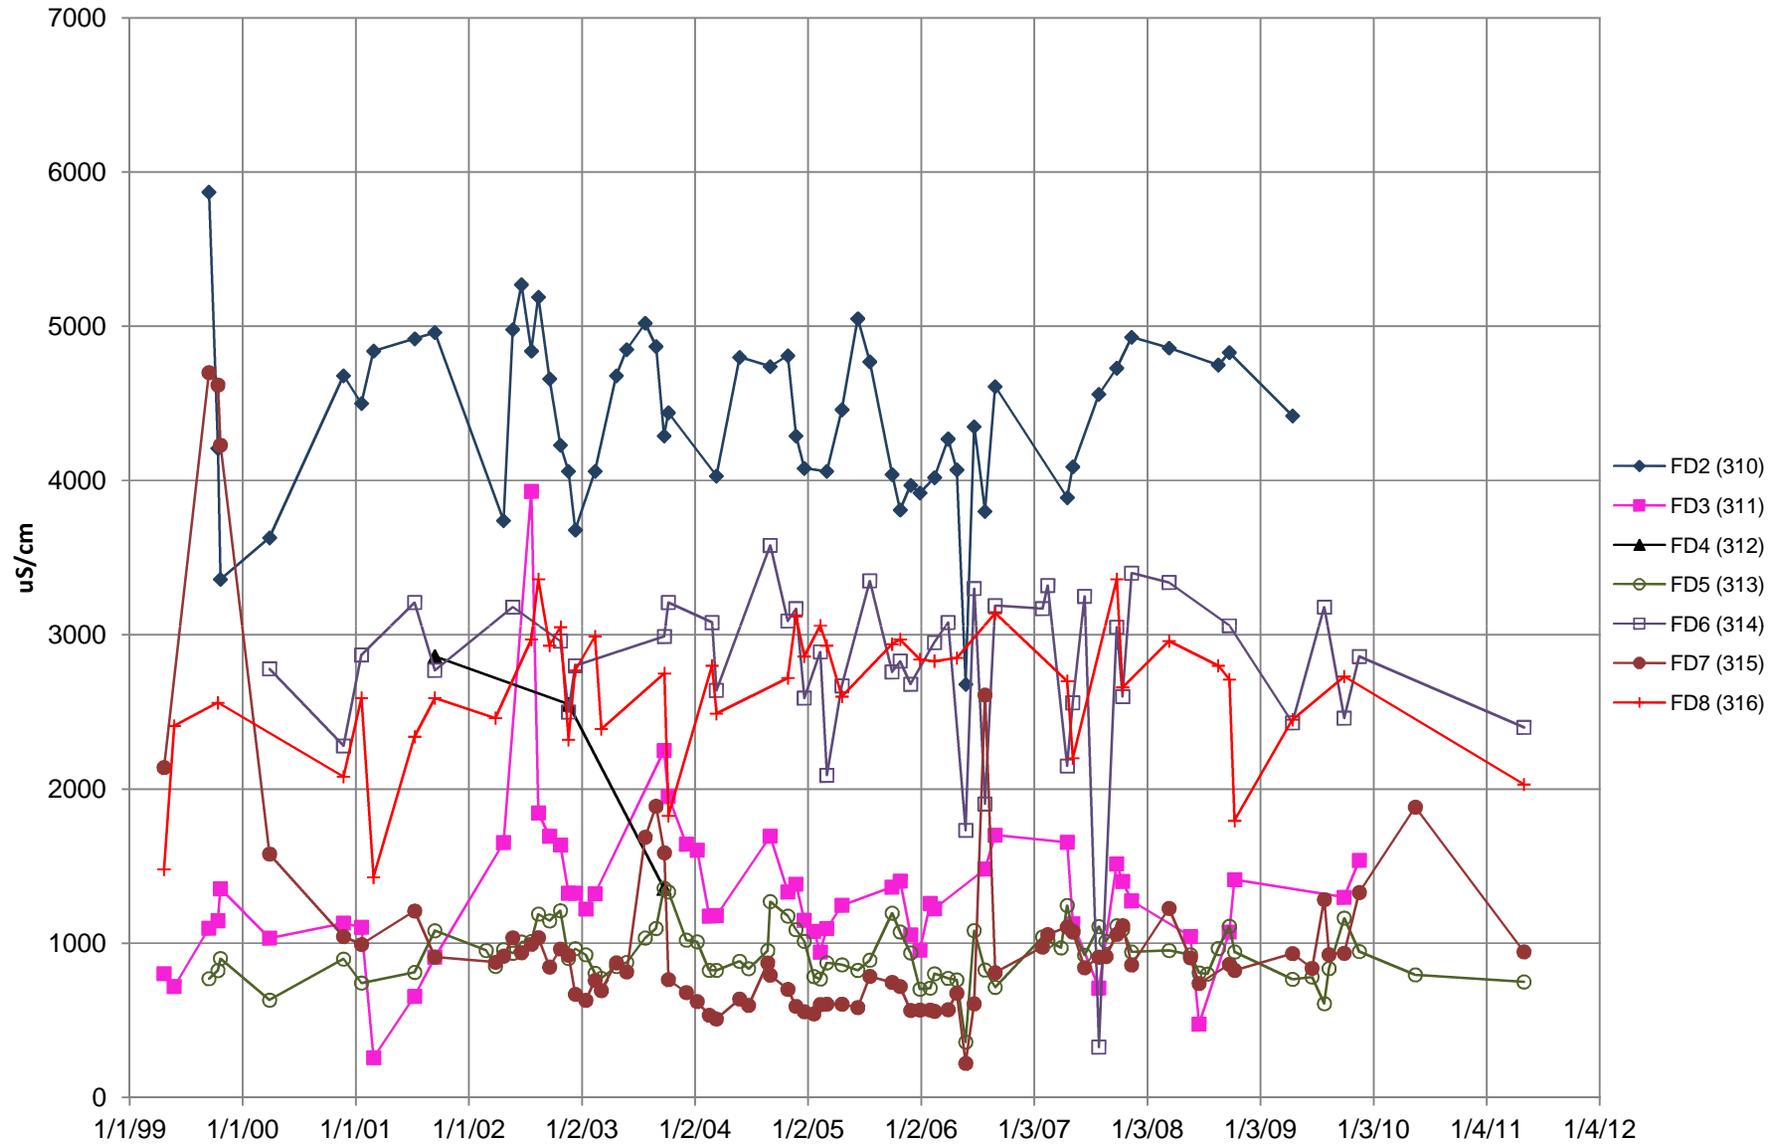
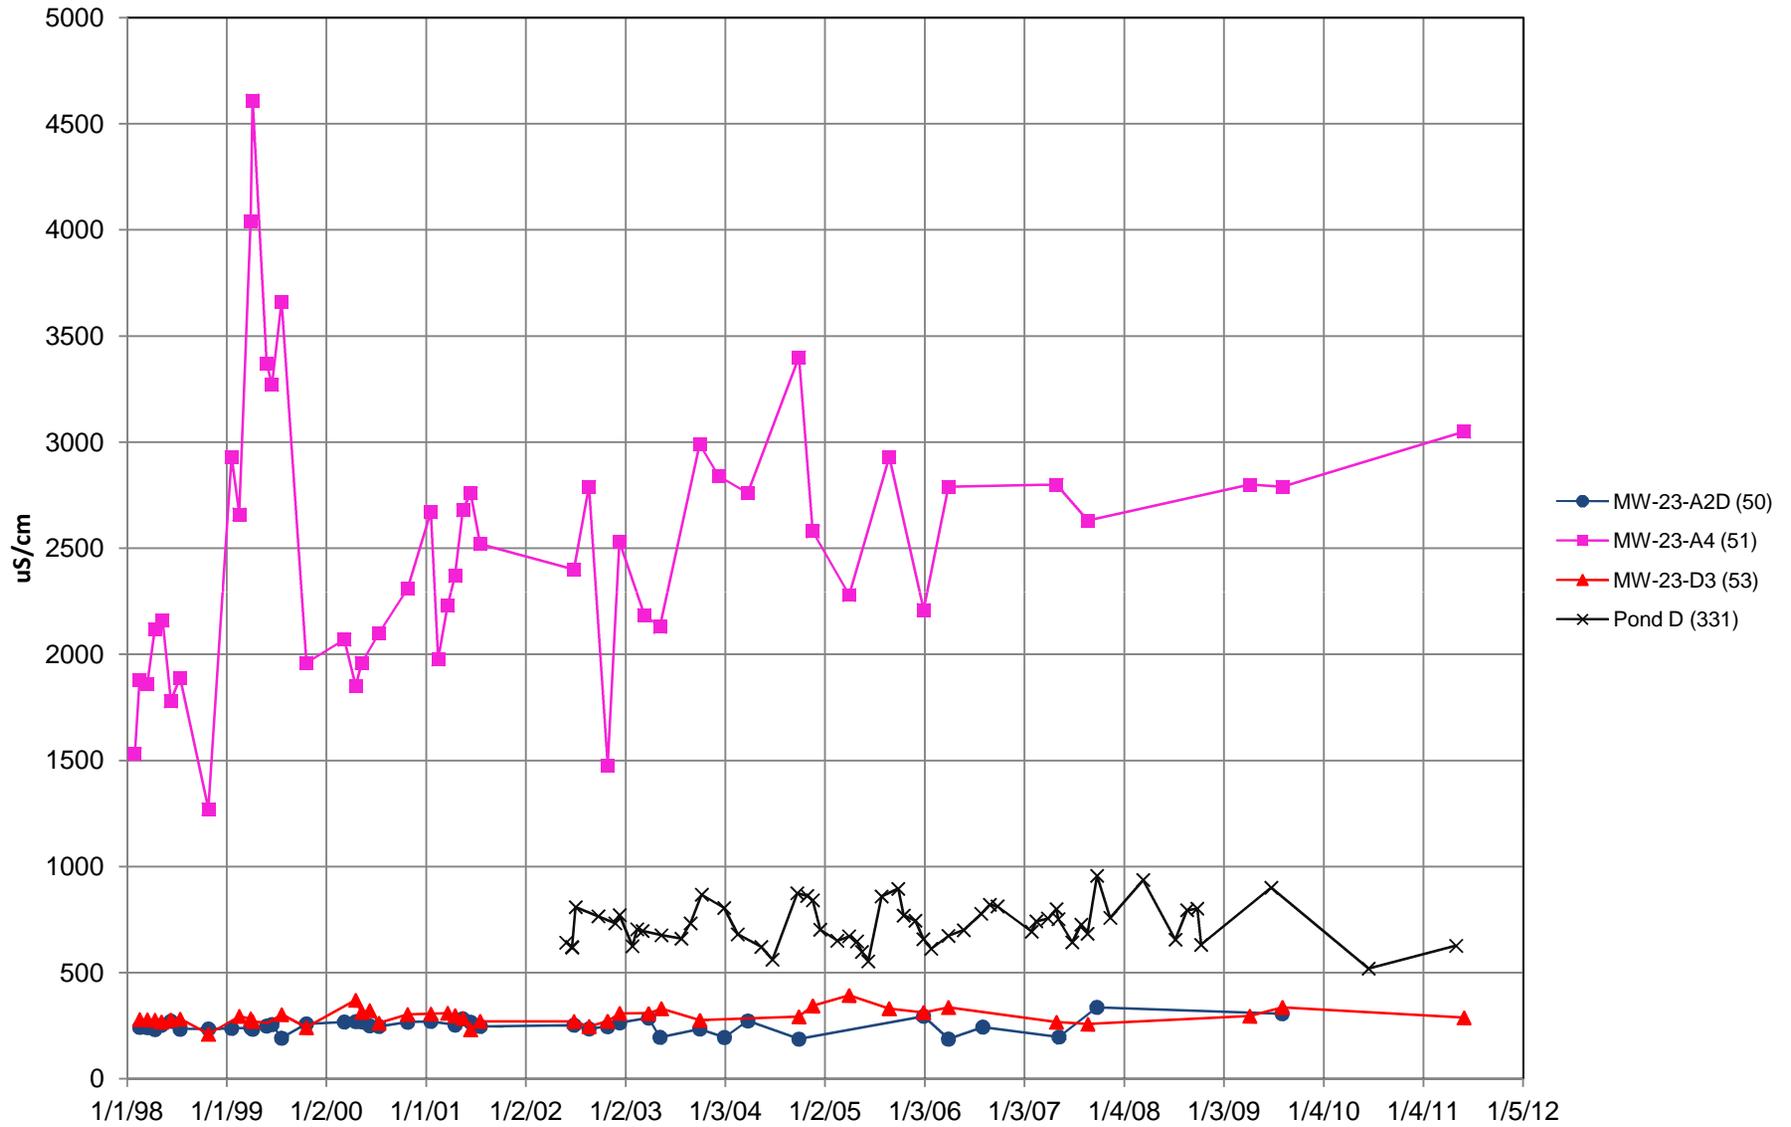
Conductivity results from internal monitoring site waters are presented in Figures 3.17a and b. The 2011 conductivity measurements continue to range up to 4,420 uS/cm. MW-23-A2D and MW-D3 have the lowest conductivity. MW-D3 is completed in alluvial sands below the fill placed at Site D. The finger drains with the highest flow (e.g. 23FD-5, which directly drains an excavated spring) generally have lower conductivities than the drains with lower flow. This reflects a larger contribution from groundwater to the high-flow drains relative to a higher proportion of site contact water in the other finger drains. The significant decrease in conductivity in 23FD-7 that occurred in 2000 is probably the result of incorporation of groundwater collected in the upper portion of the drain above the active placement area. The presence of contact water in the alluvial sand below Site 23 (as seen in MW-23-A4) is not surprising given the permeable nature of the colluvium that lies immediately beneath the site. A clay till layer underlies the colluvium and alluvial sands beneath the site. The clay till serves as a barrier to downward flow; however, as discussed earlier, it occurs well below the base of both

Finger Drain 23FD-2 has the highest conductivity but consistently low flow, suggesting no significant influence from groundwater. In fact, lack of flow from this drain typically precludes sampling. In 2009 it was dropped from the routine sampling list. The higher conductivity of the site contact waters reflects a larger dissolved load caused by weathering of the production rock. As with tailings, pyrite oxidation and carbonate dissolution contribute dissolved ions such as sulfate, bicarbonate, calcium and magnesium to the contact waters, increasing their conductivity. Sulfate concentrations for the finger drains and groundwater wells are plotted in Figures 3.18a and 3.18b and match closely the relative value patterns of conductivity. The drier than average spring and summer in 2009 and 2010 likely contributed to a greater buildup of oxidation products and reduced groundwater contribution to the water balance. This may result in higher conductivity and sulfate values for some sample sites.
