**TAILINGS AND PRODUCTION ROCK SITE
2011 ANNUAL REPORT**

Hecla Green Creek Mining Company

April 15, 2012

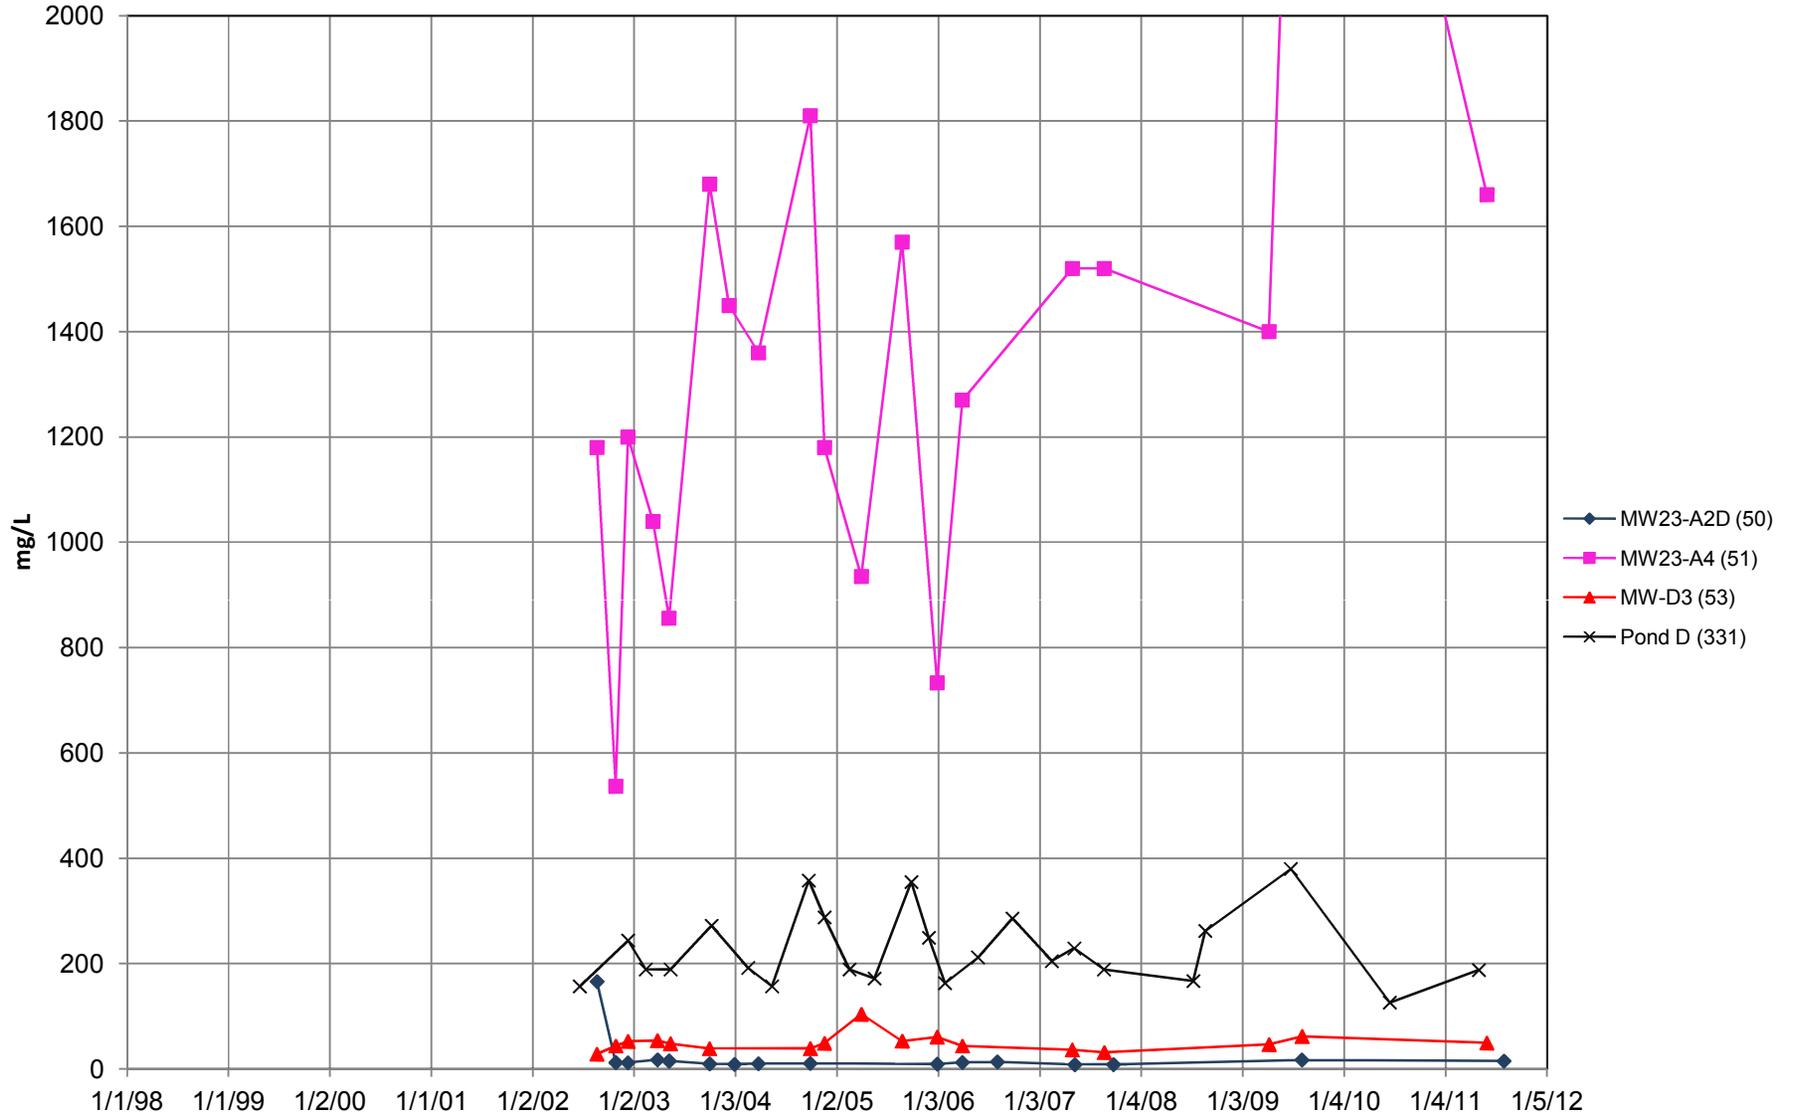
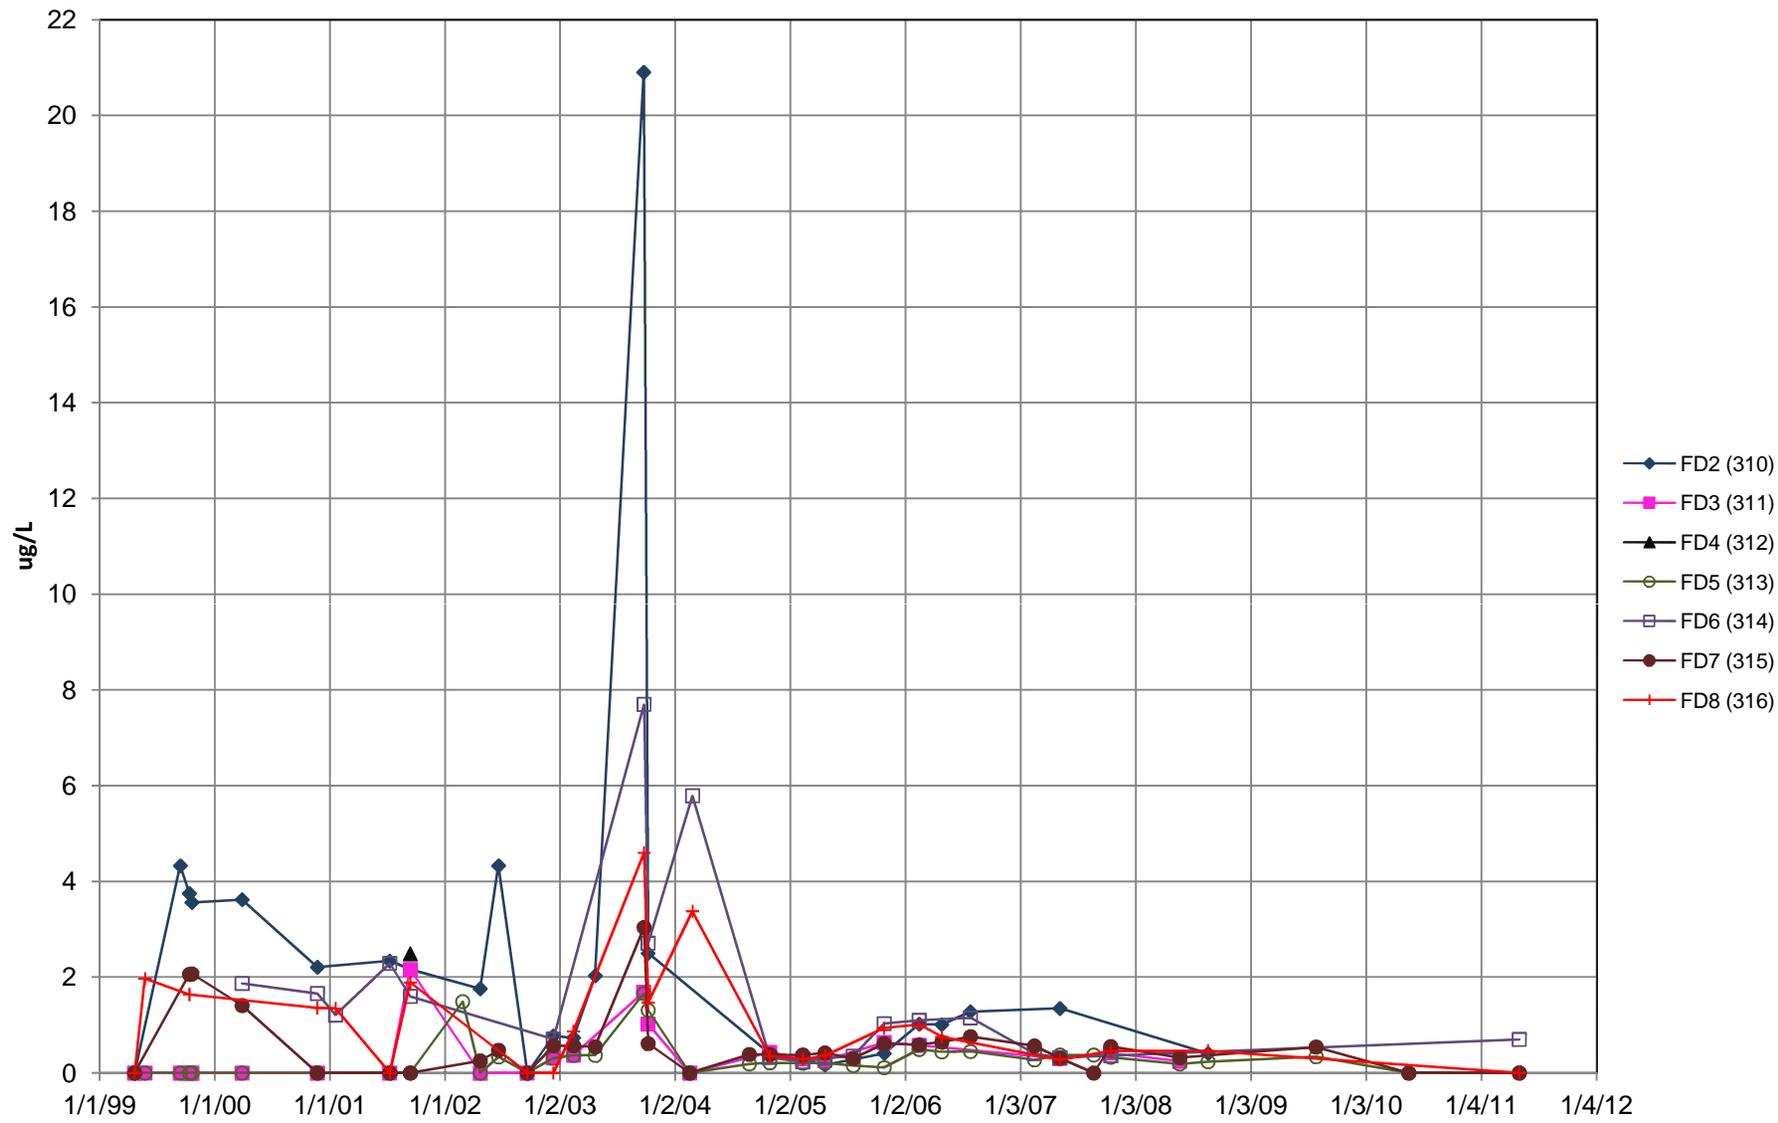
Figure 3.19a GREENS CREEK SITE 23/D INTERNAL MONITORING SITES:
FINGER DRAINS - ARSENIC DATA
(Non-detectable analyses plotted as zero)

Arsenic data are presented in Figures 3.19a and b and are generally quite low. All finger drains and MW-23-A4 experienced increases in their arsenic concentrations in September 2003, with subsequent decreases back down to historical levels in October. The flows in the finger drains positively correlate with these changes. Fluctuations in arsenic values in 23FD-2 can be attributed to changes in redox conditions. Low arsenic and iron (Figures 3.25 a and b) concentrations indicate that these metals are precipitating as oxyhydroxides on rock surfaces in the pile.

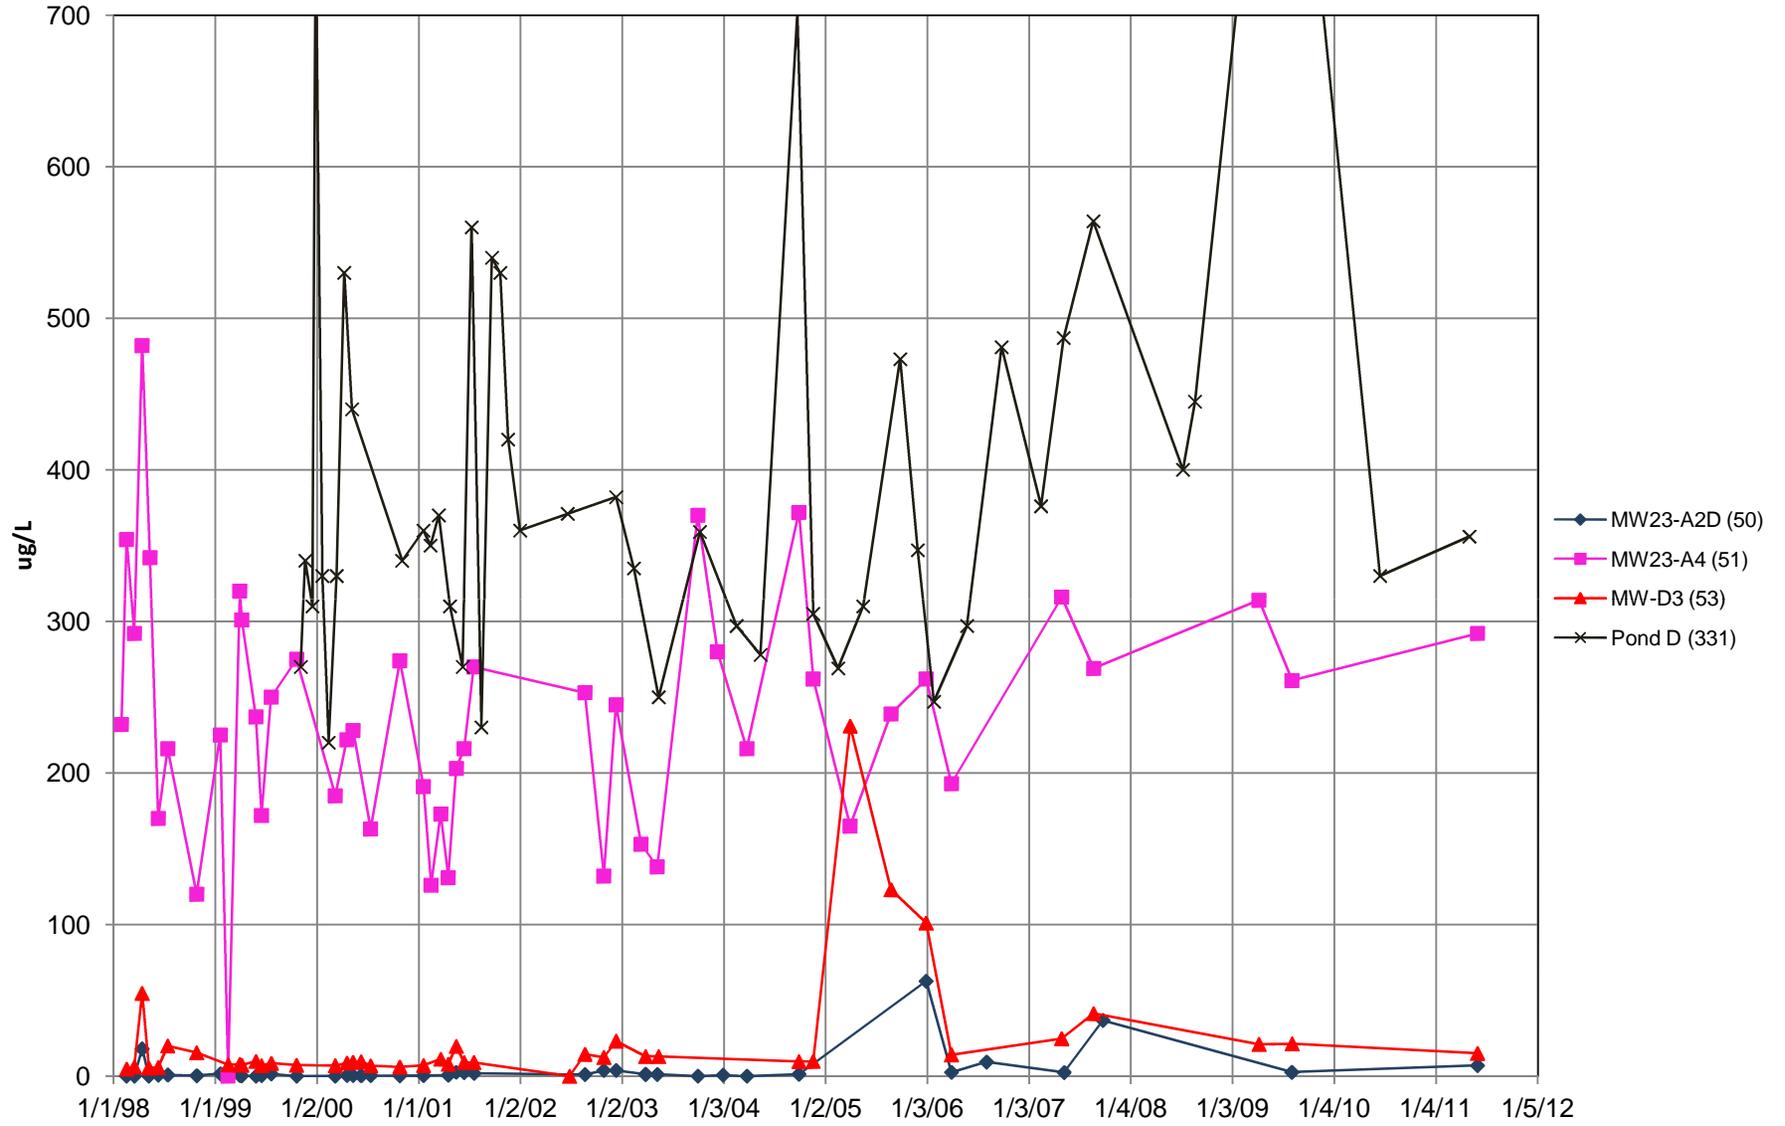
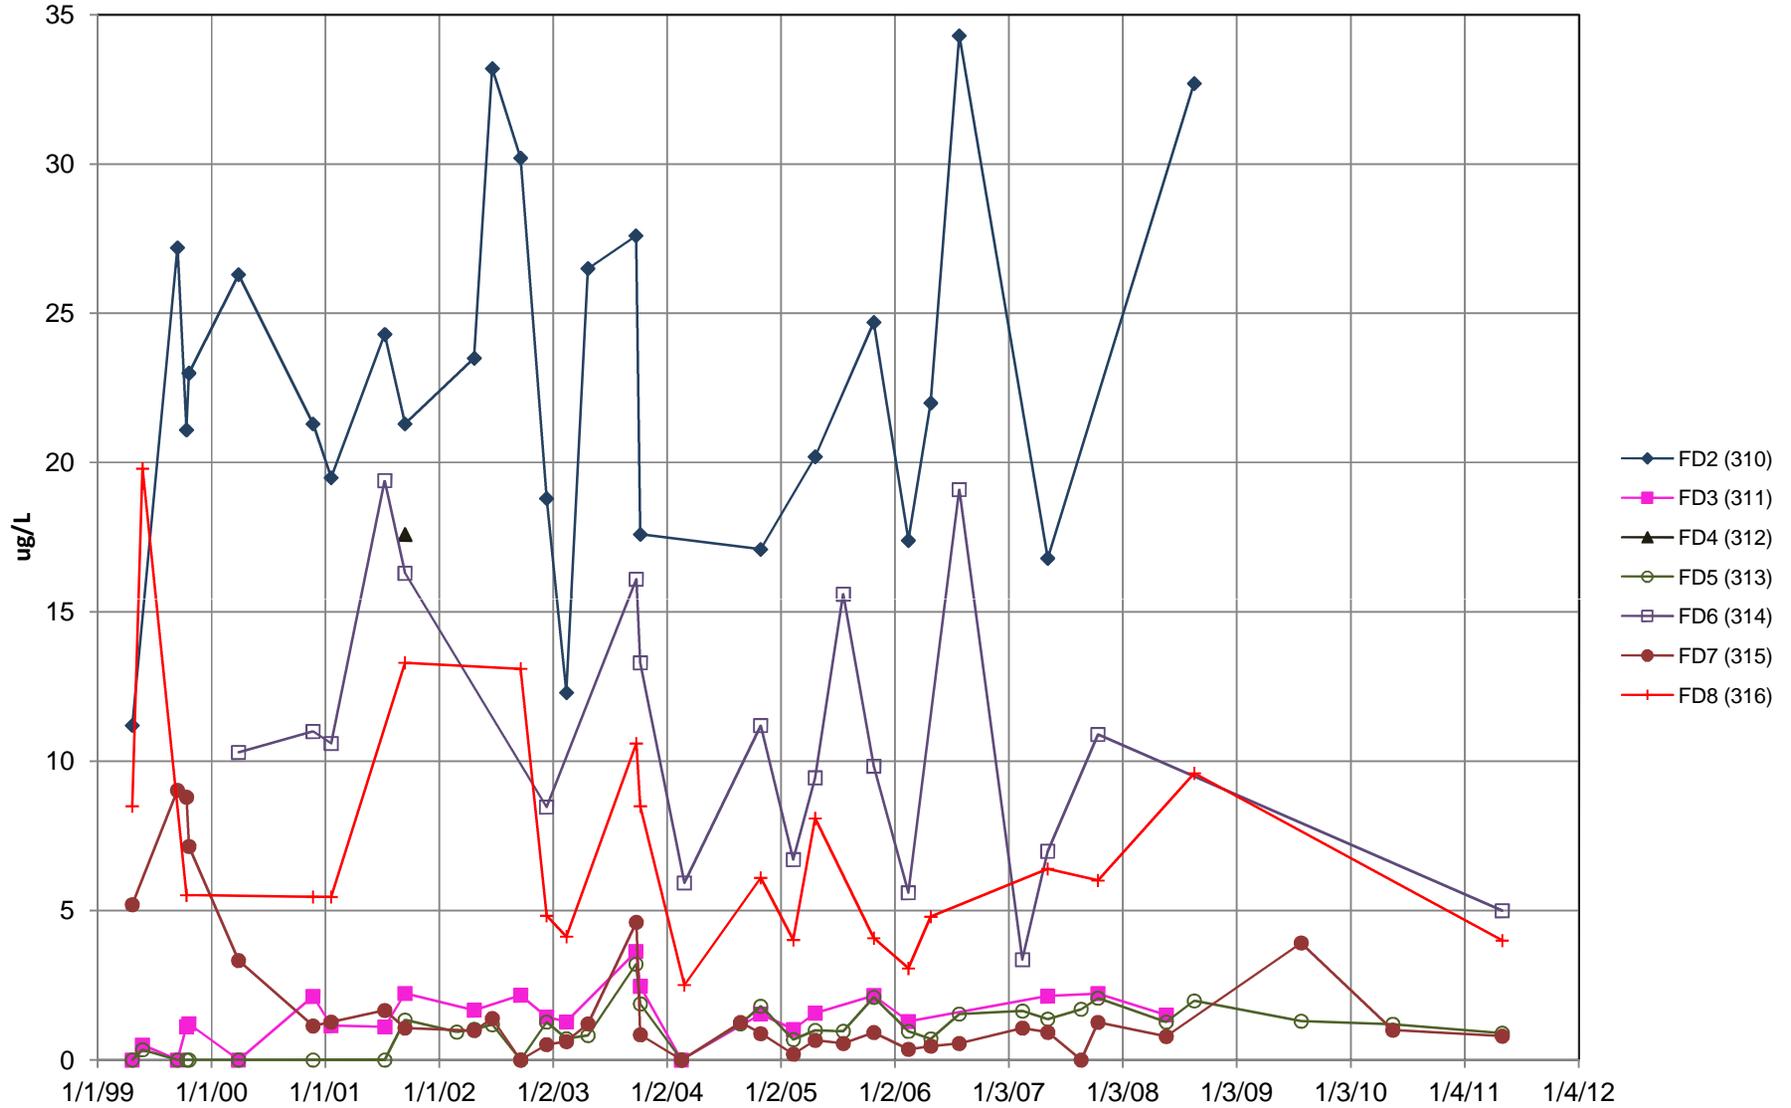
**Figure 3.21a GREENS CREEK SITE 23/D INTERNAL MONITORING SITES:
FINGER DRAINS - CADMIUM DATA
(Non-detectable analyses plotted as zero)**

Cadmium concentrations (Figures 3.21a and b) correlate well with those of zinc for the internal monitoring sites although at much lower values (0 to 35 ug/L).

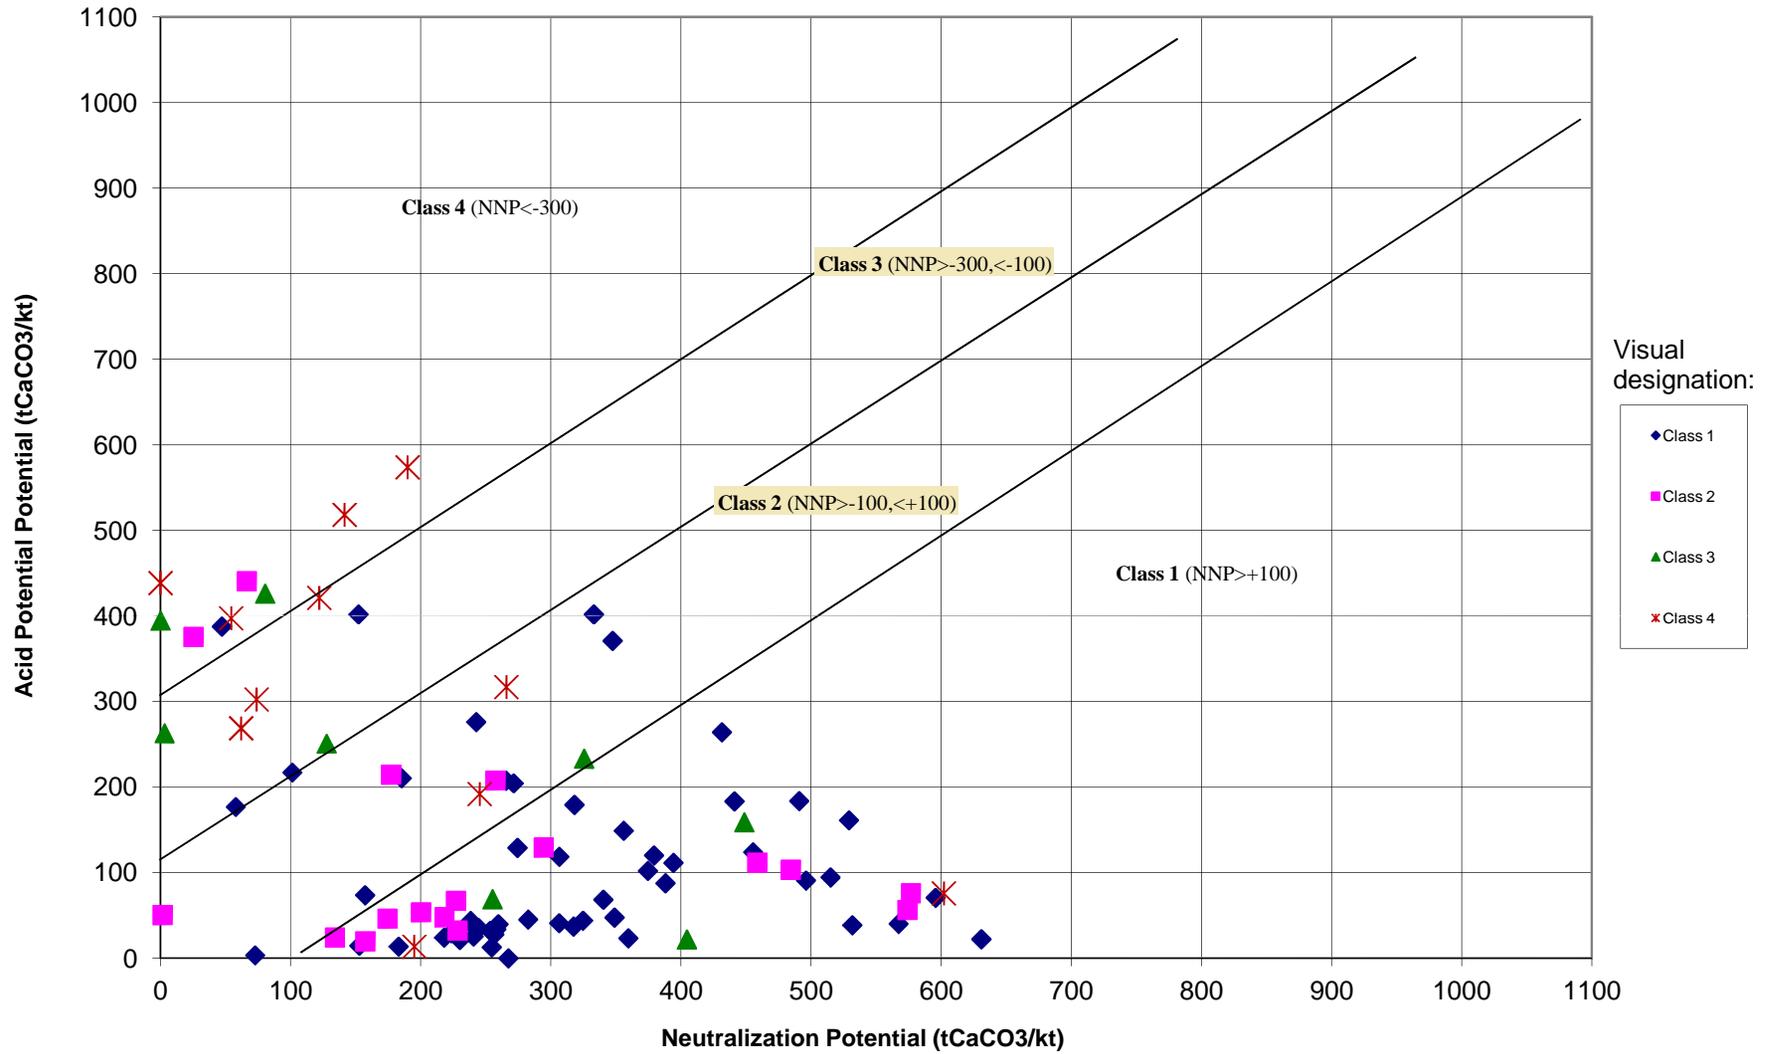
FIGURE 3.28 2011 ABA DATA FROM UNDERGROUND RIB SAMPLES

Acid base accounting (ABA) results from 89 underground rib composites collected in 2011 are presented in Table 3.3 and Figure 3.28. Class 1 rib samples had an average neutralization potential (NP) of 311 tons $\text{CaCO}_3/1000\text{t}$, which is equivalent to about 30% carbonate. The Class 1 samples had an average acid potential (AP) of 111 tons $\text{CaCO}_3/1000\text{t}$, which produced an average net neutralization potential (NNP) of 219 tons $\text{CaCO}_3/1000\text{t}$. Class 1 production rock does not have the potential to generate acid rock drainage; however, HGCMC recognizes the potential for metal mobility (primarily zinc) from this argillite rock. HGCMC has long-recognized this characteristic of Class 1 production rock and handles the material accordingly by placing it in controlled facilities, such as Site 23 and the tailings area.

Figure 3.28 compares actual class designation based on ABA analyses to the results of visual designation use underground to classify the production rock. Of the 89 composites, visual classification assigned 14 samples (16%) to a lower, less conservative class. Fifty-one (57%) of the composites were assigned to the appropriate class and 24 (27%) to a higher, more conservative class. These data represent an 84% success rate for the visual classification program.

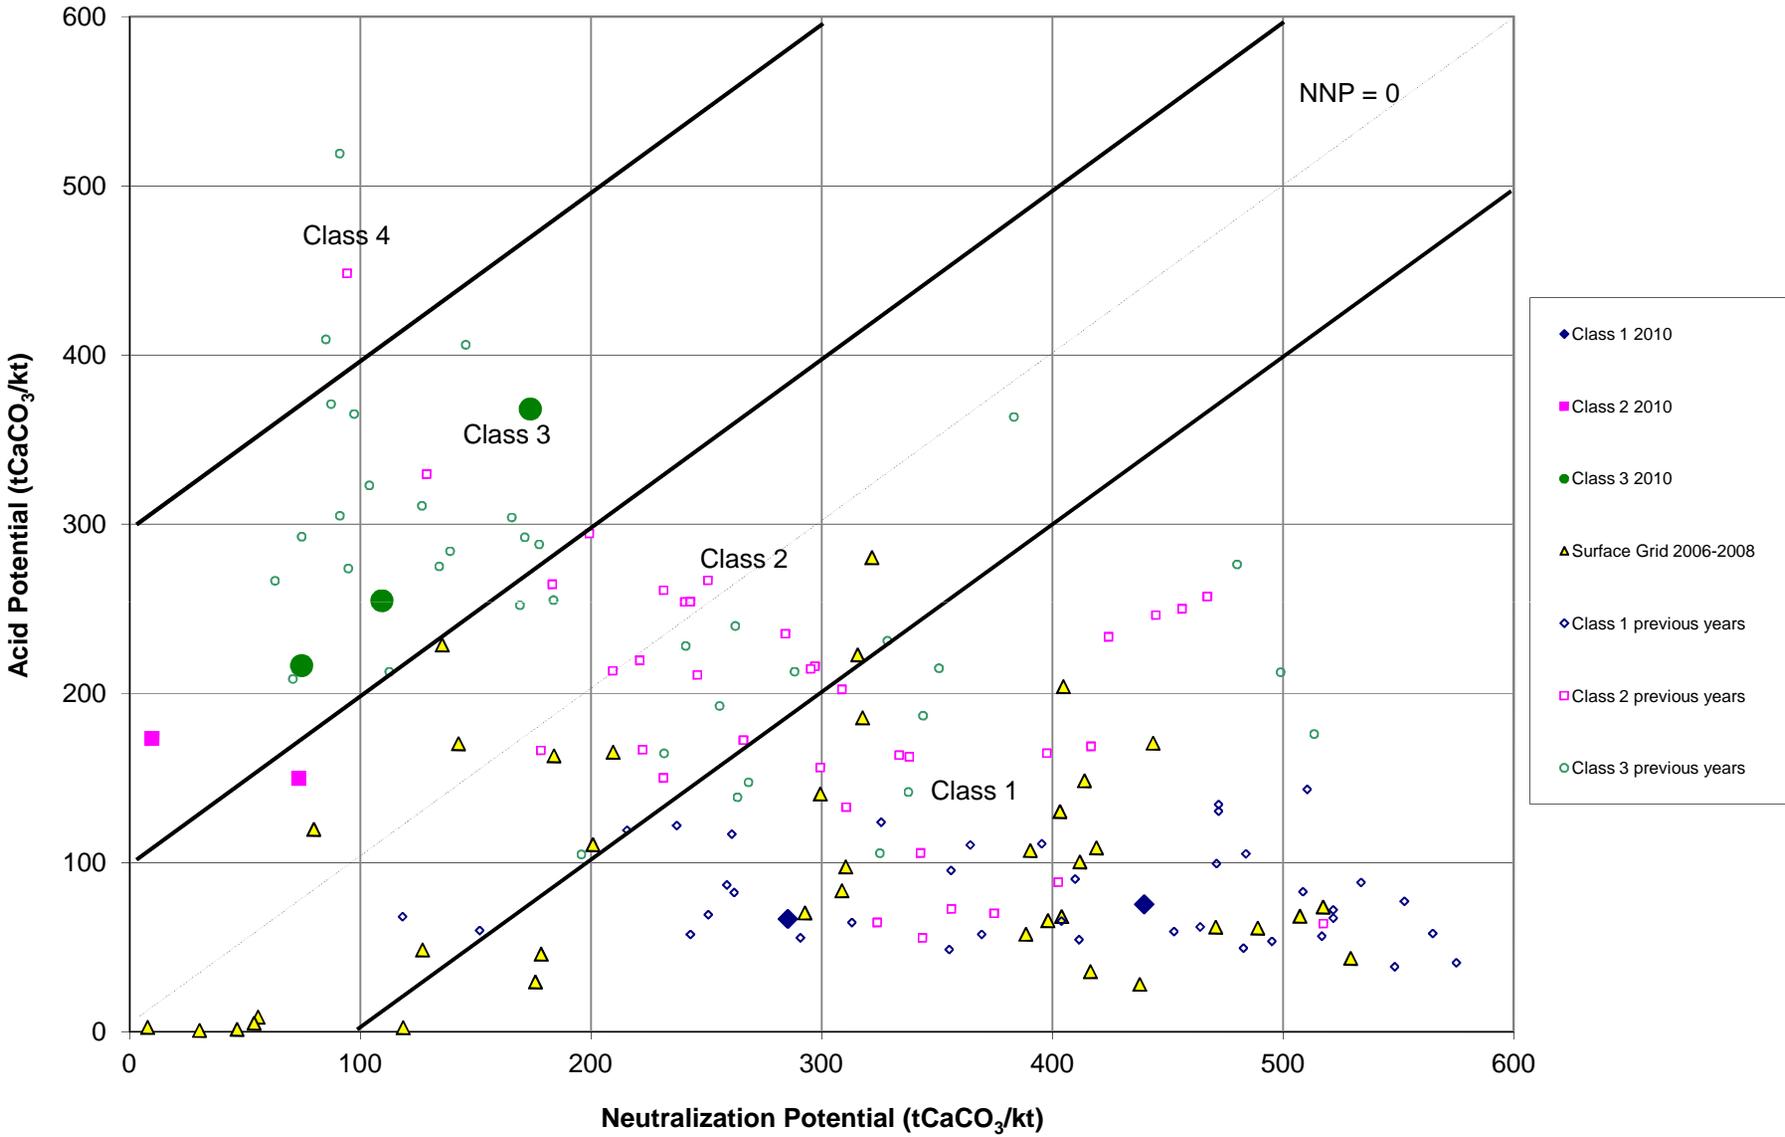
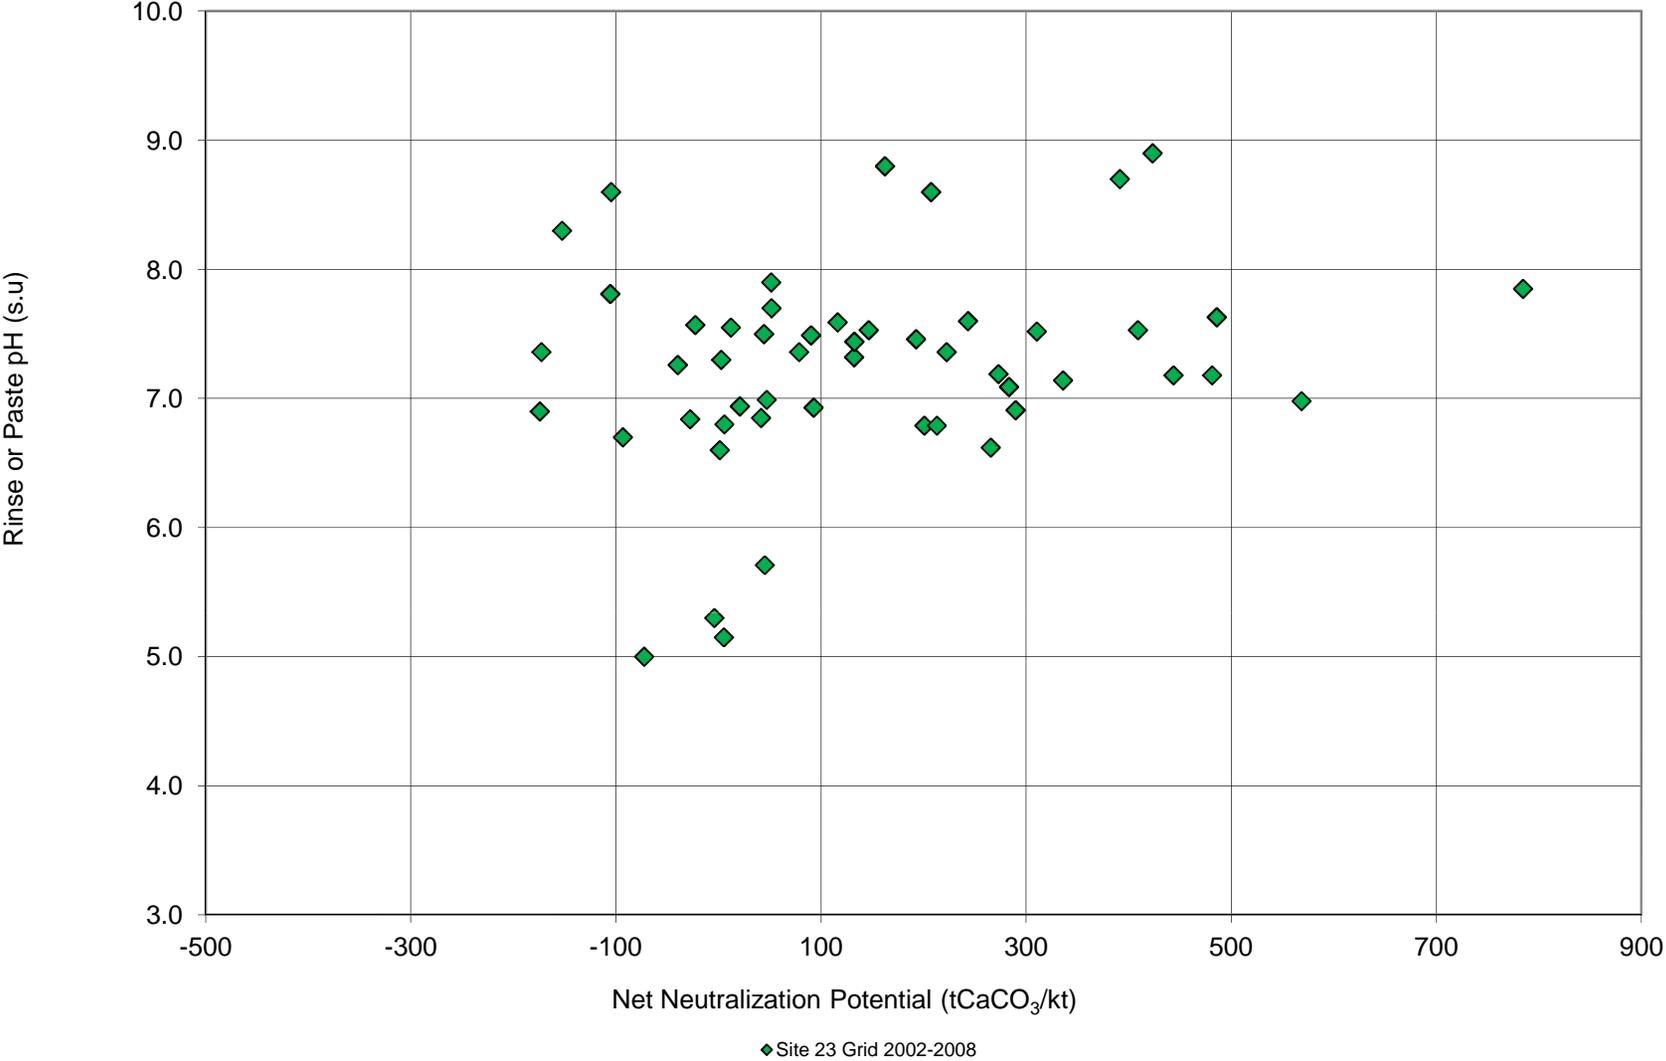
FIGURE 3.29a SITE 23 ABA DATA

Due to the minimal volume of material hauled to Site 23 and placed during 2011, no ABA data were taken from Site 23. 2010 ABA results from the Site 23 active placement areas are shown in Figure 3.29. Active placement area ABA results from previous years as well as the 2006-2008 grid data are also shown on Figure 3.29. The AP to NP distribution in the Site 23 samples differs from that of the underground rib samples. The Class 2 and Class 3 stockpiles areas are frequently empty except for a safety berm, which is constructed of Class 1 rock in the absence of other material. It is probable that several of the samples included this berm material. The grid sampling is also skewed toward higher NNP values because most of the outer surface of the pile is covered with Class 1 rock.

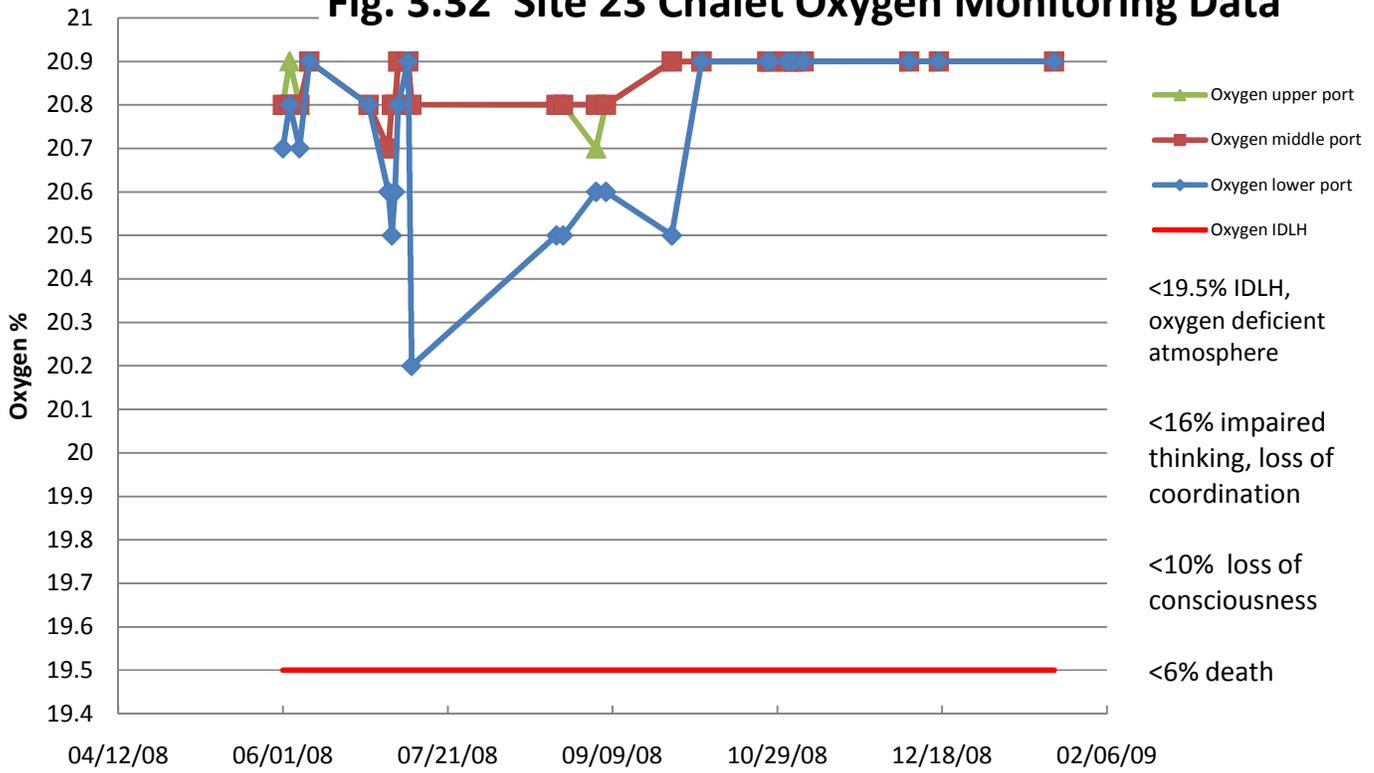
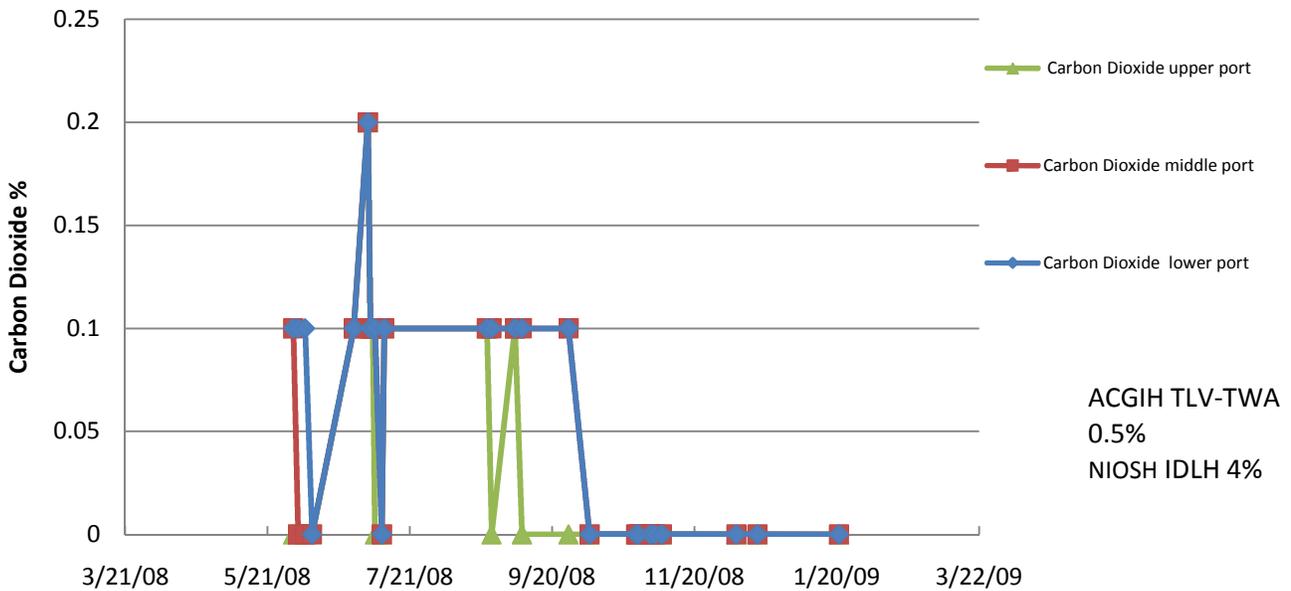
Fig. 3.32 Site 23 Chalet Oxygen Monitoring Data

In 2008 HGCMC began monitoring oxygen and carbon dioxide concentrations in the instrumentation trench building (the “Chalet”) installed over the cover plot to determine if conditions were unsafe for human entrance. Gas levels showed a slight seasonal fluctuation, but did not approach unsafe levels. Figures 3.32 and 3.33 show oxygen levels decreased slightly and carbon dioxide levels increased slightly in the summer months and were at atmospheric conditions in the winter months (20.9% oxygen and 0% carbon dioxide). These monitoring results are consistent with the conceptual model of pile gas transport. When the internal temperature of the pile is colder than the external air temperature, oxygen-deficient, carbon dioxide-rich air flows out the toe of the pile. When the pile temperature is warmer than external air temperature, oxygen rich air is drawn in at the base of the pile. HGCMC personnel will continue to monitor gas levels in the summer months prior to entering into the building.

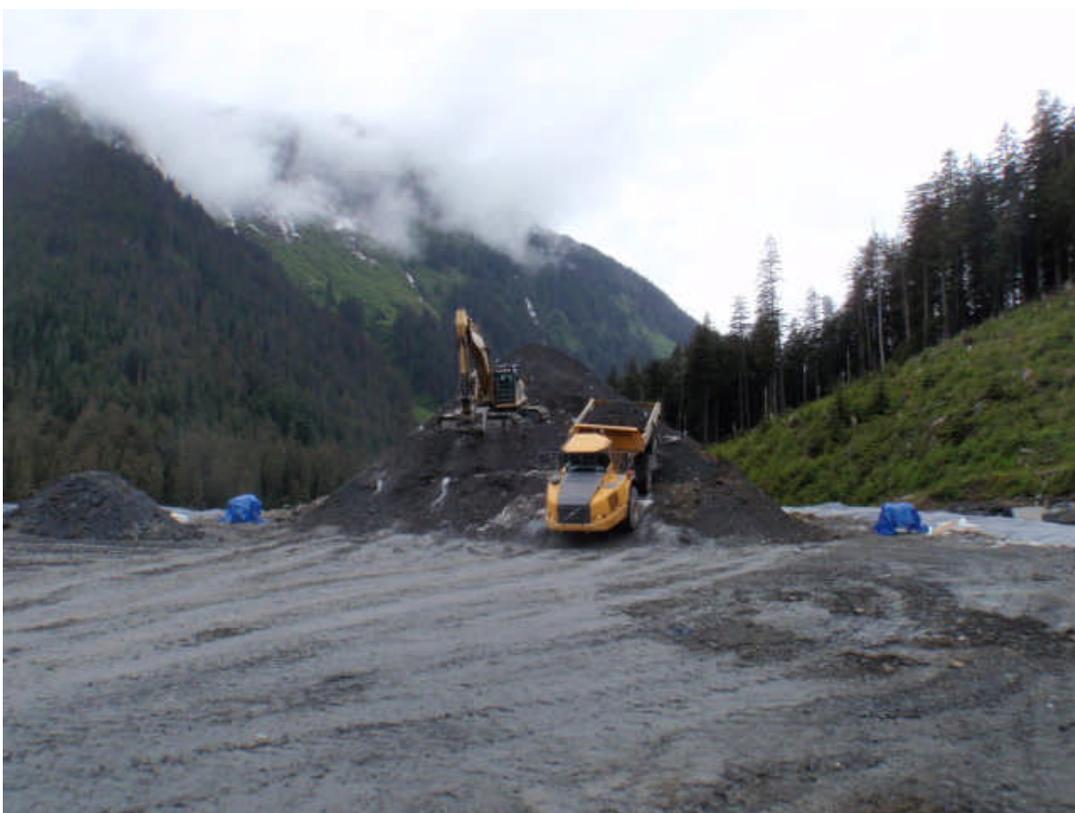
Figure 3.35 Site 23 Temporary Disposal Area- June 2011

In 2008, HGCMC received approval from ADEC to construct an interim disposal area for waste rock to be backfilled underground (see photo Figure 3.35). This 25,000 cubic yard capacity area was constructed to aid in concurrent reclamation efforts and can potentially be utilized on a continual 12-month schedule. This is a large increase over the previous 920 remuck bay which had a seasonal 700 cubic yard capacity. The area is layered with 6" of sand; a 36 mil reinforced polypropylene liner, another 6" layer of sand, 3' of class 3 production rock, and finally a geofabric layer. An HDPE pipe collects water from the area which is sloped to a central collection point. The water collected in this area drains to Pond 23. Material placed in this area is treated with up to 1 wt% lime. Waste rock from the B and D Pond berms, the 1350 and segments of the pipeline excavation were placed at the Site 23 temporary disposal area. These materials are backfilled underground as space and resources become available.
