**INACTIVE PRODUCTION ROCK SITES AND QUARRIES
2012 ANNUAL REPORT**

Hecla Greens Creek Mining Company

April 15, 2013

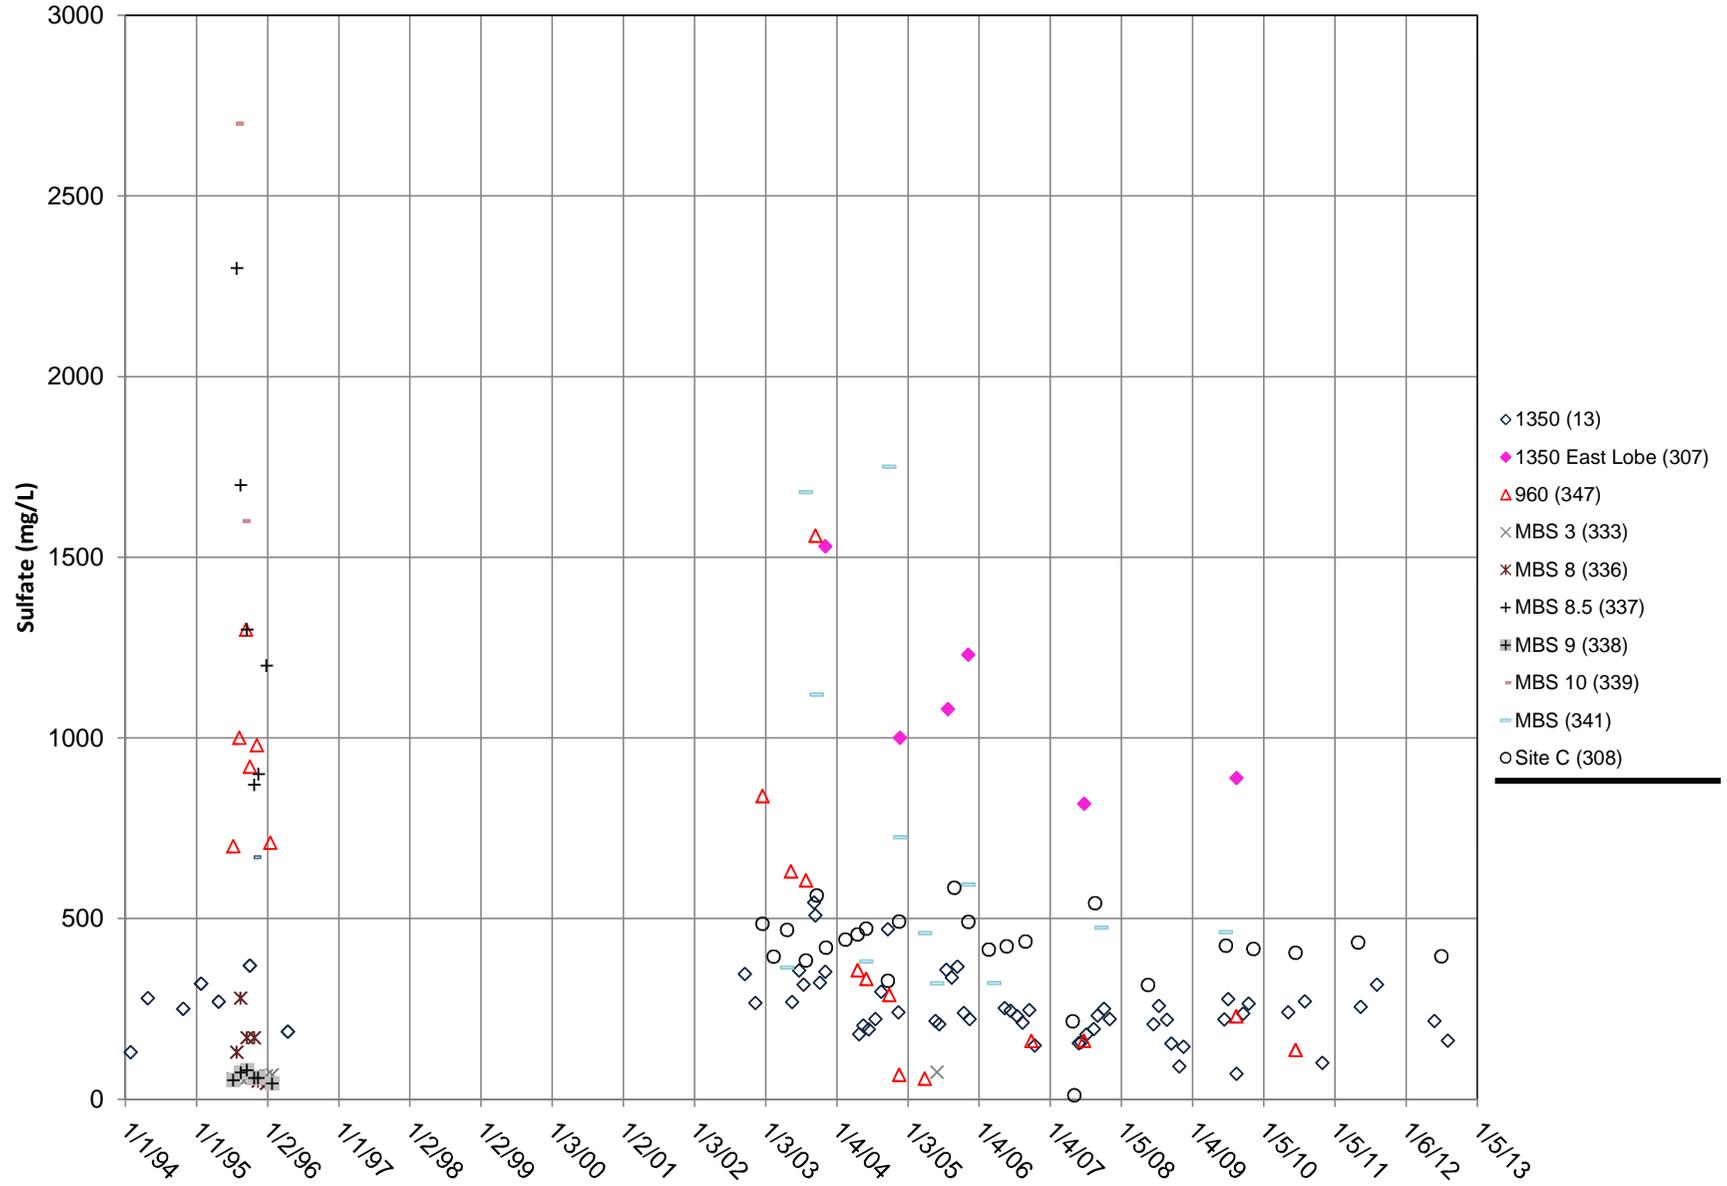
Figure 2.10 Inactive Production Rock Site Magnesium Data

the result of decreasing reactive surface area available for oxidation and dissolution. The reactive surface area decreases as reactants are consumed and mineral surfaces become coated with oxidation products. The results for sulfate, magnesium and hardness, shown in Figures 2.9 and 2.24, 2.10 and 2.25, and 2.11 and 2.26, respectively, correlate with conductivity results and are consistent with the concept of generally decreasing or static reactive surface area.
