PERIODIC SAFETY INSPECTION REPORT NO. 2 – LOWER SLATE LAKE TAILINGS DAM

**Alaska Jurisdictional Dam No. AK00308
Kensington Mine, Alaska**

December 16, 2014

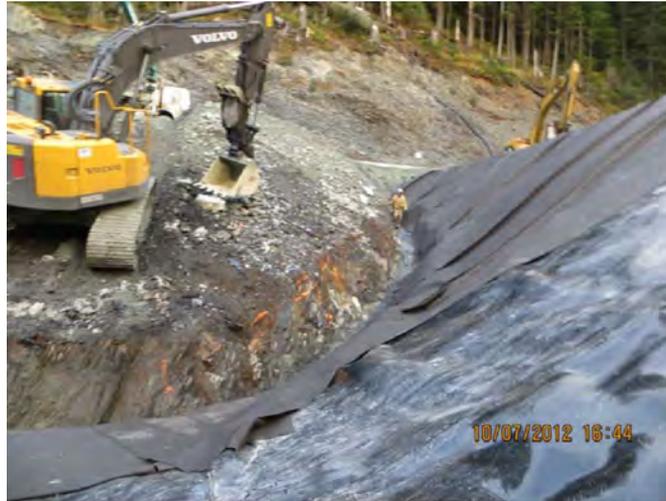
Photo 38: October 7: East grout trench ready to receive concrete.

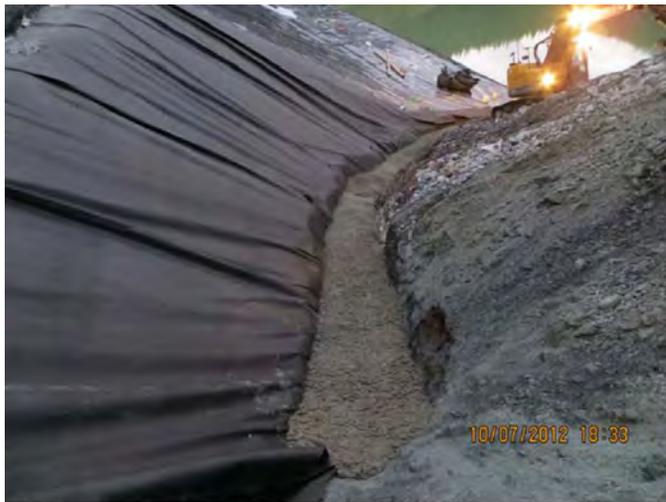
Photo 40: October 7: Completed east grout trench.

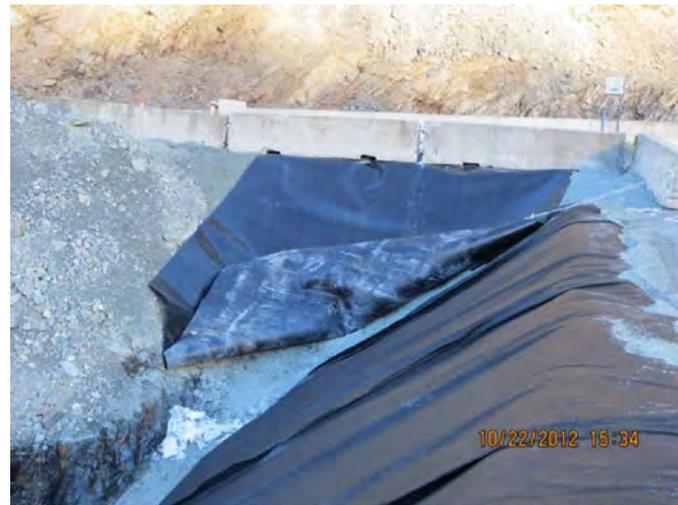
Photo 45: October 22: Geomembrane flap installed to protect road embankment on east abutment.

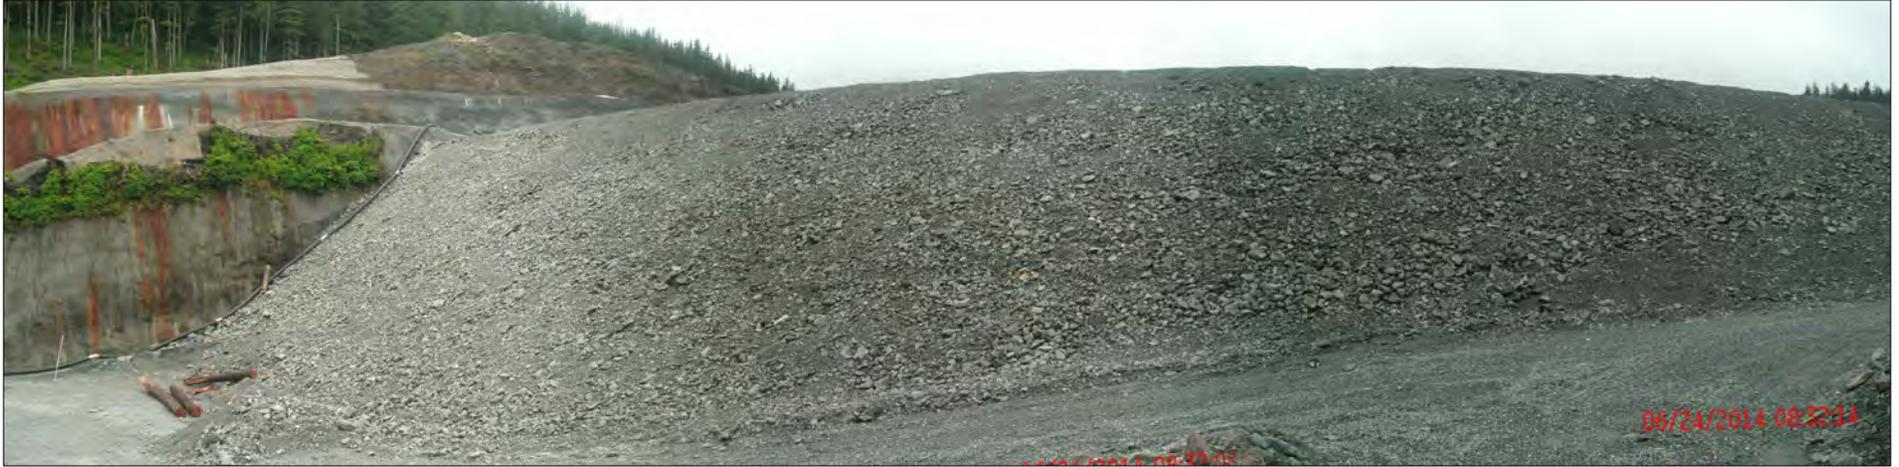
PHOTO 17: DOWNSTREAM DAM FACE, LOOKING NORTHWEST

- The downstream dam face and abutments also appeared in satisfactory condition with no indications of instability (see Photos 17 to 19 and 21). Some minor seepage was observed at the base of the west downstream abutment, which is likely flowing along the buried Stage 1 Dam interim spillway chute (Photo 21).

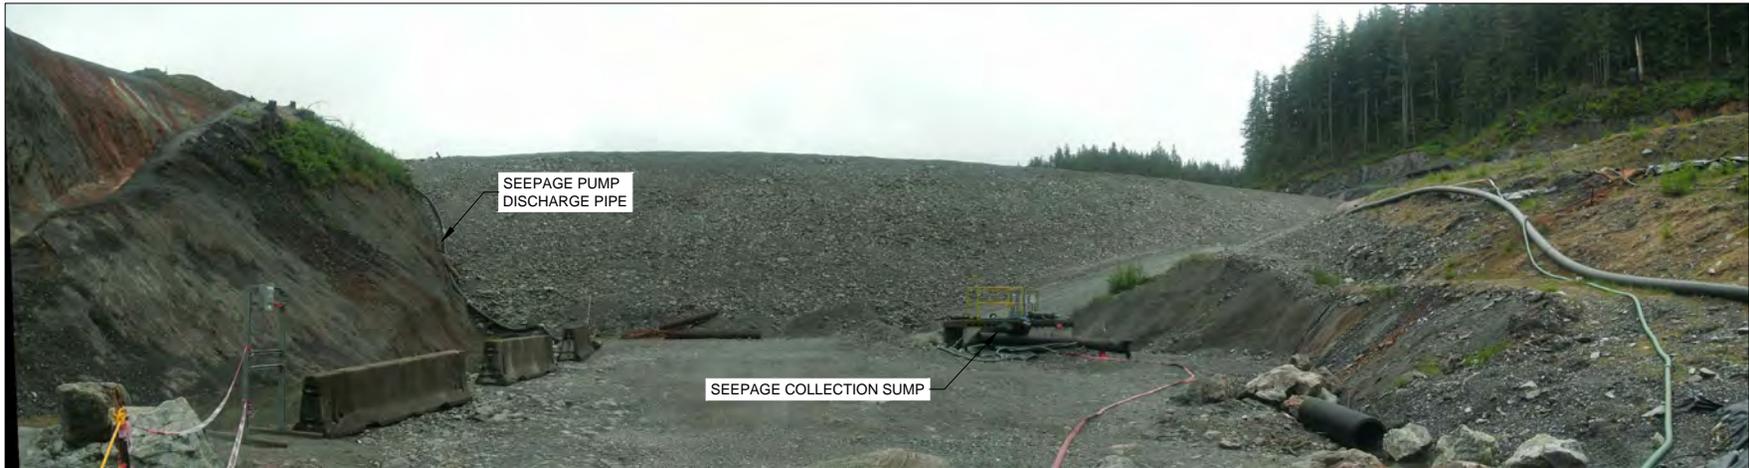
PHOTO18: DOWNSTREAM DAM FACE, LOOKING NORTH

- The seepage collection sump, pump discharge pipeline, and readout panels for the piezometers and sump pump were observed (see Photos 18, 21, and 22 to 24). The sump pump was operating at a flow rate of 2 gpm according to the readout panel (Photo 22), but no water was observed flowing from the pipe outlet near the upstream west abutment (Photo 14).

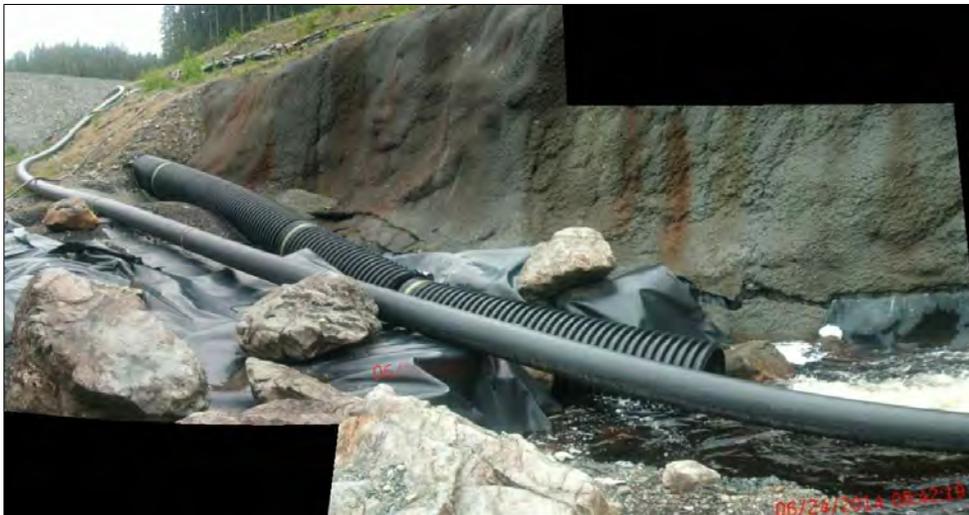
PHOTO 26: WATER CONVEYANCE PIPE OUTLET AND PLUNGE POOL, LOOKING NORTHEAST

- The plunge pool at the water conveyance pipe outlet into the East Slate Creek drainage was also observed (see Photos 26 and 27). The plunge pool appears to be fairly shallow and constructed with a geomembrane liner along the bottom and channel into the creek drainage. The geomembrane is held in place by boulders along the edge and in the channel to help dissipate energy.

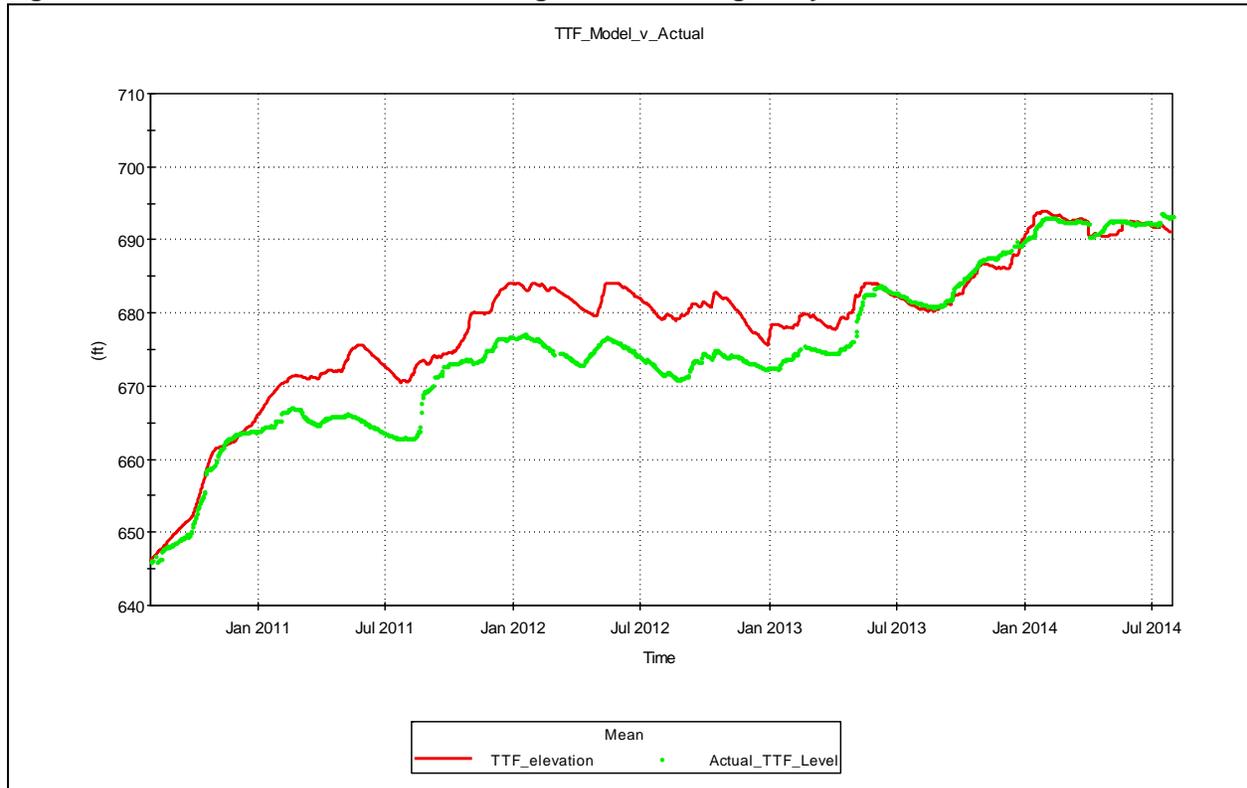
Figure 4-3: Water Balance Calibration, August 2010 through July 2014

Overall, the model shape still generally matches the shape of the TTF levels, but doesn't predict the TTF elevation accurately before June 2013, and often over predicts TTF level. The differences between the modeled and measured TTF levels are primarily due to incomplete or estimated input data, which was corrected in January 2013. Since that time the required inputs have been reliably recorded on a daily basis.

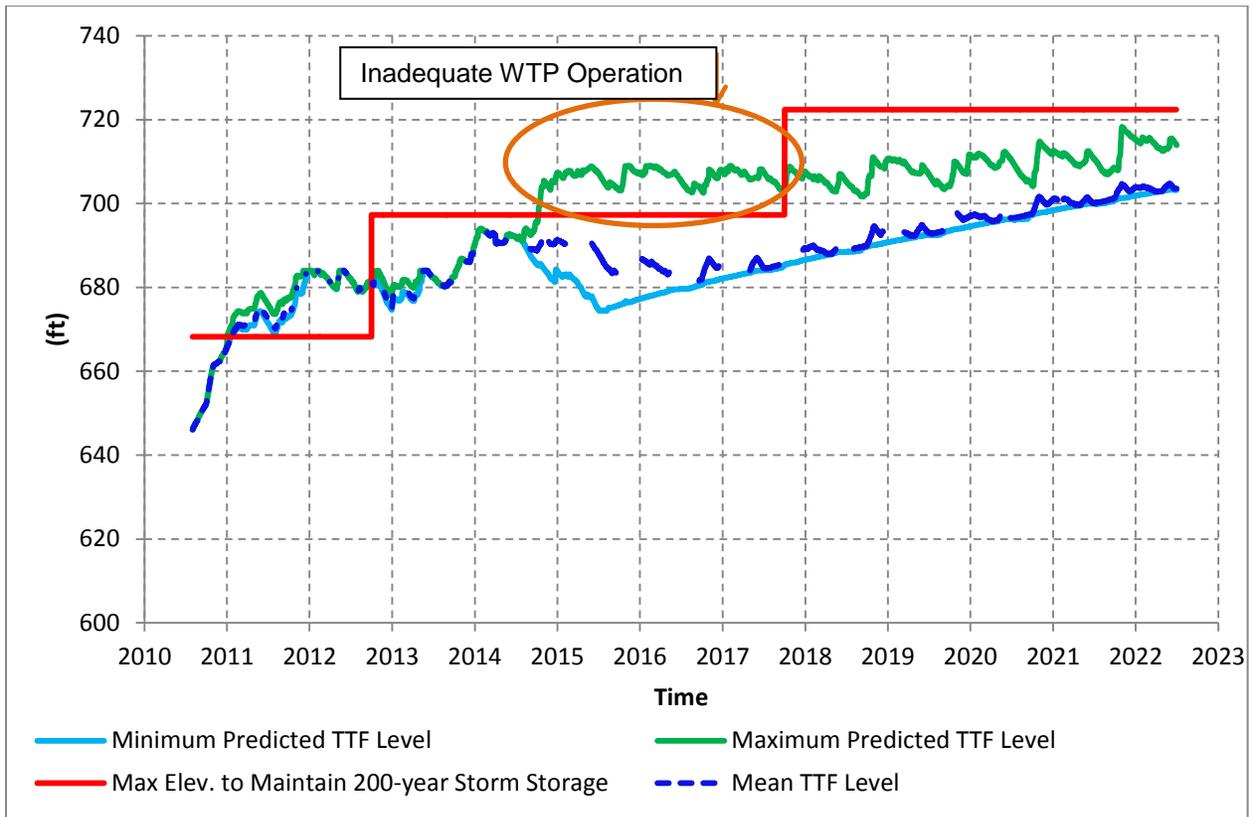
Figure 5-3: Range of Predicted TTF Elevations at TTF Water Treatment Rate of 1000 gpm

Similar to the results of the lake level trendline forecast results shown in Figure 20, the water balance modeling results indicate that if the TTF WTP rates cannot be kept at a minimum 1,000 gpm, the Stage 3 Dam raise will need to be constructed in the next several years to keep the lake level below the 200-year storm containment elevation, as required by permits. As a result of the rising lake level, we understand CAK plans to design the Stage 3 Dam in 2015 with construction in 2016.

The range of values shown in Figures 5-3 and 5-4 represents the possible TTF elevations. The blue dashed line represents the mean TTF elevation, while the darker green represents the maximum predicted elevation and the lighter blue represents the minimum predicted elevation. The solid red line represents the maximum water surface elevation that maintains a reserve storage volume equal to or greater than the 200-year storm volume below the spillway. Figure 5-3 shows that TTF elevations are currently below the maximum water surface elevation allowable to contain the 200 year storm, but could exceed that elevation and remain high if the WTP is operating at a maximum of only 1000 gpm. Figure 5-4 shows that if the TTF water treatment rate is increased to a maximum of 1500 gpm, the maximum predicted TTF water levels could exceed the 200 year storm elevation for a short period, but would decrease rapidly.

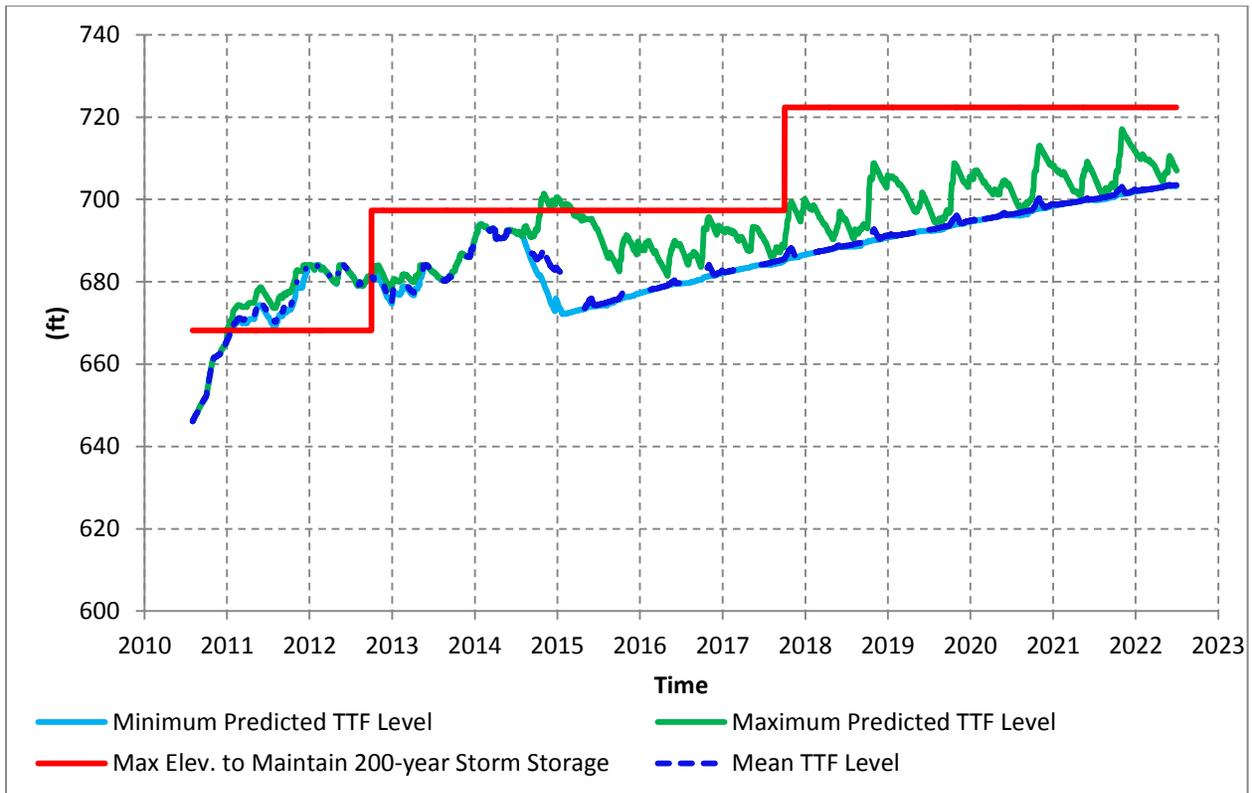
Figure 5-4: Range of Predicted TTF Elevations at TTF Water Treatment Rate of 1500 gpm

Assuming the TTF WTP rate can be maintained at 1,500 gpm from August 2104 to January 2015 and follow the predicted TTF WTP rate thereafter (a range from about 200 to 1,400 gpm), the model forecasts that the mean lake level can be kept below the 200-year storm containment elevation and the currently planned stage construction can proceed (Figure 5-1 of Appendix D). If the TTF WTP rate can be maintained at 1,000 gpm the model predicts the mean and minimum lake levels will stay below the 200-year storm containment elevation, but the maximum predicted lake level will exceed the Stage 2 Dam 200-year storm containment elevation in the fourth quarter of 2014 (Figure 5-3 of Appendix D). The model predicts that if the TTF WTP rate can be maintained at 1,500 gpm the predicted maximum lake level will exceed the 200-year storm containment elevation during a short period during the fourth quarter of 2014 and first couple months of 2015 until it drops below the 200-year storm containment elevation (Figure 5-4 of Appendix D).
