APMA A20196118- FIELD SUMMARY REPORT

Inspection Date: October 21, 2019
Weather: Broken Skies Progressing to Scattered, Winds Variable to 10 mph, Air Temp. Average 34° F
Agency Personnel: Hollie Chalup (Mining Section), Joshua Brekken (ADFG)
Operator Contact: Tim Havey, Director of Environment and Permitting, Pebble Limited Partnership
Pilot: Solomon Loop, Soloy Helicopters
Inspection Objectives: Annual Inspection

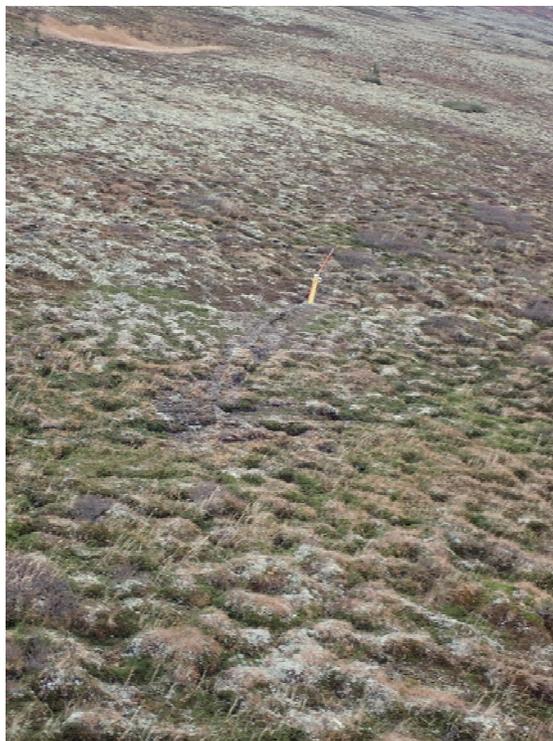
14. Boreholes
GH18-401S,
GH18-403S,
GH18-405S
21 October 2019

As viewed from
upper left to
lower right.
Borehole GH18-
401S does not
have a surface
structure.

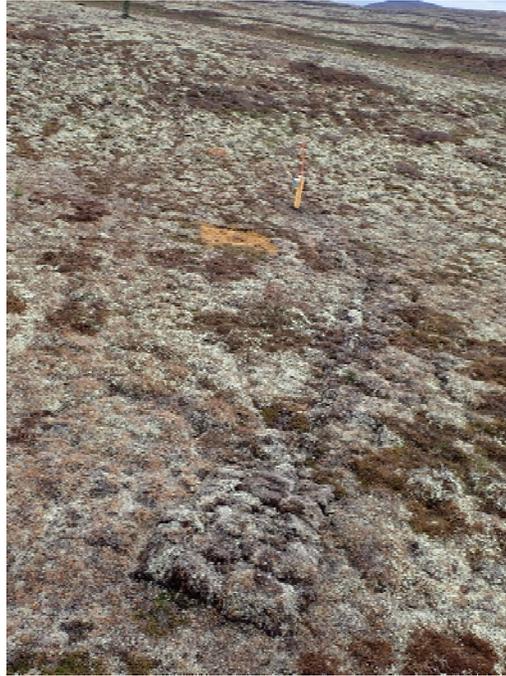
**16. GH18-408S and
GH18-407S L to R.**
21 October 2019

Engineering crews were actively collecting data at the time of inspection. The operator was reminded to replace caps and subsequently provided photo documentation of cap replacement post inspection.

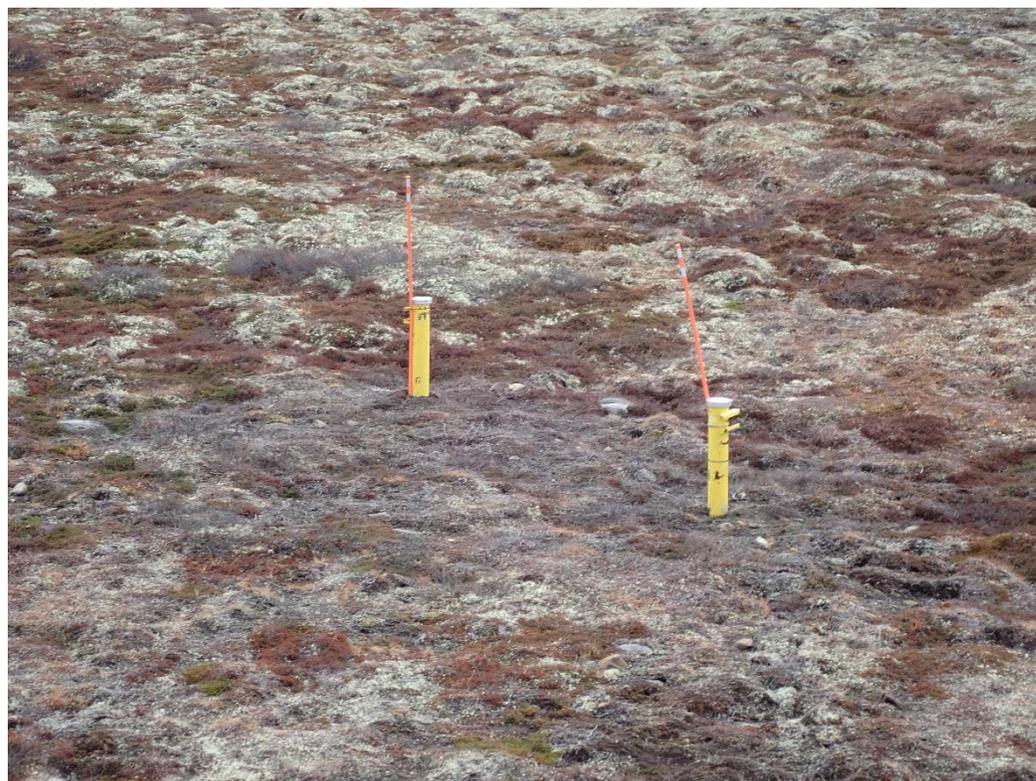
**21. GH18-399S,
GH18-406S,
GH18-392S**
21 October 2019

As viewed from
upper left to lower
right
