KINROSS

Fort Knox

**WALTER CREEK VALLEY FILL
HEAP LEACH PAD
OPERATIONS & MAINTENANCE MANUAL
REVISION 15**

**Fairbanks Gold Mining, Inc.
A Subsidiary of Kinross Gold Corporation
P.O. Box 73726
Fairbanks, Alaska 99707-3726**

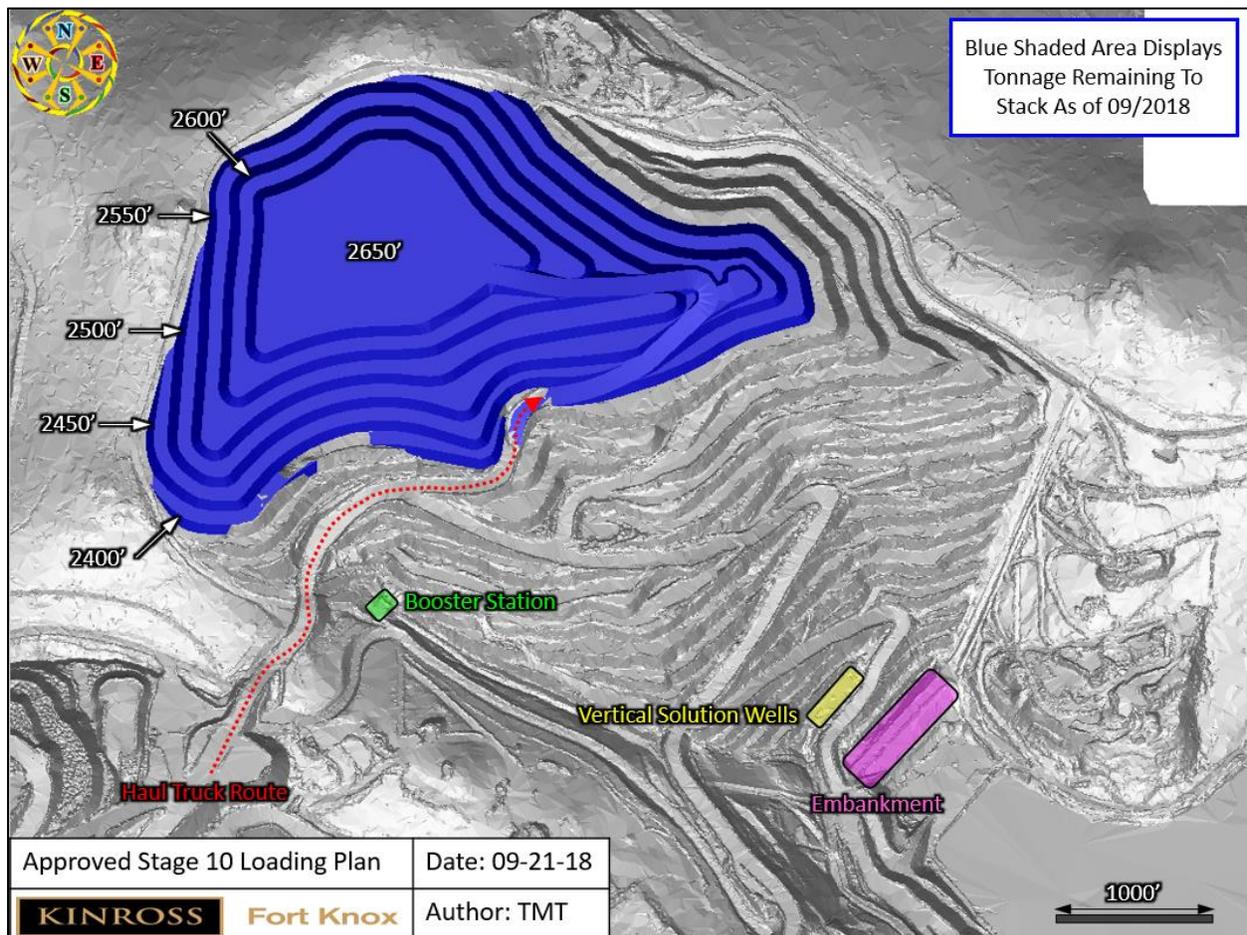
Figure 2-1 –Stage 10 Heap Loading Configuration

As of the 08/31/2018, the WCHL facility had 228.7 Mtons placed with an additional 68.5 Mtons still planned for placement over the period through 2022. The currently approved ore heap configuration through Stage 10 is illustrated below.

The WCHL is a gold heap leach pad located in the upper end of the Walter Creek drainage immediately upstream from the Fort Knox tailing impoundment facility. Run-of-mine ore from the Fort Knox pit and existing ore stockpiles is stacked in the lined containment area located behind and above the in-heap storage embankment, which is constructed in the upper reaches of the Walter Creek drainage. The design capacity of the WCHL is approximately 307 million tons. Ore is loaded on the pad in incremental lifts which are 50' tall. A general arrangement of the WCHL facility can be viewed in the next section in Figure 2-1. A Project Data Sheet presenting key statistics for the WCHL is available in Appendix A.

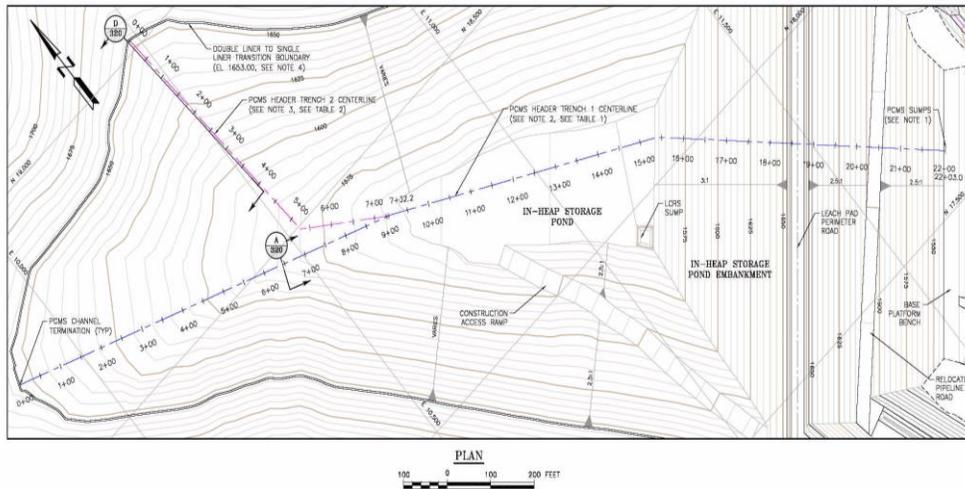
Figure 2-2 – In-Heap Storage Embankment

The in-heap storage pond embankment has been designed to provide containment of process solution and any precipitation amounts up to a 100-year/24-hour design storm event.

Construction of the embankment first began in 2008 with the removal of unsuitable soils, weathered rock, alluvium, and organic material from the foundation footprint and corresponding abutments. FGMI geologists compiled a geologic map containing bedrock types, fractures, faults, and other pertinent information in the exposed embankment footprint. Afterwards mine waste rock meeting the random fill specification was placed in 4-foot-thick compacted lifts in the base platform, underdrains, and in-heap pond embankment areas. Waste rock was compacted by loaded haul truck traffic being routed across the designated areas. In order to transfer flow from springs, seeps, and other flows beneath the WCHL, random fill drains consisting of a backfill material with no fines was incorporated into the base platform.

When inspecting the embankment, it should be noted that some settlement and movement of the embankment is anticipated, and normal, given its size and type. Commonly settlement-cracking parallel to the dam crest can occur. However, any cracking, regardless of orientation to the embankment crest is to be recorded in the daily logs, making sure to note the amount of movement, and photographed. Any movement is to be discussed and reviewed by the Engineer of Record to verify that it is within normal and anticipated limits.

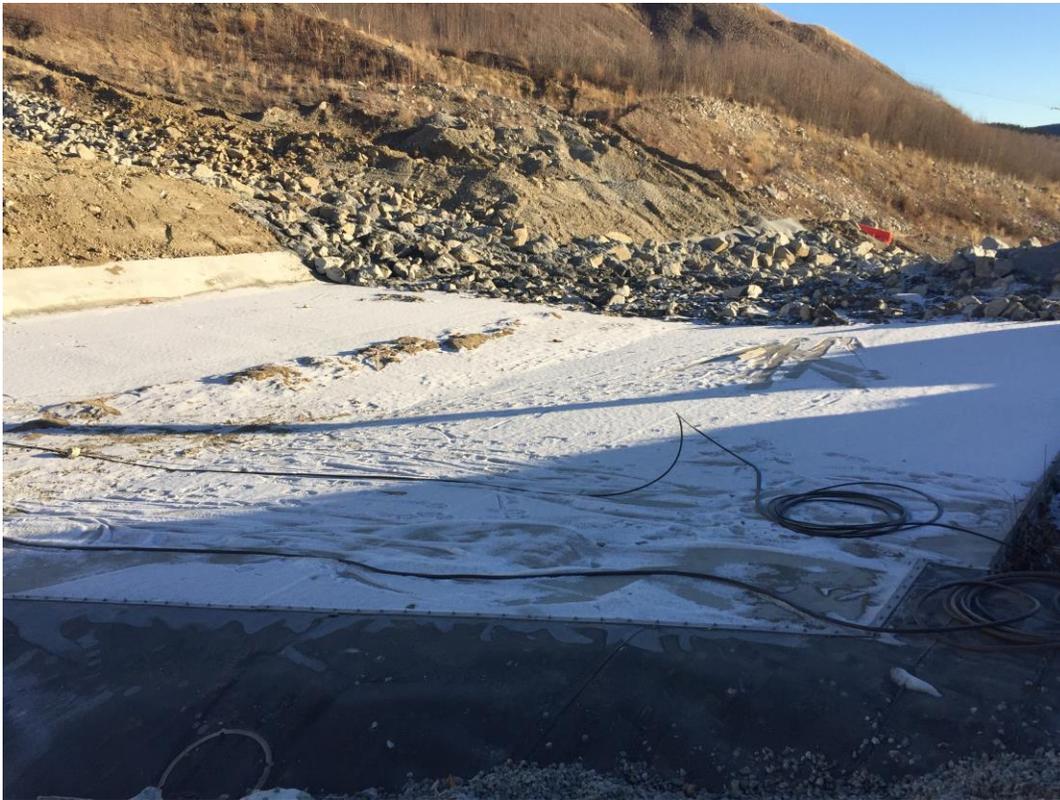
Figure 2-3 – Concrete Spillway

A spillway has been constructed through the Northern side of the embankment and is photographed in Figure 2-3. In the event of an emergency, the spillway protects the main embankment from being overtopped by a rising solution pond. The spillway invert sits at the 1650.5 elevation, which is 2.5 feet below the embankment's design crest. Where it crosses through the embankment, the South side slopes down at a 10:1 gradient to a flat channel bottom that is 35' wide and constructed of concrete. From the channel bottom, the North side slopes back up at a ratio of 2:1. The spillway has been designed to maintain 0.5 foot of freeboard on the dam while passing the peak flow from a 100-year/24-hour storm event. This freeboard is deemed acceptable within the weir section because:

1. The conditions leading to potential flow through the spillway (100-yr/24-hr January rain-on-snow event with the entire surface of the heap frozen resulting in 100-percent surface runoff to the swale) represent highly conservative assumptions. See
2. With the design configuration, the 0.5-ft freeboard represents a 30-percent increase in potential flow area above the 2-ft flow depth. The weir flow capacity rating to the embankment crest elevation, 1653 ft, is estimated to be 460.8 cfs or an approximate 40-percent increase in flow capacity.
3. The containment level along the spillway weir section can be temporarily raised using sandbags or other methods if needed.

The spillway will direct any overflow to the downstream TSF via the riprap-lined and grout supported spillway channel, seen in Figure 2-4. The outlet channel matches the channel width of 35-ft initially and then transitions down to 15' in some areas. Channel width varies and is determined by the depth, cross-sectional area, and steepness of the channel section. The end results in to provide a continuous channelized flow from the concrete spillway to the outlet channel discharge point, immediately upstream of the TSF.

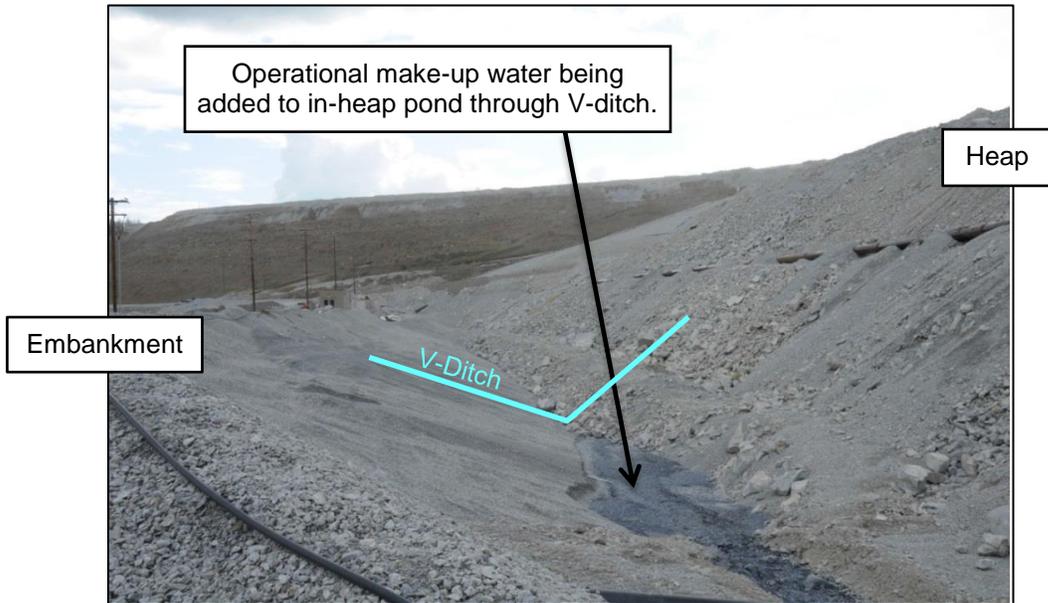
Figure 2-6 – V Ditch Looking South

In the time prior to the spillway becoming active, solution levels will rise in the pond and begin to pool in the area between the upstream face of the embankment and run of mine ore. Seen in Figure 2-6 and Figure 2-7, this area is known as the “V” swale or “V” Ditch. During normal operations, this area is available to temporarily store storm water runoff that flows to it from around the heap toe. Flow or accumulation in this area will enter the pervious ore at the base of the heap and drain into the pond below. The estimated as-built storage volume of the swale is approximately 6.2 million gallons. In the unlikely event that the surface of the swale is completely frozen, the calculated runoff volume of 38 million gallons from the 100-year/24-hour design storm event could be conveyed through the emergency spillway.

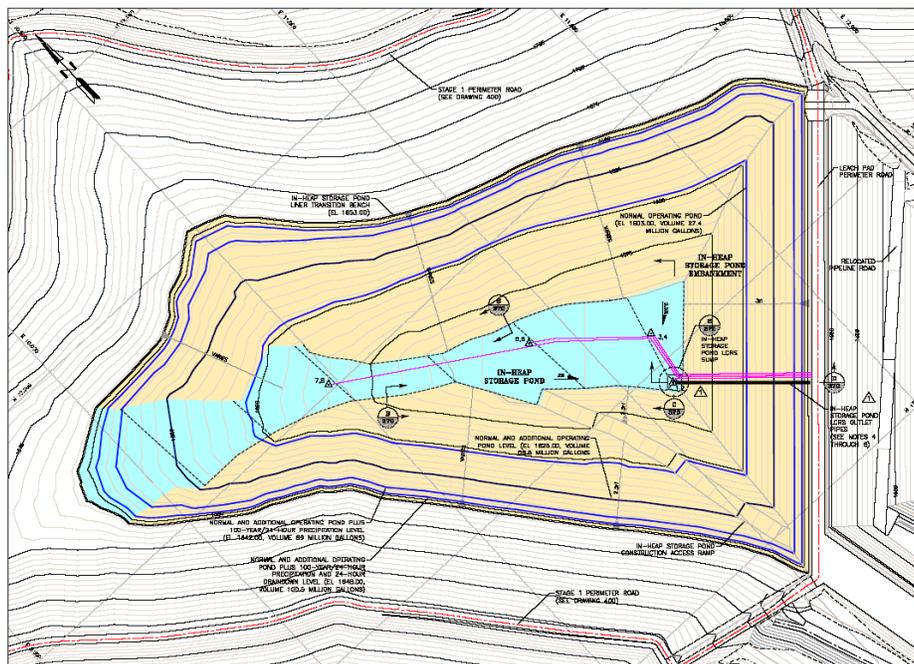
Figure 2-8 – In-Heap Storage Pond

The in-heap embankment creates an internal in-heap storage pond for collection of pregnant solution. At the design stage for WCHL, an in-heap pond was selected to avoid freezing of the pond during winter months. A plan view of the in-heap storage pond is shown in Figure 2-8.

- A. Maximum normal operating level
- B. 24-hour draindown volume
- C. The 100-year/24-hour storm event potential contribution
- D. Freeboard on the embankment

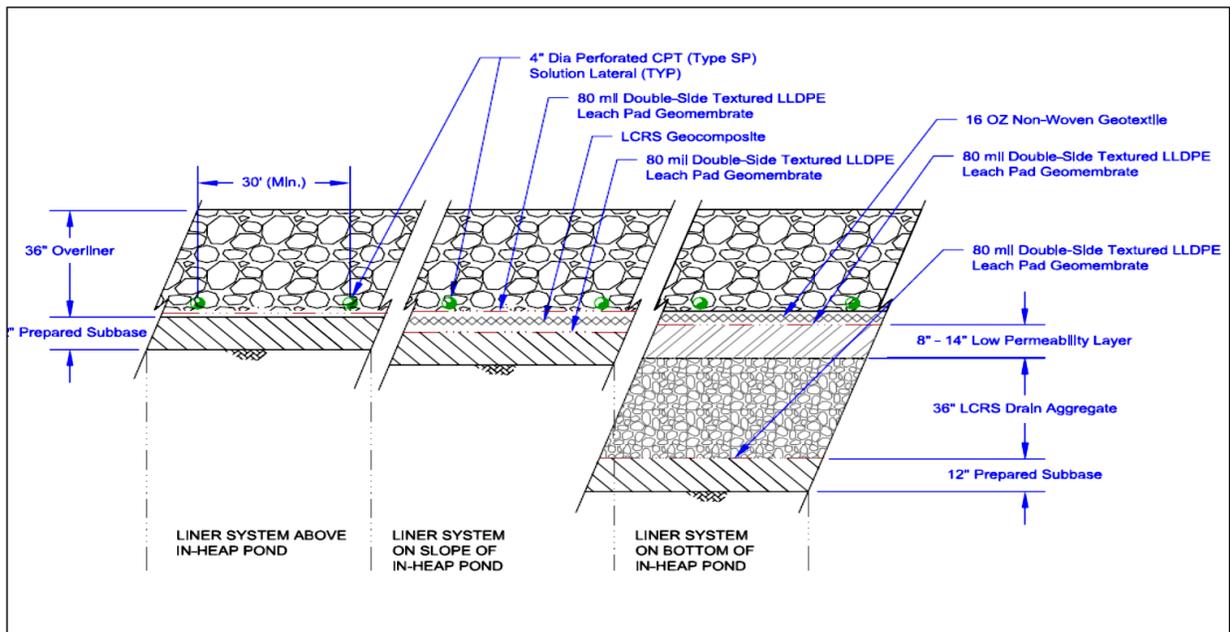
Figure 2-9 – Composite Liner Cross Section

Two distinct containment zones exist within WCHL. The first zone consists of the in-heap storage pond directly behind the embankment. The second zone comprises the elevations above the in-heap storage pond. Each zone was constructed following a specific construction plan consisting of different elements that are layered on top of each other; a cross-sectional view is available in Figure 2-9.

- 1) 12-inch-thick low permeability prepared sub base
- 2) 80-mil double-side textured LLDPE geomembrane liner
- 3) 3-foot-thick overliner cover with solution collection pipes buried within. These pipes are a direct extension of the pipes placed in zone 1. Along with promoting drainage, the overliner and solution collection pipework will significantly reduce head pressure on the zone 2 liner. Feet of head on liner in zone 2 is designed to be less than 1 foot on average.

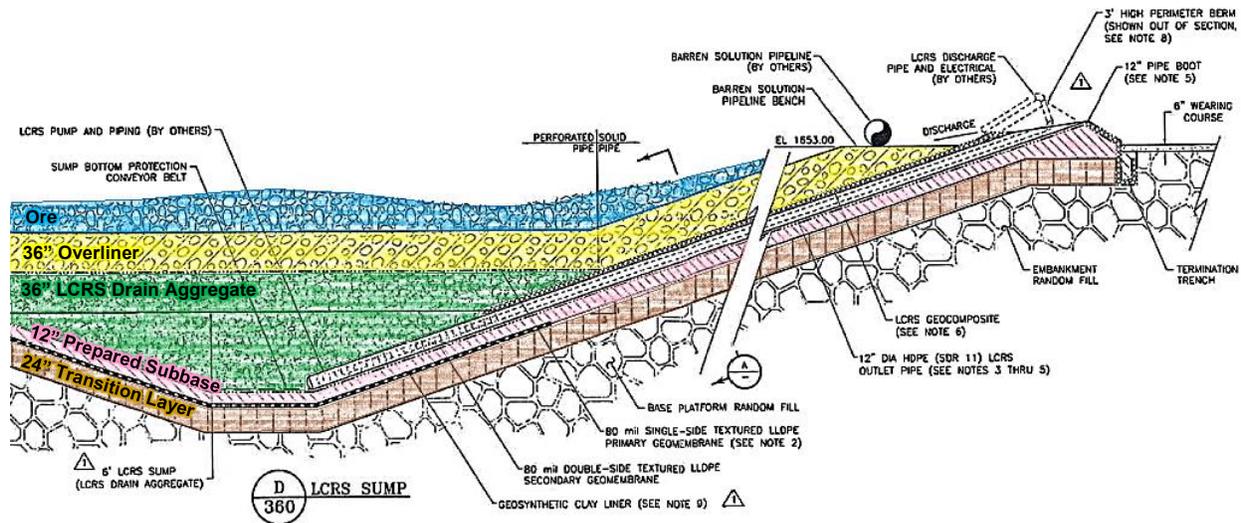
Figure 2-10 – LCRS Details

The LCRS is part of the double lined pond zone. The LCRS serves as a monitoring and collection system for any process solution passing through the primary liner; it also provides a hydraulic break between the primary and secondary containment liners. This break means that although the head acting on the primary liner is the full depth of process solution during operations, the head acting on the secondary liner is designed to be less than one foot.

sump to the embankment crest. The portions of the pipes within the sump are slotted with openings sized appropriately with to avoid migration of the LCRS drain aggregate into the pipes. The bottom of the LCRS sump has been protected from damage by the outlet pipes with the placement of conveyor belting. A layer of geosynthetic clay liner was installed below the LCRS sump, between the 12-inch-thick prepared sub base and the secondary liner, to further limit the potential for leakage. Reference Figure 2-10 for LCRS details

A monitoring station and access to the LCRS sump is located on the in-heap embankment crest. The LCRS was initially monitored daily for flow establishing a baseline. Currently the LCRS is visually inspected daily and pumped on a weekly basis. During Q2 of 2014, Piezometers 1 and 2, which are located at approximately elevation 1541, at the bottom of the LCRS sump, began registering a small head of approximately 4.0 feet. These readings suggest that a small depth of water has accumulated in the sump, but this level remains below the top of the sump.

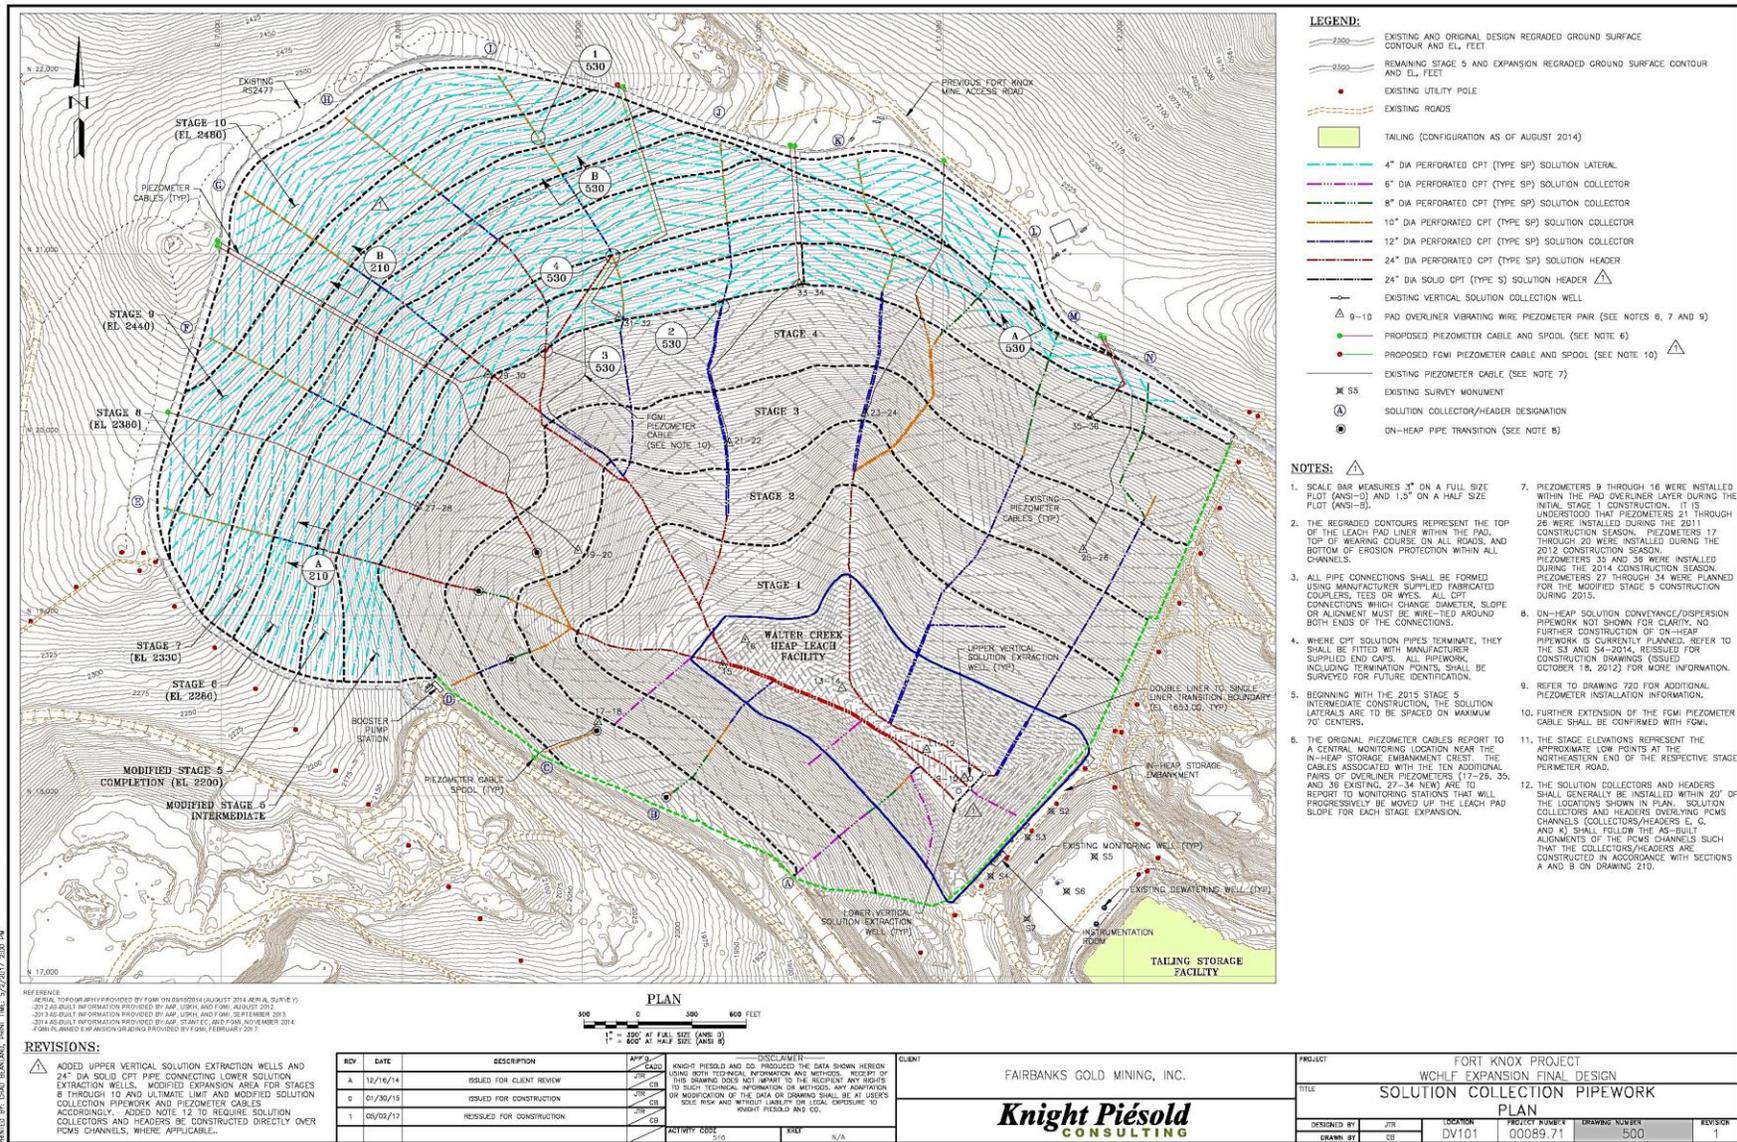
Figure 2-11 – Solution Collection System

See the following Figure 2-11 for the general layout of the solution collection system through Stage 10

Evaluation of eighty-three (83) flow-analysis points throughout the WCHLF basin determined that there were 6 points in which calculated flows would exceed the estimated pipe capacities above the limits of the in-heap storage pond. In these areas excess flow will be conveyed through the overliner rock drainage layer. In addition to the six flow transfer conditions, three areas were identified where localized hydraulic heads could exceed the 1-ft maximum adopted in the design criteria. Conclusions of the study were that the calculated head applied to the pad liner system under the increased flow regime of 20,000 gpm will remain low, at less than 1.0', for the area under leach. Some small areas are predicted to have localized heads higher than 1.0'. The consultant KP concluded that even with these small areas of exceedance, the high-quality liner and solution monitoring systems installed in the WCHLF in tandem with the hydraulic containment provided by the downstream TSF provides for a very high level of environmental protection.

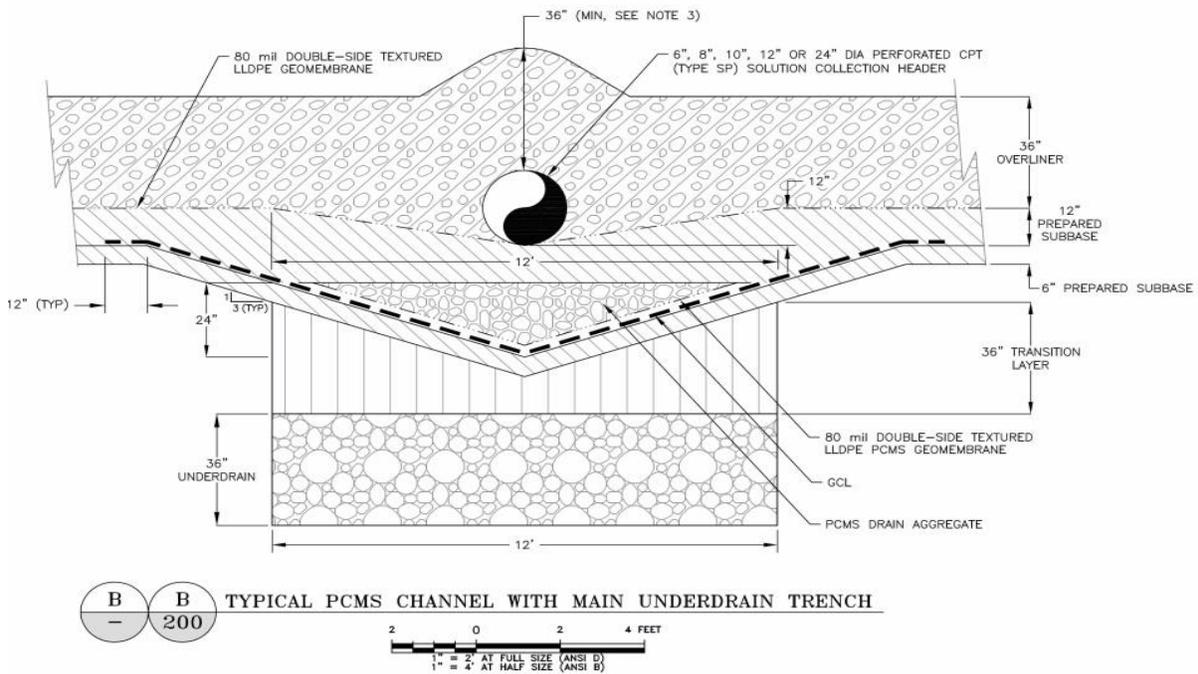
Figure 2-12 – PCMS Channel Detail

In the three drainages, the PCMS consists of a lined “V” channel filled with pervious PCMS drain aggregate. The design width of the top of the PCMS channel is 12 feet, and the depth is 2 feet. The composite liner for the channel includes a geosynthetic clay liner (GCL) overlain by an 80-mil double-side textured LLDPE geomembrane. The GCL was used in lieu of the prepared sub base to simplify construction and extends about a foot outside the edges of the PCMS trench. Figure 2-12 illustrates the design.

The PCMS serves to monitor the performance of the liner system beneath the solution collection headers. These headers have been placed in the three drainages where concentrated flow is anticipated, the valleys are designated Valleys 1, 2 and 3, of the heap leach pad. The PCMS monitors for leaks through the liner beneath the solution collection headers where they are outside the limits of the in-heap storage pond.

If leakage occurs through the liner beneath the solution collection headers, it will be collected in the PCMS channel and conveyed by header pipes to the monitoring and discharge points.

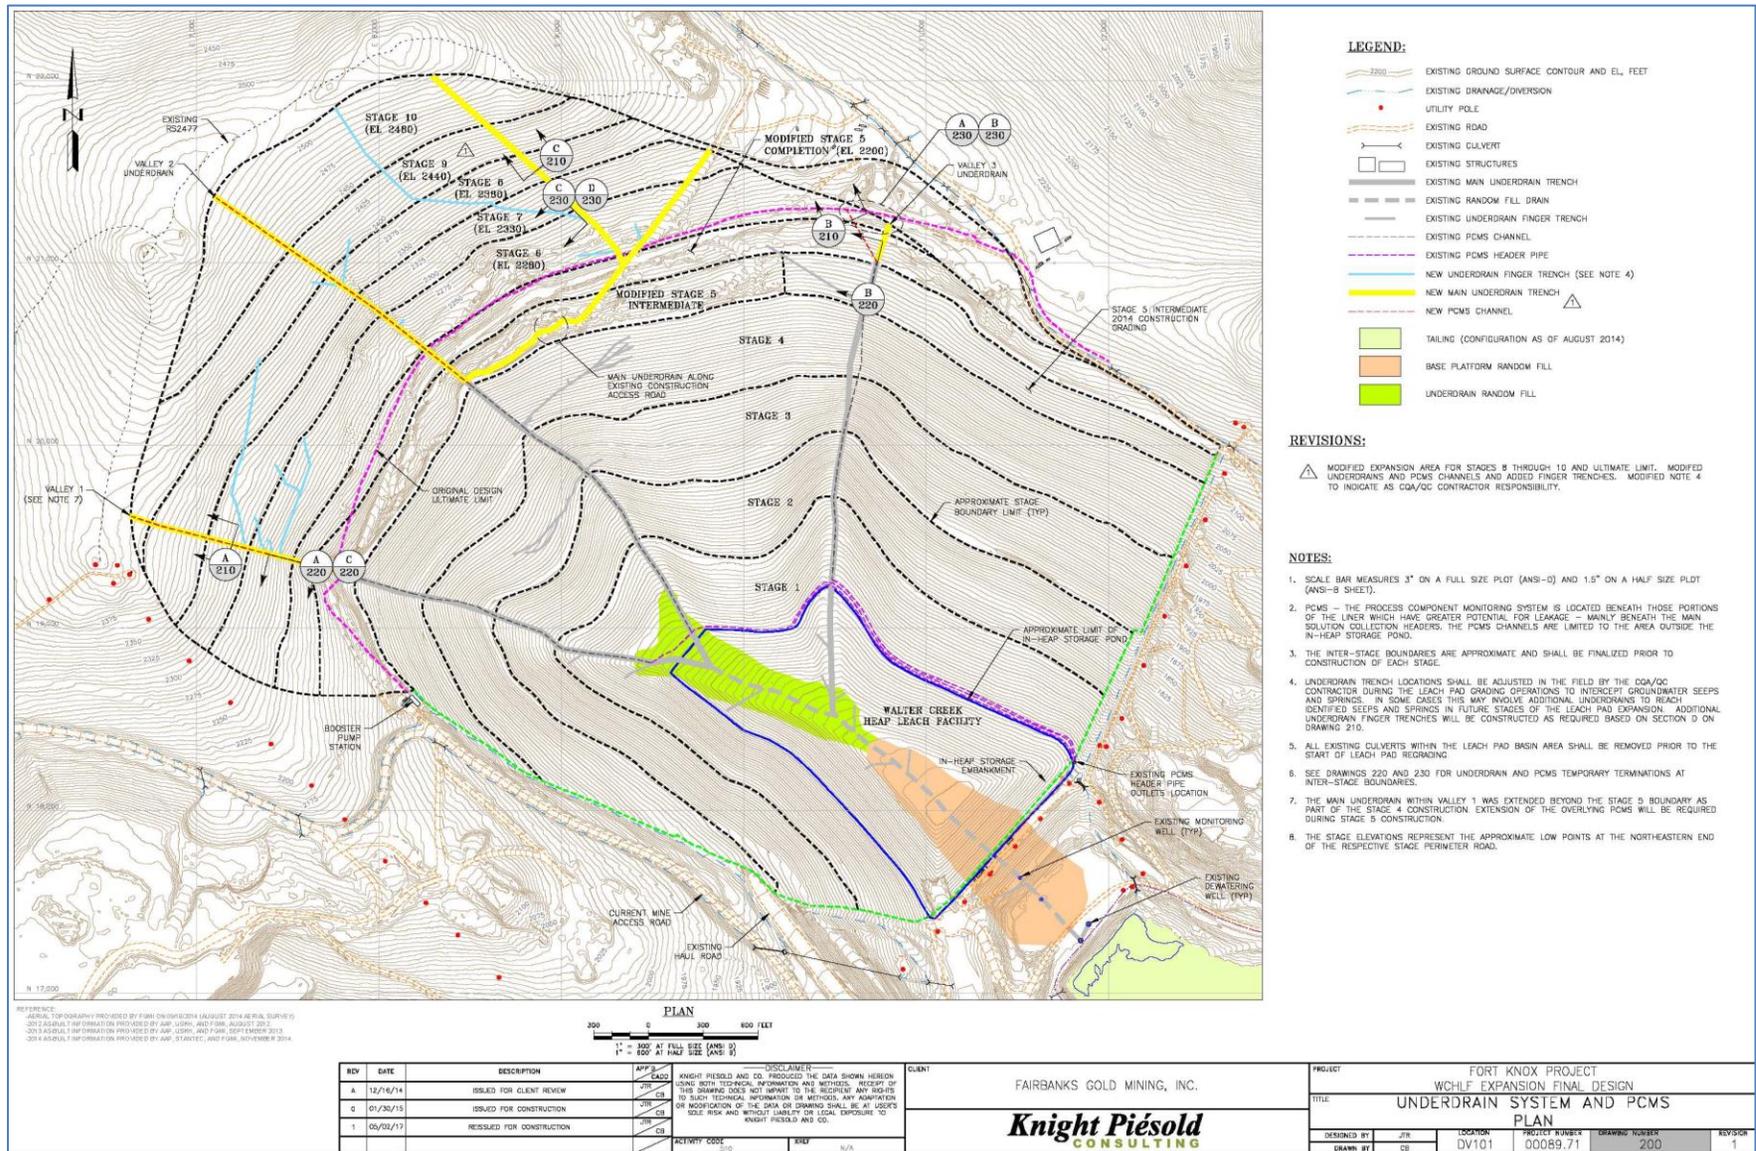
Figure 2-13 – PCMS and Underdrain System

The 4-inch-diameter PCMS header pipes are routed along an alignment just above the north side of the in-heap pond. The pipes follow a 1% slope down gradient to the outlet monitoring points and operate through gravity flow. The outlet monitoring point is in the northeast corner of the in-heap storage pond at a location downstream of the ore pile but upstream of the in-heap storage pond embankment. The outlet monitoring points are exposed and easily accessible to field monitoring personnel and will discharge any flows directly onto the double lined pond area. The pipes penetrate the single geosynthetic liner in a reinforced concrete block and the geomembrane is connected to the concrete block by embedment strips. This penetration is just above the transition boundary from the double lined in heap pond (below) to the single liner (above). The last 50 feet of the pipes are heat traced to prevent icing of the outlets in winter. The PCMS plan is shown on Figure 2-13.

A number of groundwater springs and seeps, including the original Walter Creek, flow down and through the valley bottom. An extensive underdrain system incorporating trenches and coarse rock fill has been included in every stage of liner construction including the region below the in-heap pond. The system is designed to collect flows below the lined areas and route them to a sump downstream of the embankment. Ground water sources and surface water outside, or above, the active leach pad are transported around the pad in diversion channels. This both serves to reduce the flow required to pass beneath the leach pad and limit recharge to seeps/springs.

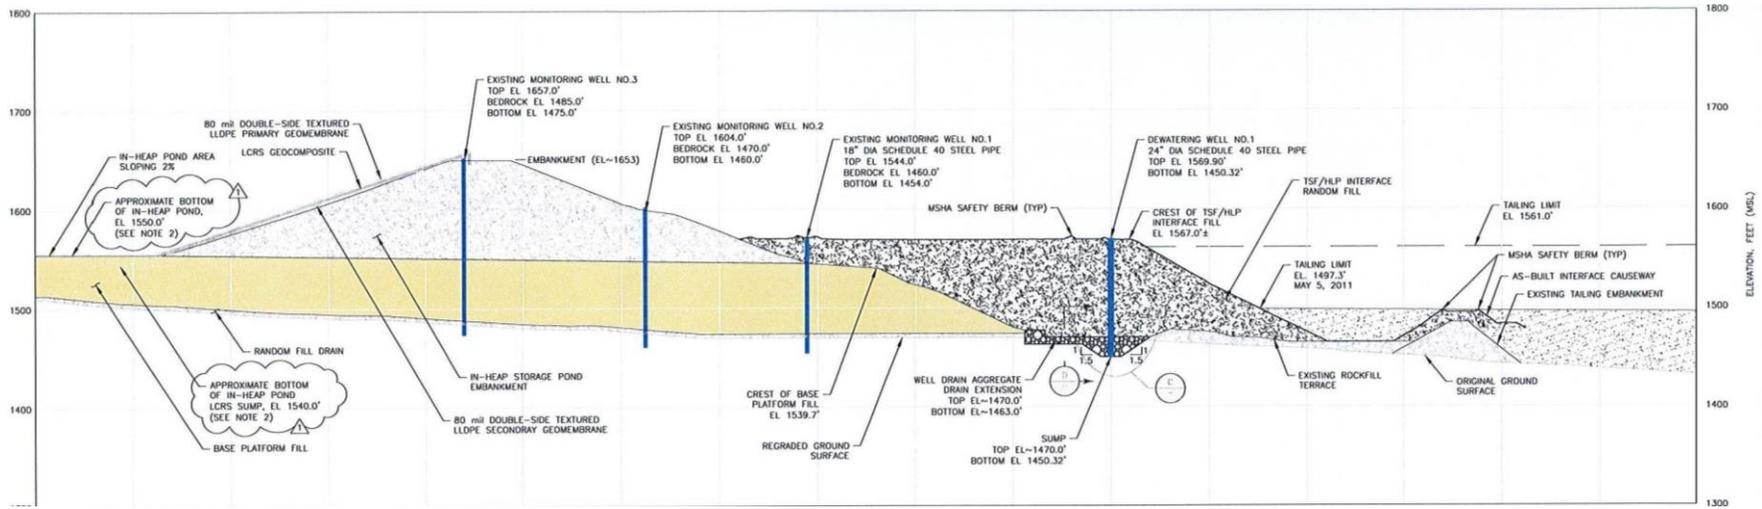
Figure 2-14 – Dewatering Wells At TSF/HPL Interface

Two underdrain dewatering wells are installed at the TSF/HPL interface fill through the heap leach underdrain, see Figure 2-15 and Figure 2-16 below. These wells were constructed in place as the random fill was placed. They are on the same plane 100 feet apart. Their designed intent is to capture any backflows from the tailings pond prior to such flow entering and restricting the underdrain flow into the TSF. In theory, when operating they will effectively reduce pressures from developing at the underside of the in-heap storage pond liner system. Per design, the pumps need to be operating when the TSF pond water elevation reaches 1540' or higher. Water elevations are such that continuous pumping is now required.

A permanent pump is installed in Dewatering Well 1. The water elevation in DW 1 is typically 5 feet lower than DW 2.

Increased water levels in the wells does not pose a geotechnical stability issue for the WCHL facility or dam. Potential uplift on the LCRS liner is undesirable for a number of reasons, but mainly due to the potential for infiltration of groundwater into the LCRS. Review of the LCRS water quality data and pumping volumes indicate there is currently no infiltration of decant water or groundwater into the LCRS.

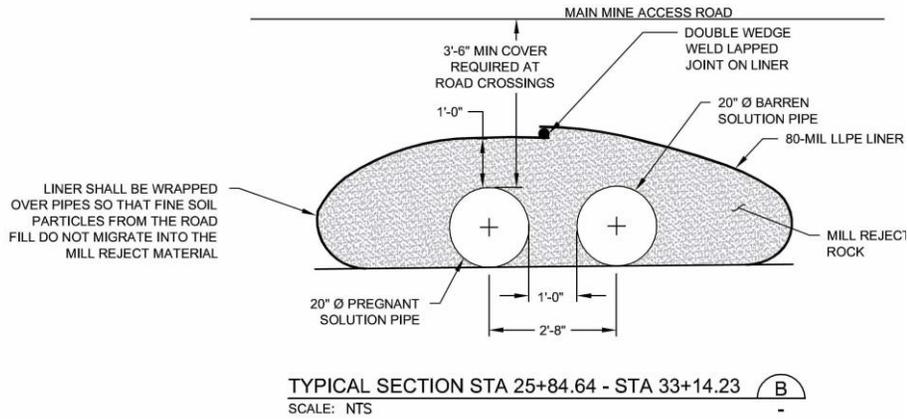
Figure 2-16 – CIC #2 Pipeline Corridor Detail 1

The pipeline corridor conveying the pregnant and barren lines from the two 2012 solution collection wells to the CIC#2 plant was designed using the same standards and criteria as the corridor to CIC#1. There was minimal disturbance of the CIC 1 pipeline corridor to maintain its integrity. The second pipeline corridor is approximately 2,500 feet in length. Starting from the trestle bridge, the pregnant and barren lines enter a corridor trench located next to the mill parking lot. Where the corridor crosses below the access road, the pipes were placed on 80 mill LLDPE liner that was backfilled with mill reject material and folded over itself, see Figure 2-16 on the following page. This portion of the corridor does not interact with CIC#1 corridor.

The trench is filled with overliner drain aggregate, which protects and covers the pipes. Additionally, the permeable overliner aggregate will pass small flows from pipe leaks to the heap leach pad. The overliner drain aggregate will allow an estimated capacity of 25 GPM flow to the leach pad, which is sufficient for a minor leak. Any flows through the trench will be detected and alert operators of the need for a pipeline repair. To facilitate the location of a leak, a series of 4-inch PVC and steel pipes with an atrium grating at the bottom were placed inside the trench at designated locations along the corridor. Inside of the trench, the pipe was placed on the side adjacent to the access road for easy access and monitoring.

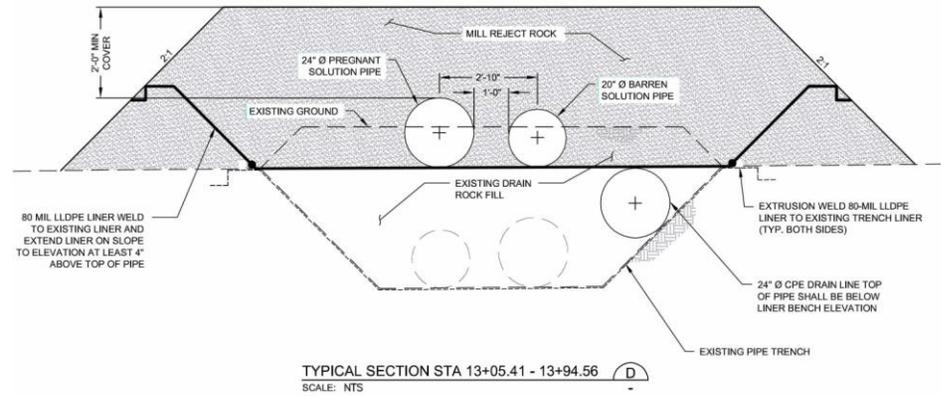
Figure 2-18 – Pipeline Corridor Detail 3

After the mine access road crossing, the CIC#1 corridor trench was carefully excavated to expose the trench liner, which was then connected to the CIC#2 corridor liner as seen in on the following page in Figure 2-17. To increase the flow capacity of the combined trench, a perforated, corrugated polyethylene drain pipe was installed. Inspection ports with similar spacing were installed between the CIC#1 corridor ports. This construction method exists between the mine access road and valve house enclosure except for a small section that is constructed using the design detail in Figure 2-18. The remaining run was installed following the design detail shown in Figure 2-19 on the next page.

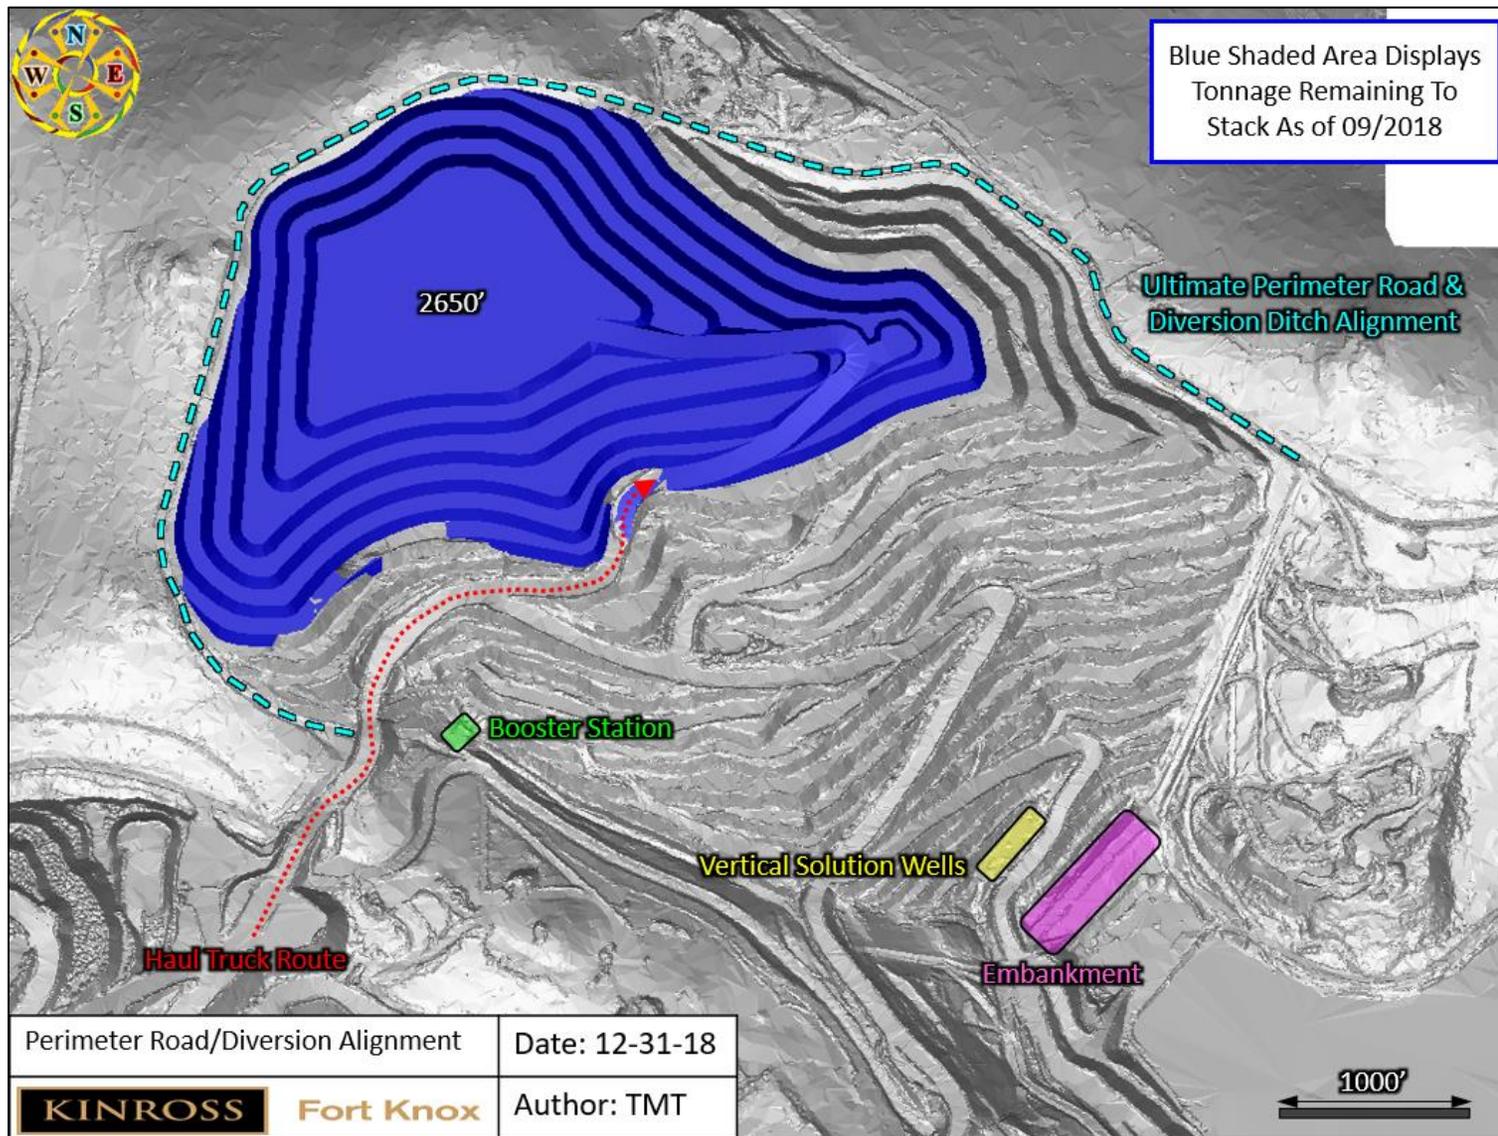
Figure 2-20 – Ultimate Perimeter Road Alignment

At the easternmost corner of WCHL, the ultimate pad perimeter road proceeds away from the facility as the Fish Creek utility road. To pass the design peak flows from upstream catchment areas, beyond the current organics and unsuitable waste stockpiles, improvements have been incorporated in the WCHL Expansion final design for the Fish Creek road and diversion channel. The improved diversion channel adjacent to the Fish Creek utility road is only envisioned to be required during the WCHLF operational period. See the following page for a general alignment.

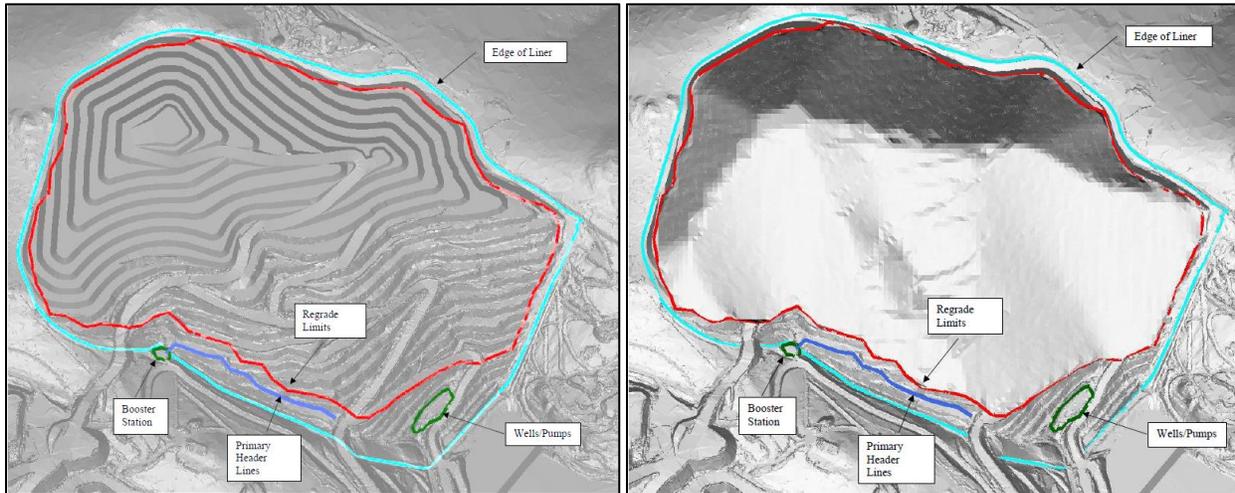
Figure 3-1 – Conceptual Pad Pre and Post Regrade & Project Limits

- A safety berm will be placed at the toe of the re-contoured slope. The berm must be of sufficient size to stop rolling and/or falling rocks from continued travel down the slope.
- The area will be surveyed and an as-built file created. This information will be compiled and incorporated into mine as-built topography files as appropriate.
- At the mines discretion, drip tube emitters may be placed or ripped into regraded slopes to allow for active leaching of the area.

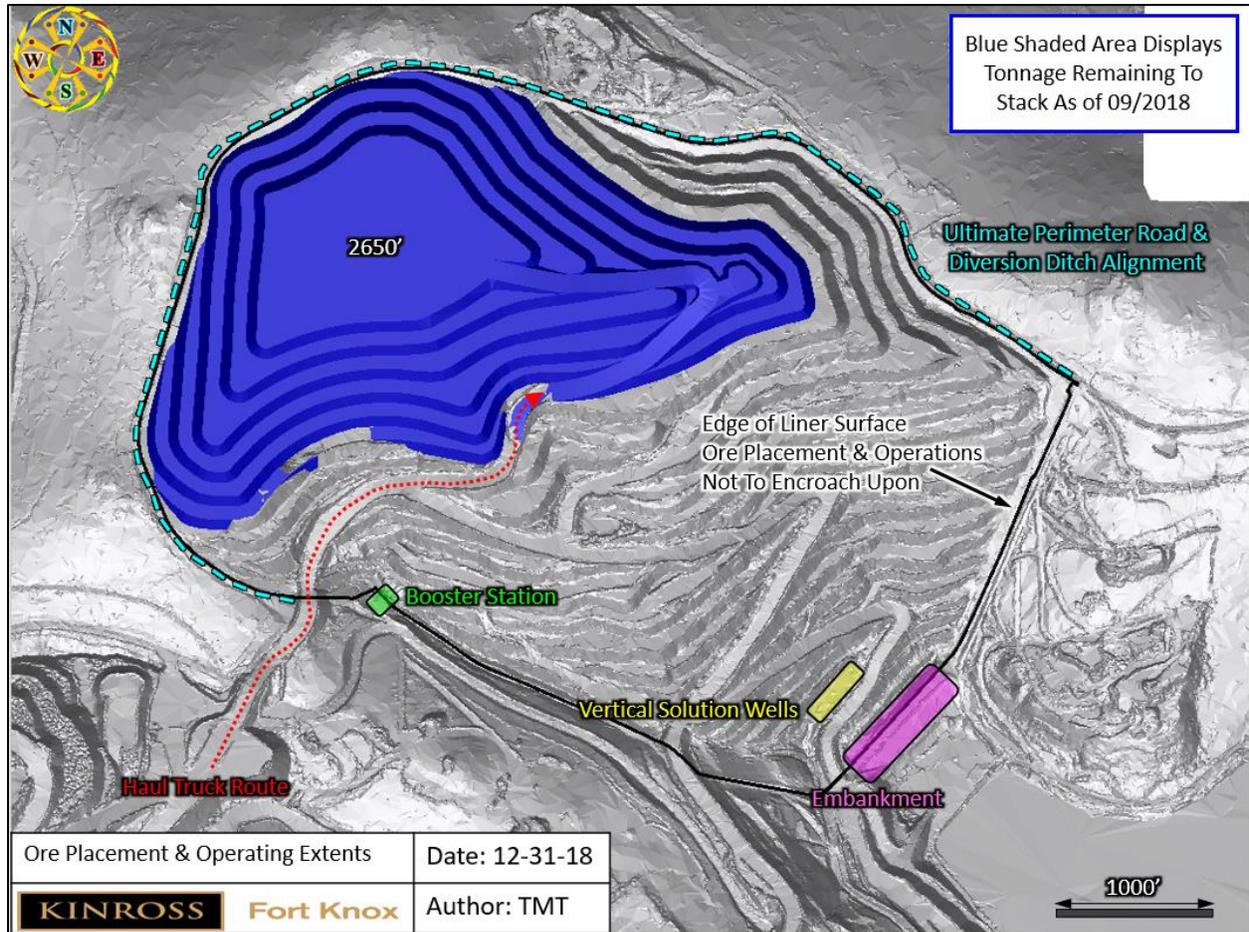
Figure 3-3 – Limits of Leaching and Ore Placement for Stage 10.

With the completion of liner construction through stage 10 in the 2018 construction season, the approved ore stacking and leaching area has been expanded. The current ore loading and leaching configuration is shown in Figure 3-3 and encompasses all liner stages constructed through stage 10. Note that the top elevation of material placement is limited to the 2650' elevation.

Ore is placed under leach at a rate of up to 20,000 gpm or up to a unit rate of 0.005 gpm/ft². At any one time there can be up to 4.0M ft² of ore being leached at the prescribed unit rate. Under the direction of the Chief Metallurgist or their delegate, FGMI may choose to increase the amount of area under leach through the lowering of the application rate to less than 0.005 gpm/ft². The amount of total solution applied to the pad shall not exceed 20,000 gpm.

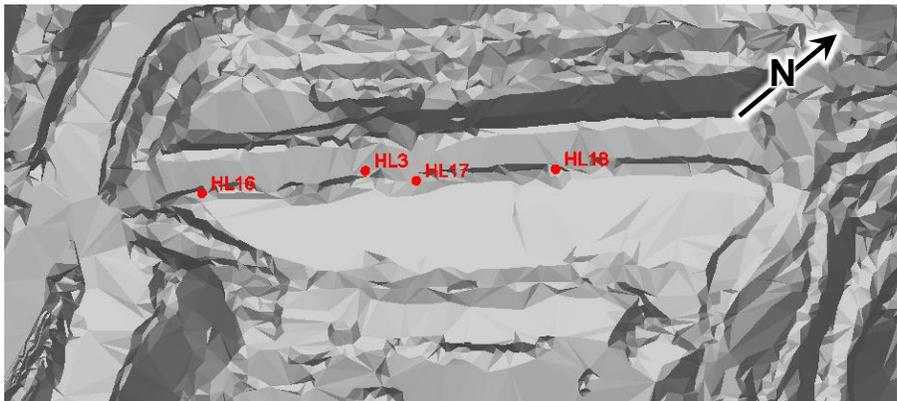
Figure 3-4 – WCHL Embankment Prisms

Seven survey monuments are installed to enable monitoring of embankment movements. Three are located on the 50-foot-wide bench at the top of the base platform. Surveying the four embankment monuments will be on a quarterly basis. These are also to be surveyed following any significant seismic event. Data will be reviewed by the Engineer of Record (EOR) at a minimum of once per year. Review by the EOR will occur more frequently if movements in any direction exceed 0.05 foot from the movements reported in the previous annual inspection. FGMI’s survey department records survey data in a spreadsheet which is entered into the Fulcrum database.
