KINROSS

Fort Knox

**WALTER CREEK VALLEY FILL
HEAP LEACH PAD
OPERATIONS & MAINTENANCE MANUAL
REVISION 15**

**Fairbanks Gold Mining, Inc.
A Subsidiary of Kinross Gold Corporation
P.O. Box 73726
Fairbanks, Alaska 99707-3726**

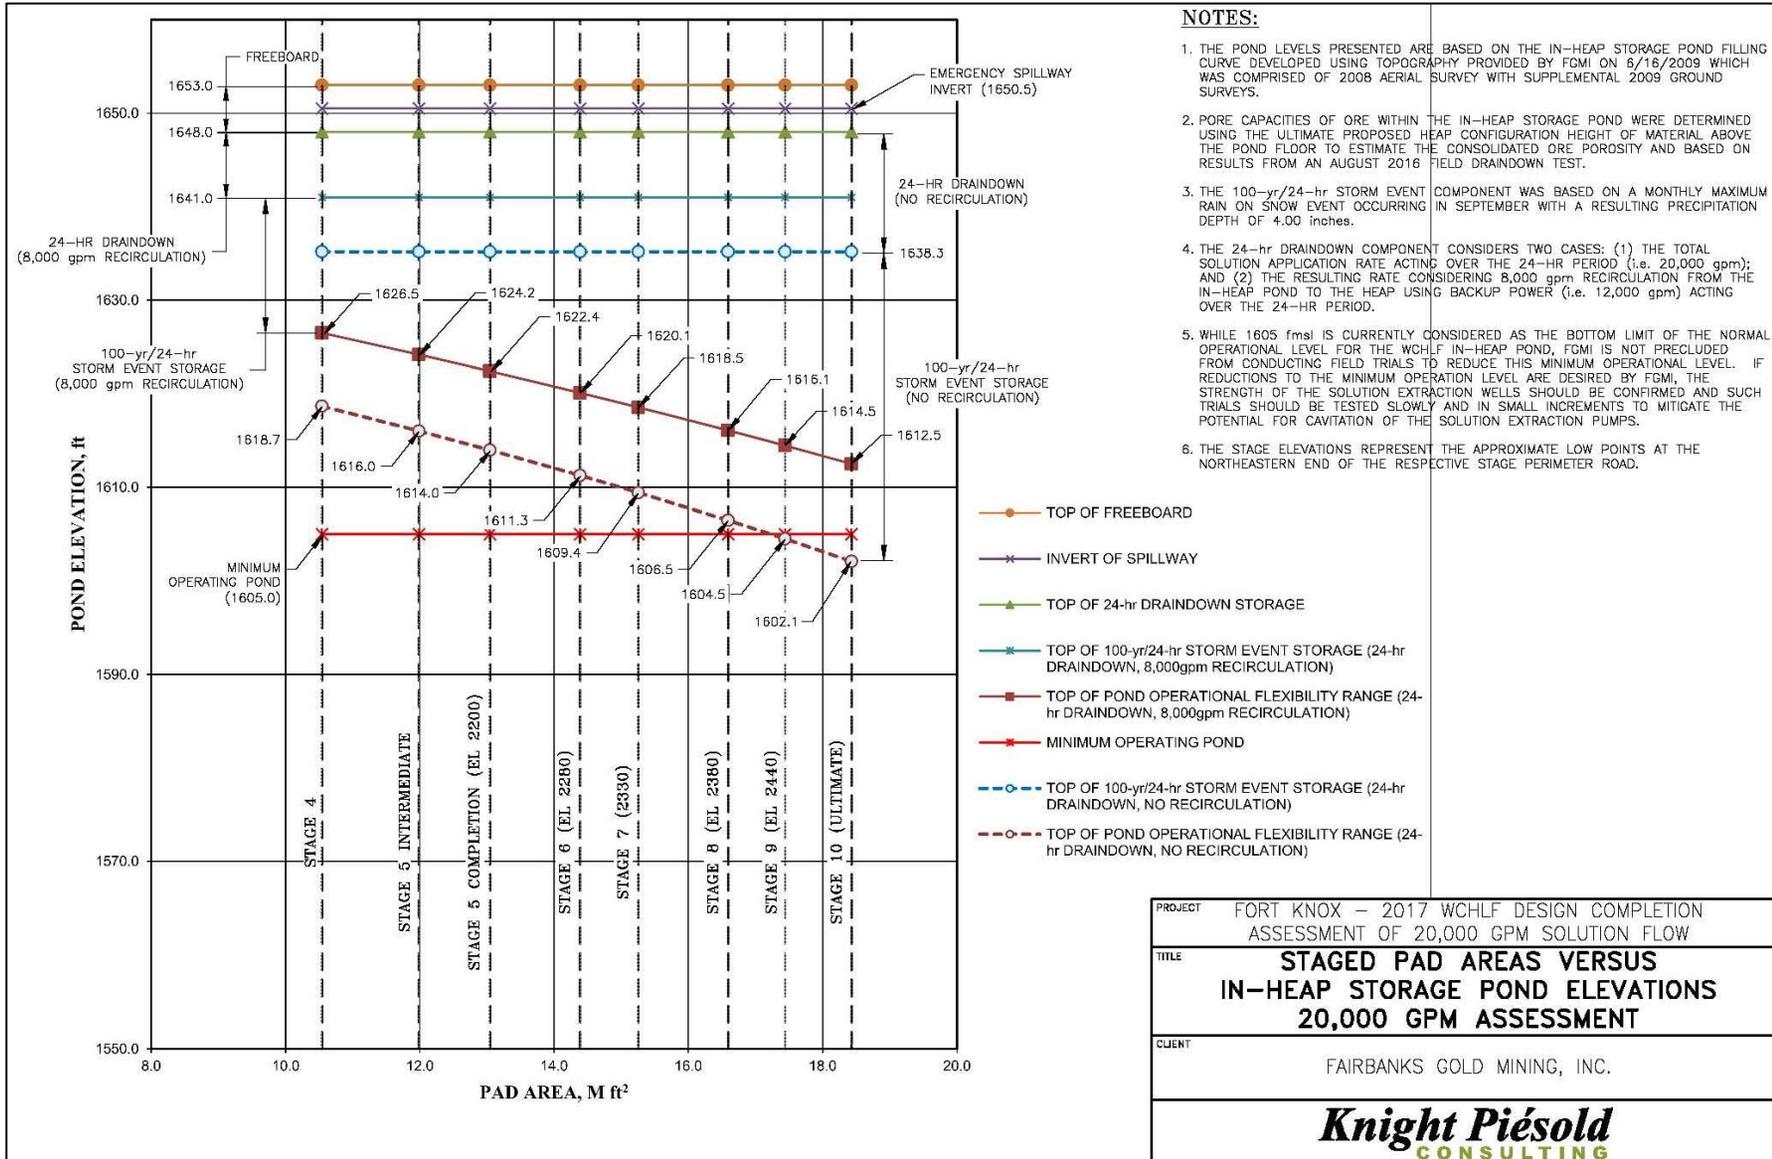
Figure 3-5 – Stage Pad Areas vs. Pond Elevations @ 20,000gpm

- **1650.5'** is the invert of the in-heap pond emergency spillway. During extreme conditions, flow will begin to pass through the spillway when water levels within the pond rise above this elevation. This occurrence could be from the design storm event acting on frozen ground conditions, or it could be due to a storm event that exceeds the established 100-yr/24-hr design event.

4. The 24-hr Emergency Draindown component provides storage for a condition where the power supply is interrupted or if pumps are temporarily rendered inoperable; both of which would result in reduced pumping capacity from the in-heap pond and its subsequent filling. Although FGMI has equipped the WCHLF with sufficient back-up power and redundant pumps such that 8,000 gpm would continue to be extracted from the in-heap pond and recirculated to the top of the ore heap, the 24-hr emergency draindown component was assessed based solution draindown rates of 12,000 gpm (i.e. considering 8,000 gpm recirculation) and 20,000 gpm (i.e. no recirculation). Due to the layering of the pond storage components, as presented, the components below the 24-hr Emergency Draindown are dependent on its storage requirement and elevation range.

5. During extreme conditions, flow will begin to pass through the spillway when water levels within the pond rise above this elevation. This could be from the design storm event acting on frozen ground conditions, or it could be due to extreme storm events above those established for the in-heap pond design criteria (i.e. greater than the 100-yr/24-hr storm event).

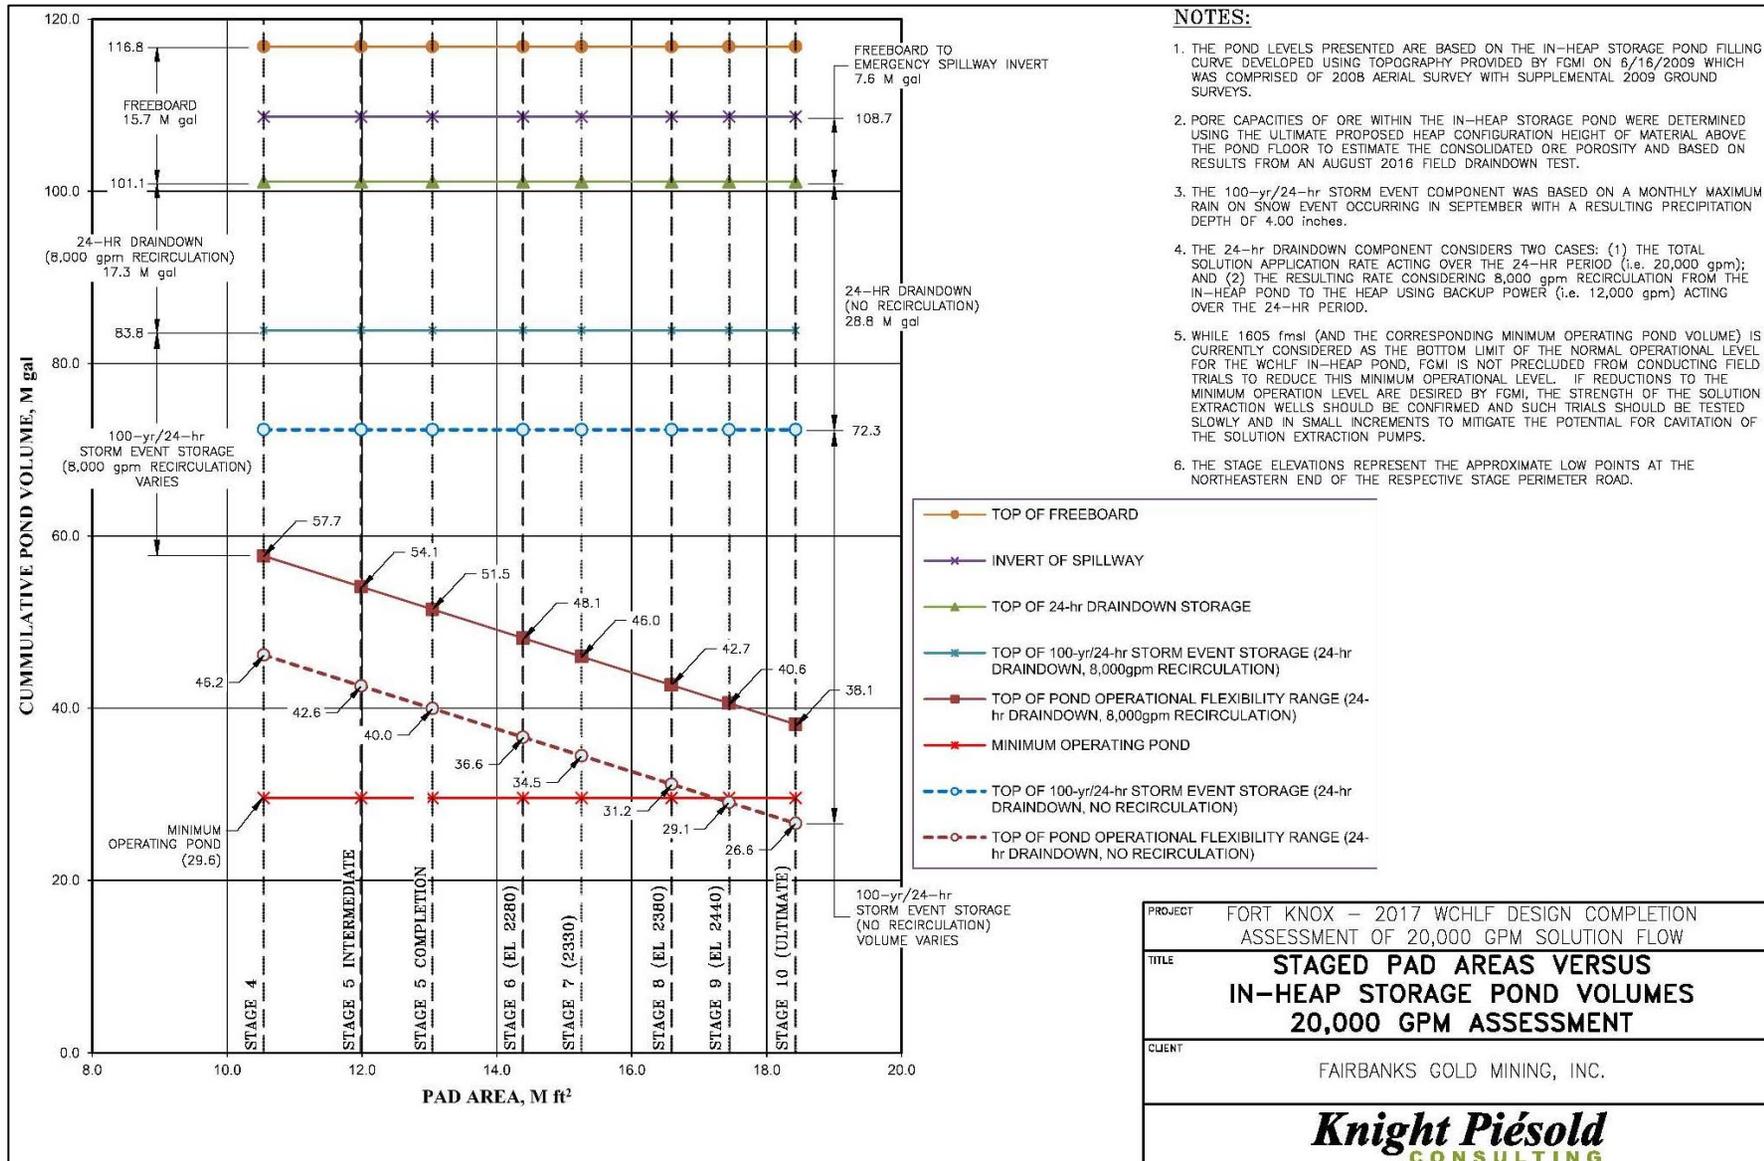
Figure 3-6 – Stage Pad Areas vs. Pond Volumes @ 20,000gpm

PROJECT	FORT KNOX – 2017 WCHLF DESIGN COMPLETION ASSESSMENT OF 20,000 GPM SOLUTION FLOW
TITLE	STAGED PAD AREAS VERSUS IN-HEAP STORAGE POND VOLUMES 20,000 GPM ASSESSMENT
CLIENT	FAIRBANKS GOLD MINING, INC.
<i>Knight Piésold</i> CONSULTING

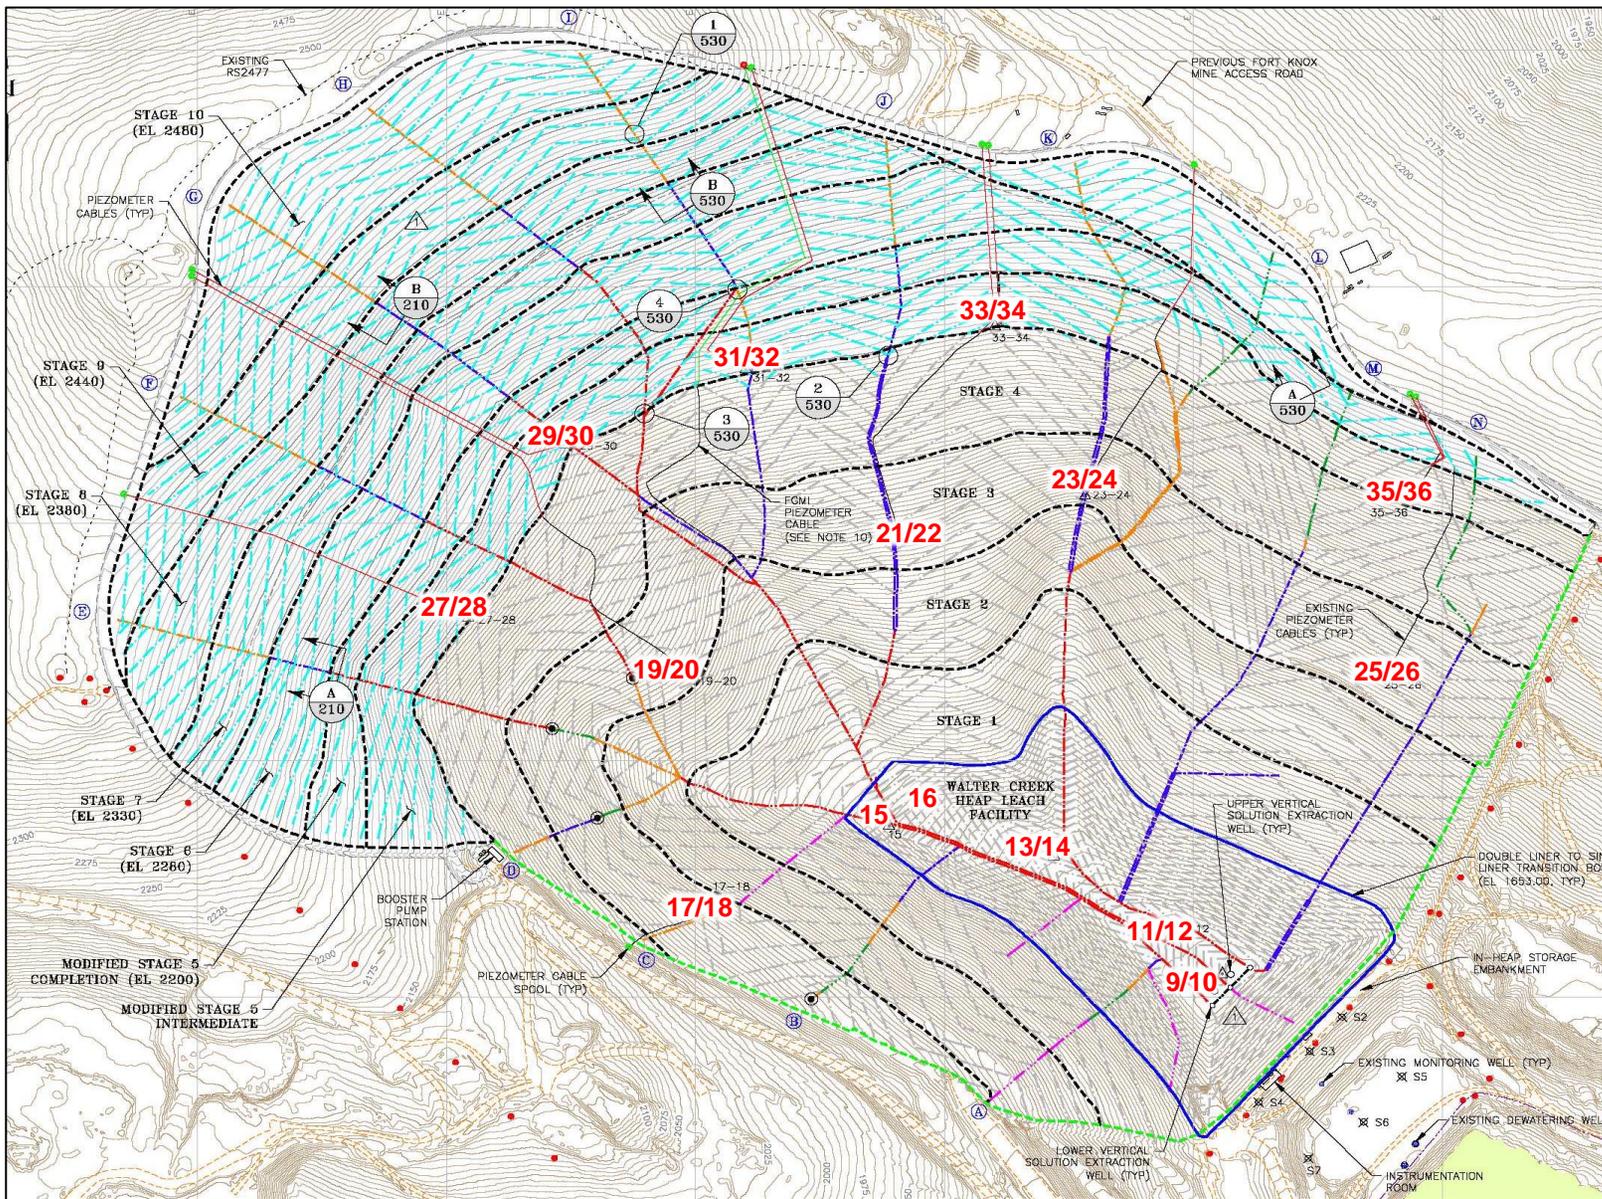
The leads from vibrating wire piezometers 9-16 are extended to a single monitoring location located on the right abutment of the in-heap storage embankment. These piezometers are also hardwired to the mill to allow for continuous and instantaneous readings.

In accordance with the original design, three pairs of vibrating wire piezometers are used to monitor solution levels within the in-heap pond. Piezometers have also been installed above the pond elevation, which are used to monitor the depth of solution on liner. The design calls for less than one foot of head on liner in these areas. See Figure 3-8 in the following section for details on piezometer locations.

See Figure 3-8 – Vibrating Piezometer Locations on the next page for location

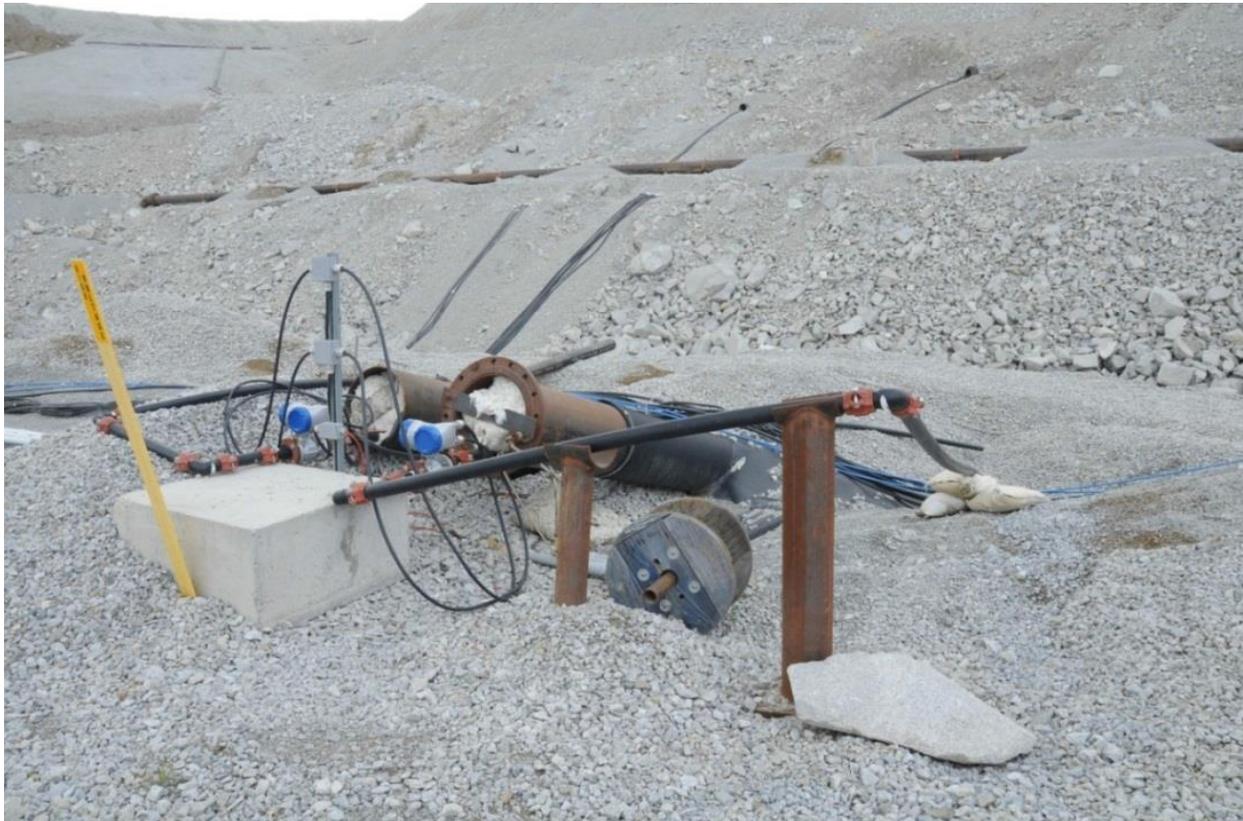
Figure 3-9 – LCRS Solution Collection Pipes

The LCRS monitors and collects process solution passing through the primary liner of the in-heap pond. It is buried beneath the pond so there is no practical way to perform maintenance. . The estimated leakage rate to the LCRS at the long term normal operating pond level is 330 gpm. A pond level at elevation 1648 feet will result in an estimated 520 gpm

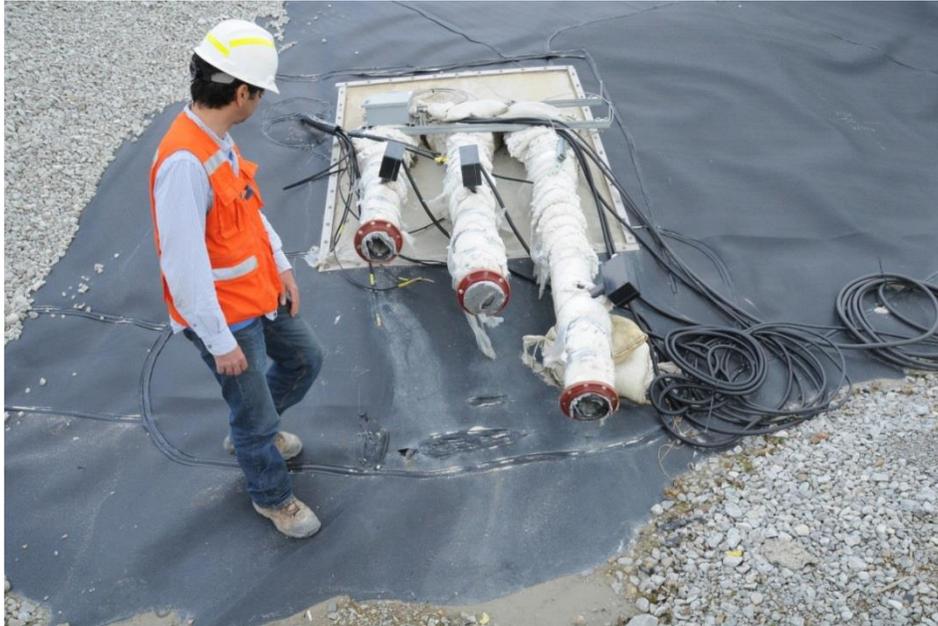
Figure 3-10 – Close-up View of the PCMS Outlets

The only accessible portion of the PCMS are the outlet monitoring points located in the northeast corner of the in-heap storage pond along the slope just behind the spillway. The outlet monitoring points are exposed and will discharge any flows directly onto the double lined pond area. The PCMS outlets have heat traces at the ends of the pipes that will be maintained as part of the routine FGMI maintenance program.

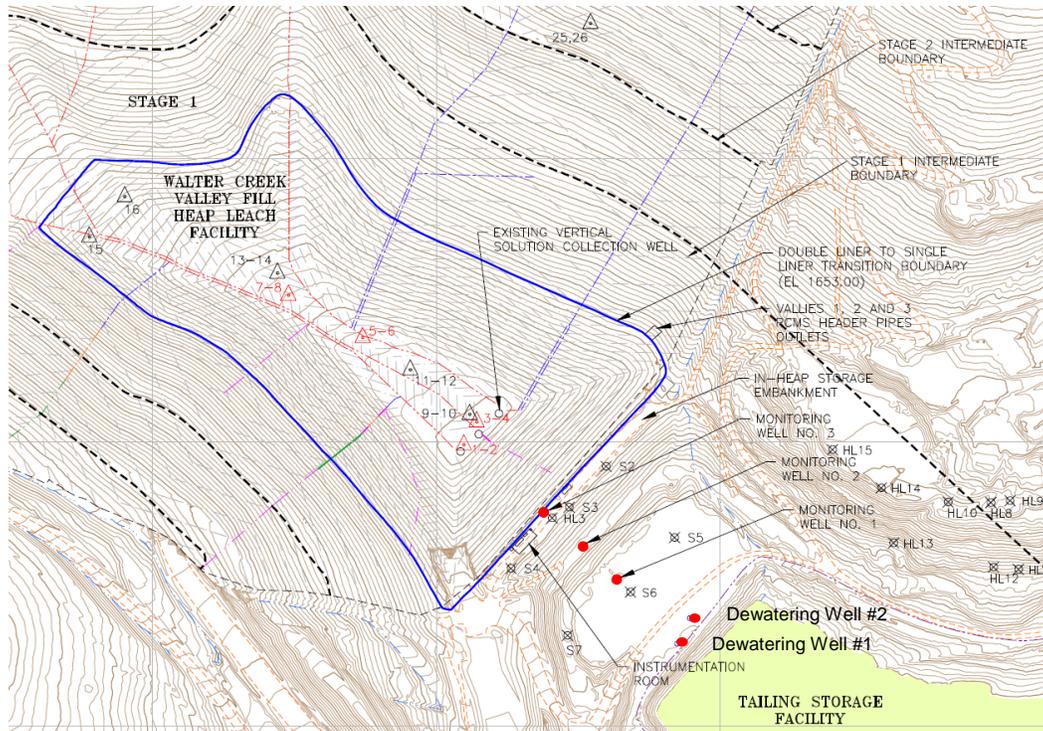
Figure 3-11 – Monitoring & Dewatering Wells

The surface around the monitoring wells shall be maintained such that ready access is available for reading water levels and water sampling. This includes snow management and removal from around the wells so that the above ground casing extensions are clearly visible to avoid damage. The above ground casing on all wells must be well marked and/or painted to be highly visible to an equipment operator.

The underdrain monitoring wells are provided for obtaining water quality samples, as well as measuring the water level in the drain. Three monitoring wells, seen above in Figure 3-11, are installed:

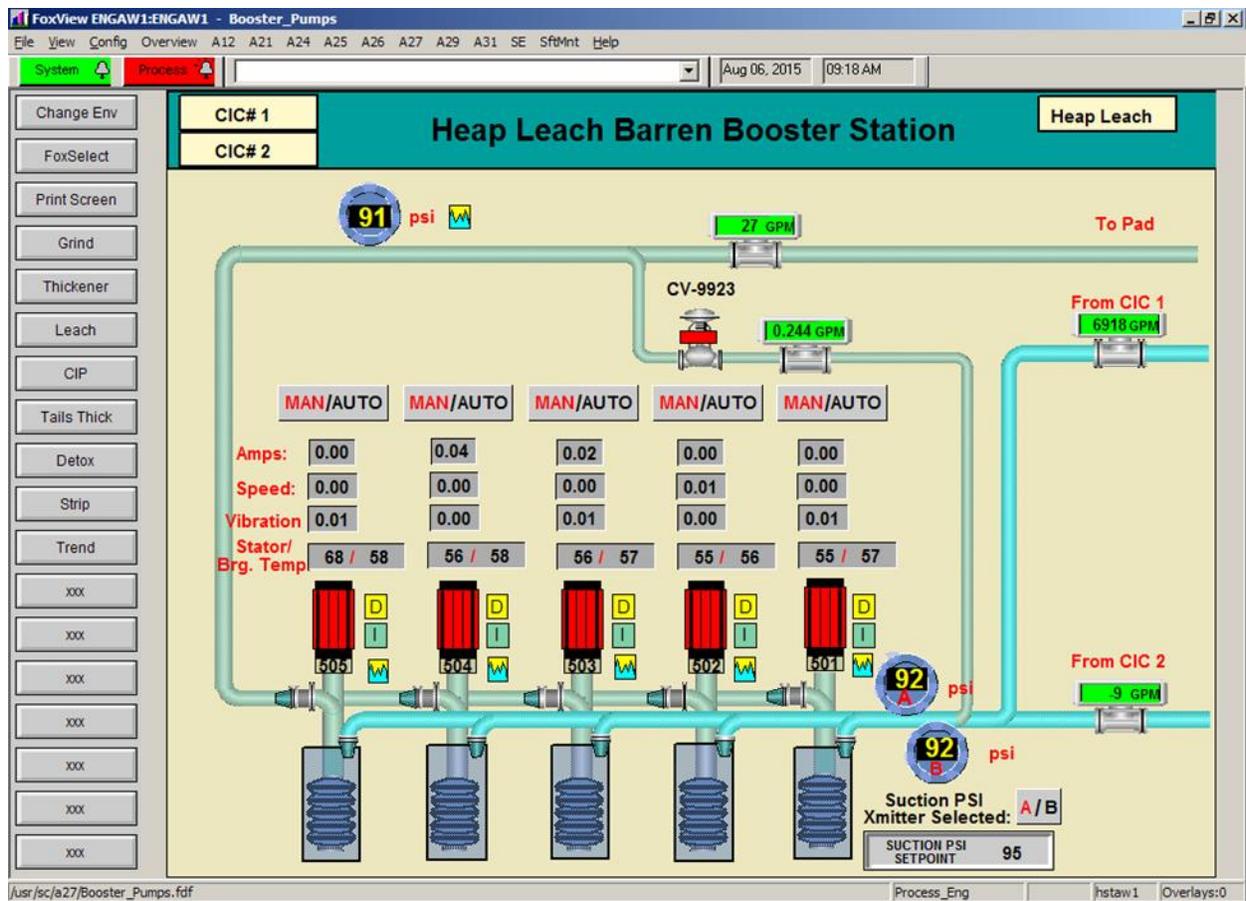
Figure 3-12 – CIC Booster Station DCS Interface

A recirculation valve has been installed to protect the equipment associated with the booster station, named CV-9923 in the DCS system. This valve is controlled by mechanical pressure and the indicator seen in the DCS is for the pilot solenoid that enables it. If the inlet pressure drops below 30 psi or any pump is placed into manual mode, whether it be at the local hand station or on the DCS, the pilot valve will open and allow operation of the recirculation valve. The indicator on the DCS screen does not indicate whether the valve is open or closed, just if it is enabled.

Each pump can be operated in manual or automatic mode. In manual mode, the pump speed and start/stop values are controlled by the corresponding inputs of the operator. In auto mode the pump speed and start/stop are automatically controlled by the process logic controller (PLC). Generally, active operation/oversight of the booster station is done remotely through the Data Collection System (DCS) interface in the mill control room. A picture of the DCS interface is seen in the following Figure 3-12.

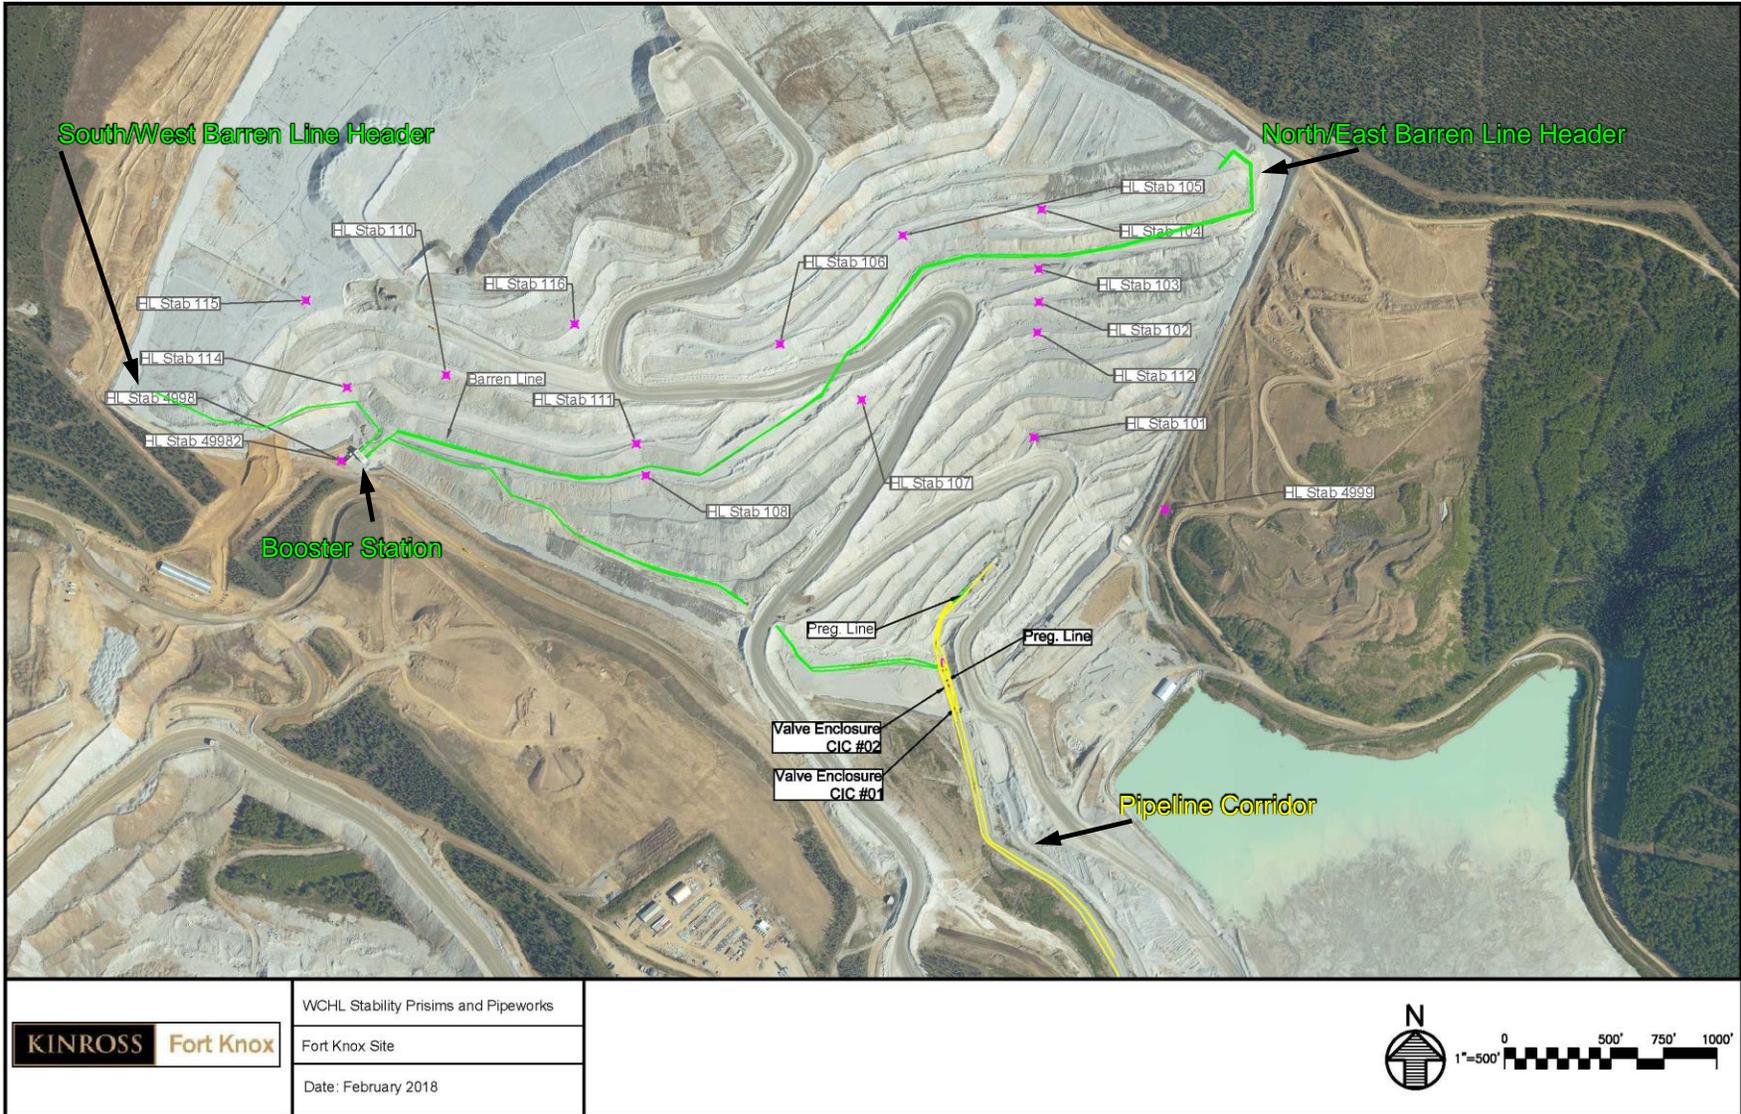
Figure 3-13 – On Pad Major Pipelines, Stability Prisms & Pipeline Corridor

Automatic alarm notifications will be distributed when surveys are out of tolerance by 1', 3' and 5'. Alarm notifications will be sent to the Chief Surveyor, Chief Engineer, Chief Geologist, Heap Leach Superintendent, and Technical Services Manager. The Chief Surveyor is responsible for monitoring the data received from the system. On receipt of a first level alarm, the area will be inspected to determine if actual slope failure movement is occurring. If a true stability concern is detected or thought to be potentially present, the monitoring frequency will be increased to a level agreed upon by the responsible parties above. In the event of a slope failure having occurred, or indications that one is beginning to occur are seen, the environmental department, engineer of record and site geotechnical department will be contacted to determine remediation and/or evacuation procedures. The Slope Failure form found in Appendix B will be completed and distributed. See Figure 3-13 on the following page for current prism locations.
