**GREENS CREEK MINING COMPANY  
GENERAL PLAN OF OPERATIONS**

**APPENDIX 11  
WASTE ROCK MANAGEMENT PLAN**

**November 2014**

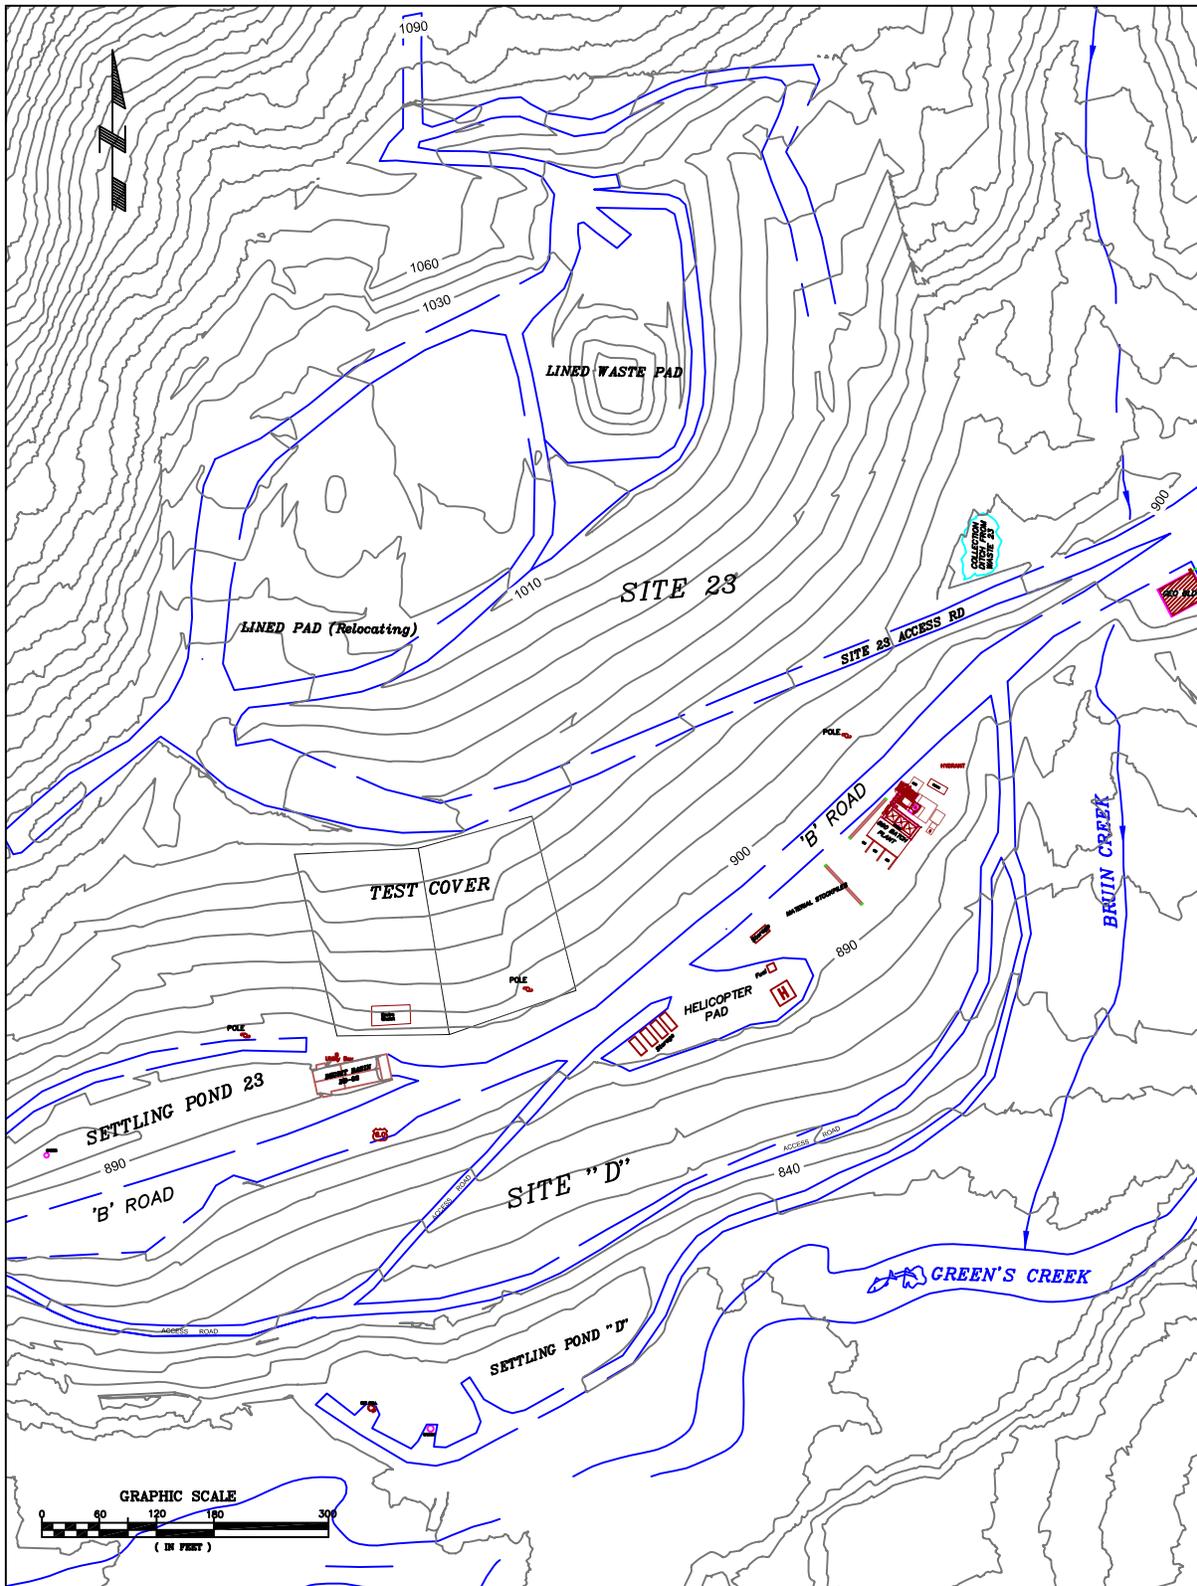
Figure 2. Site 23 As-Built - 2013

Attachment B, Figure 2 includes the 2013 Site 23 as-built for reference; refer to HGCMC annual reports for the most recent facility as-built.
